Periodic Review Report

(January 19, 2025 to January 19, 2026)

149 Kent Avenue
Brooklyn, New York
Site Number: C224159

February 18, 2026

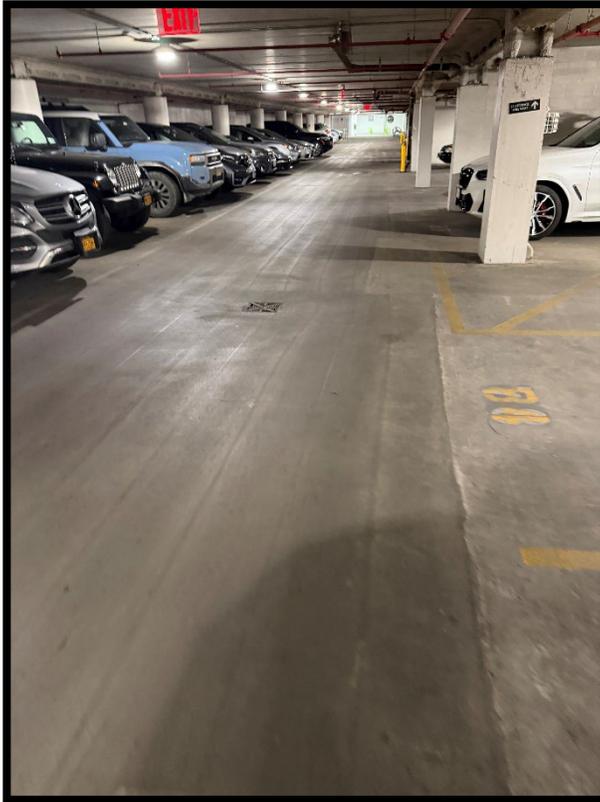
Photograph 1: View of cellar parking garage, looking east. All visible foundation elements were inspected.

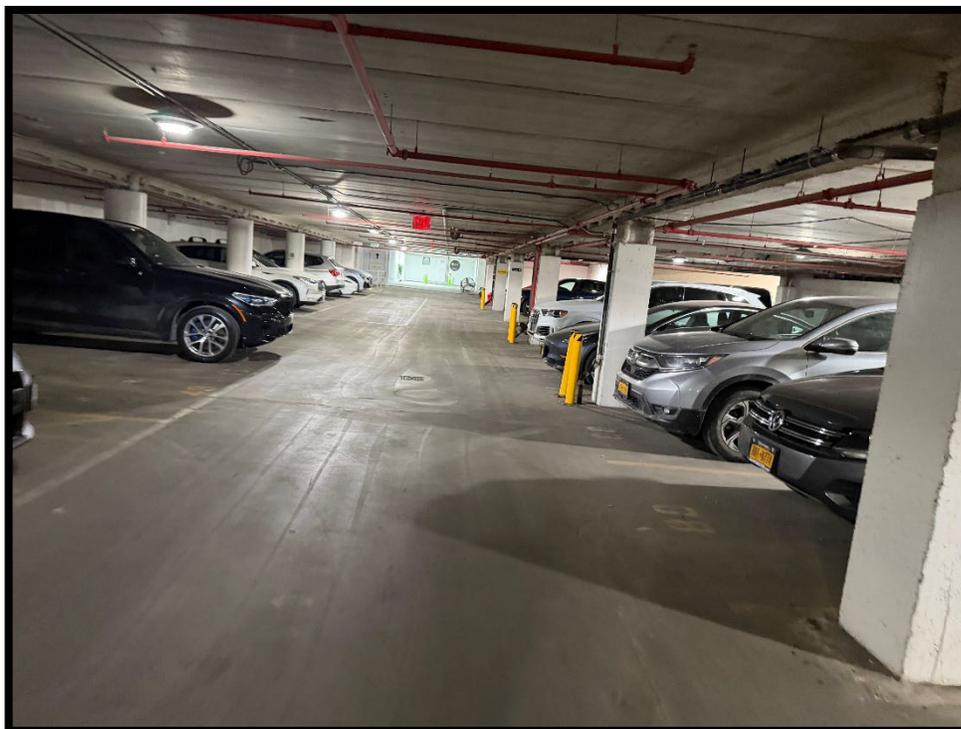
Photograph 2: View of cellar parking garage, looking east. All visible foundation elements were inspected.

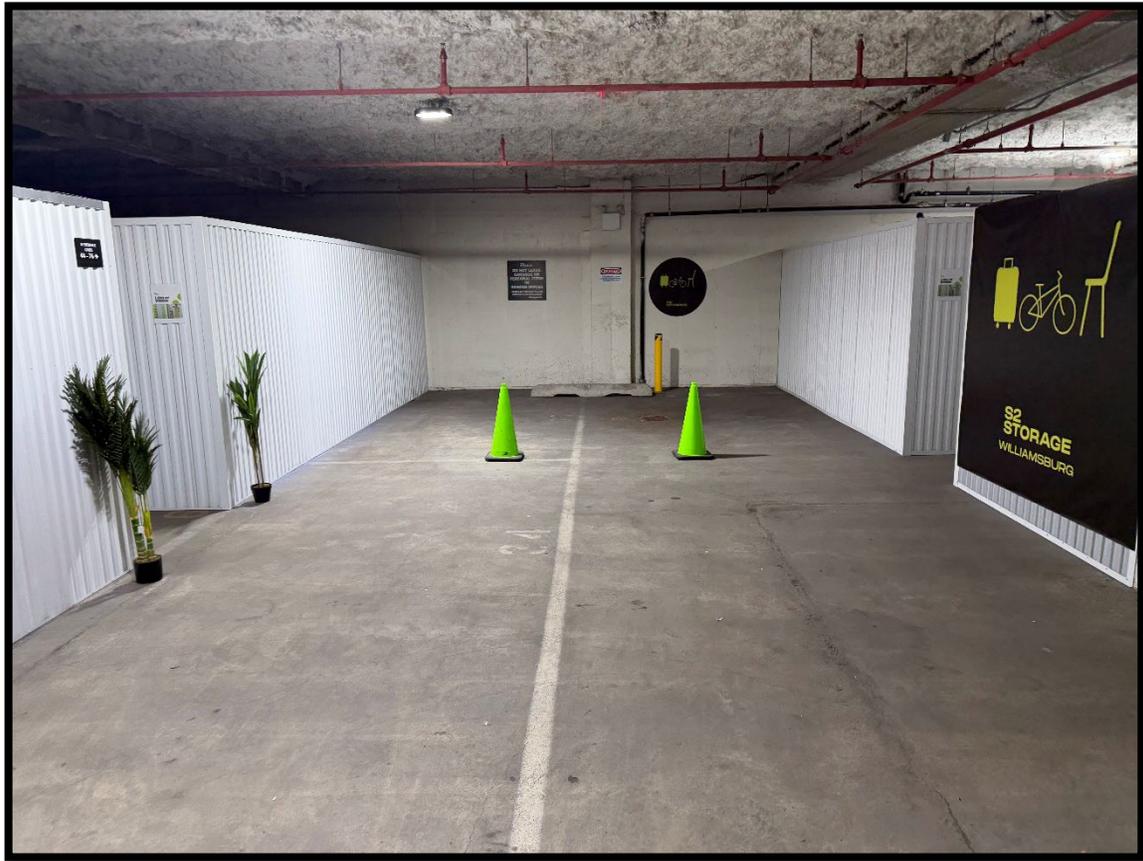
Photograph 3: Looking south, all site cover components were intact.

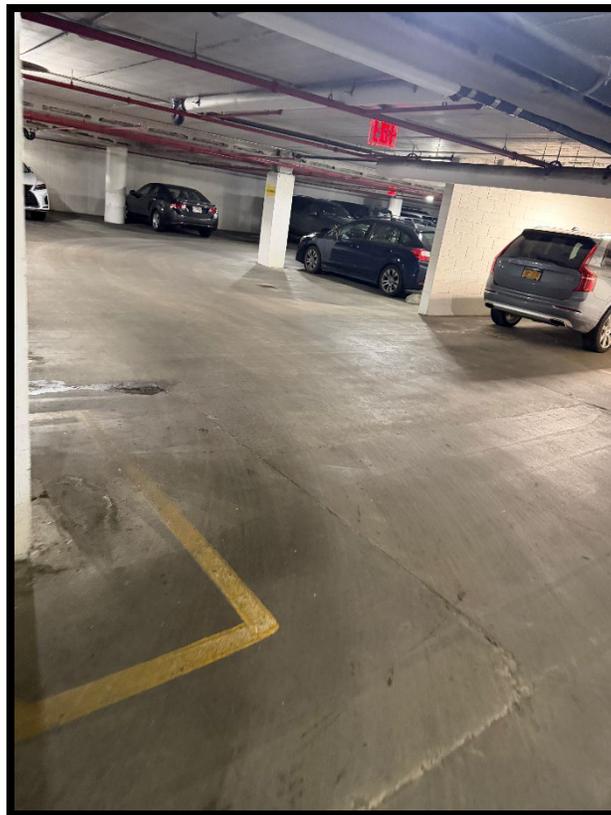
Photograph 4: View of overhead components and foundation elements.

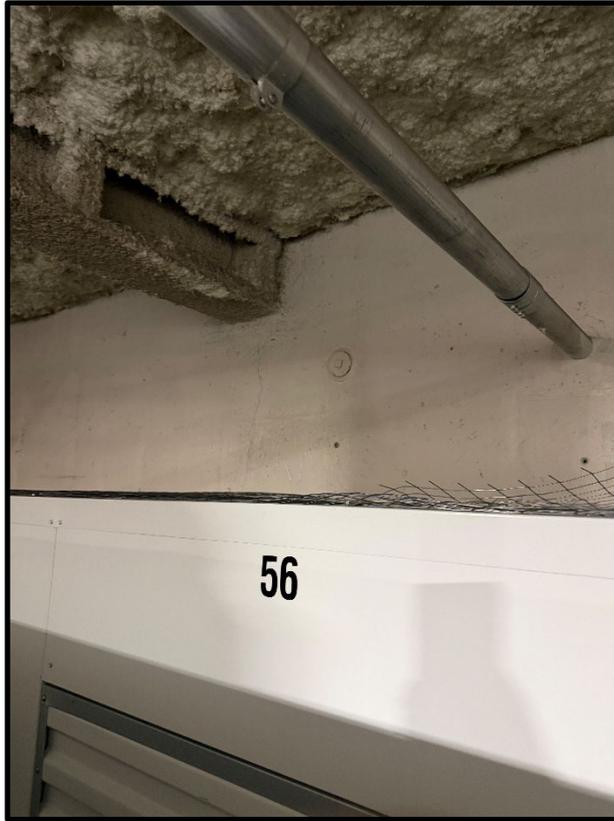
Photograph 5: View of MP-2 location and protective cover located on the east side of the northern wall of the cellar parking garage.

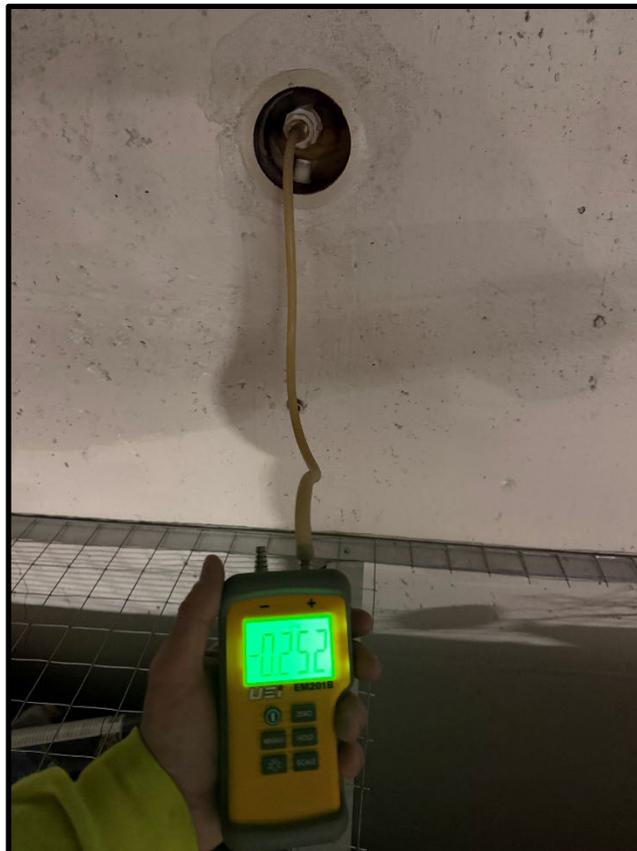
Photograph 6: View of MP-2 (east SSDS) field pressure test.

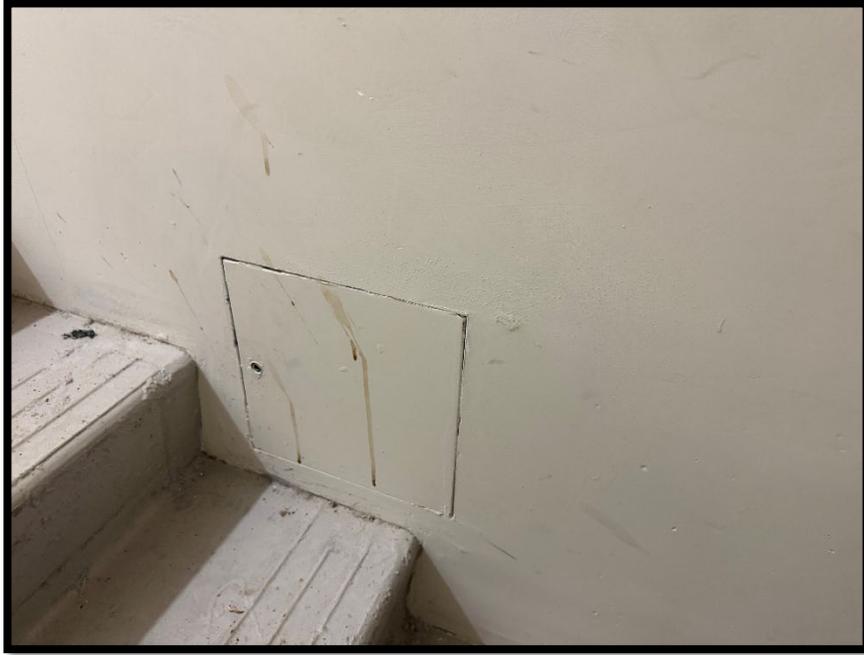
Photograph 7: Photo of lock box containing MP-1 (west SSDS) within stairwell between first floor to the cellar.

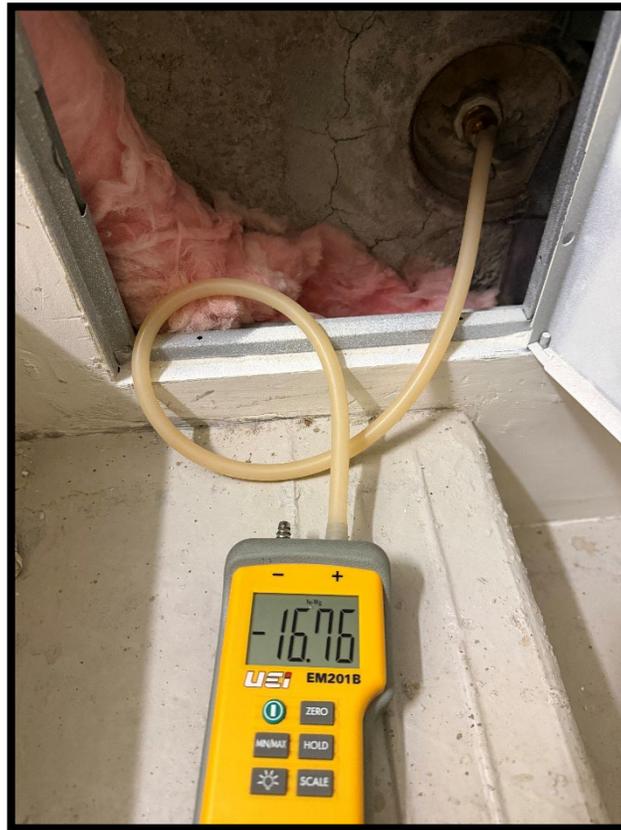
Photograph 8: Photo of MP-1 (west SSDS) field pressure test.

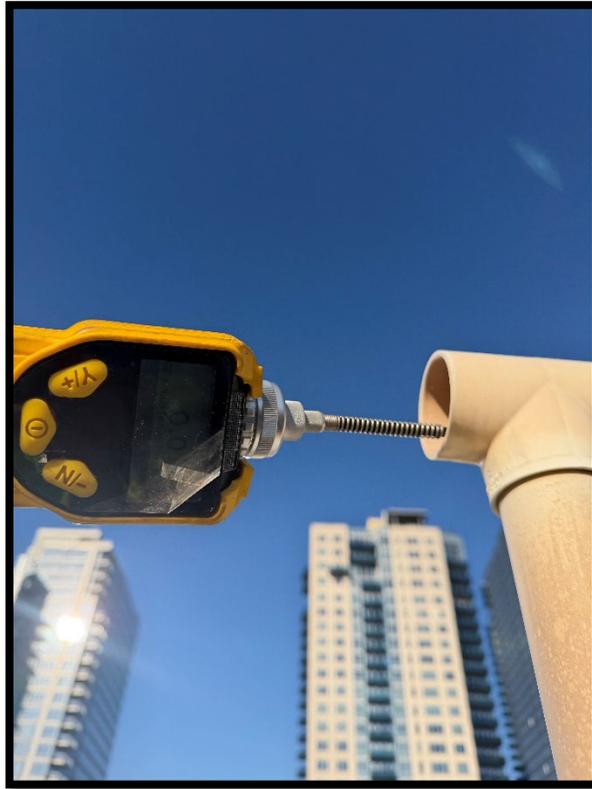
Photograph 9: View of 0.0ppm PID reading at SSDS Blower 1 (west).

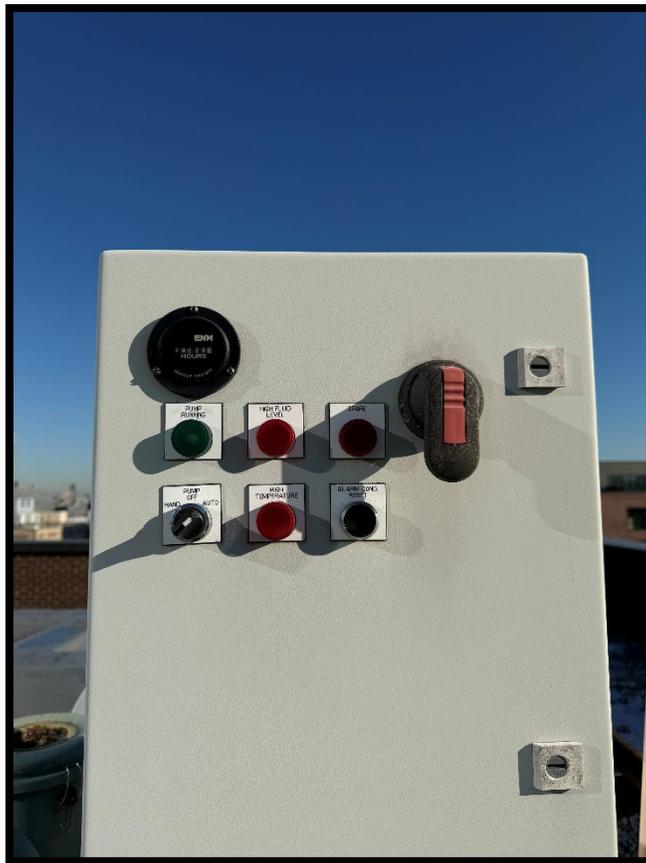
During the December 18, 2025 inspection it was observed that the green running lights on SSDS-1 and SSDS-2 were not working. During the same inspection, it was also observed that all three gauges at SSDS-1 and all three gauges at SSDS-2 (four vacuum gauges and two pressure gauges, total) were not working. These lights and gauges will be replaced in the first quarter 2026.

Photograph 10: View of SSDS Blower 1 (west) control panel.

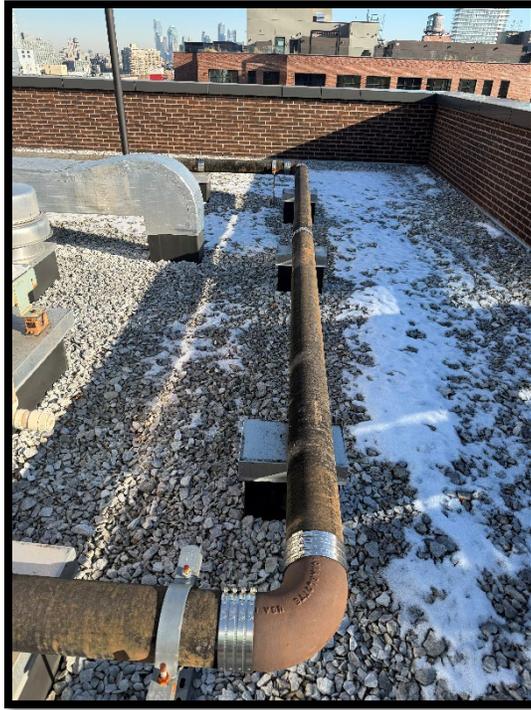
Photograph 11: Representative view of aboveground piping located on the roof leading to the SSDS Blower 1. All piping and couplings were intact.

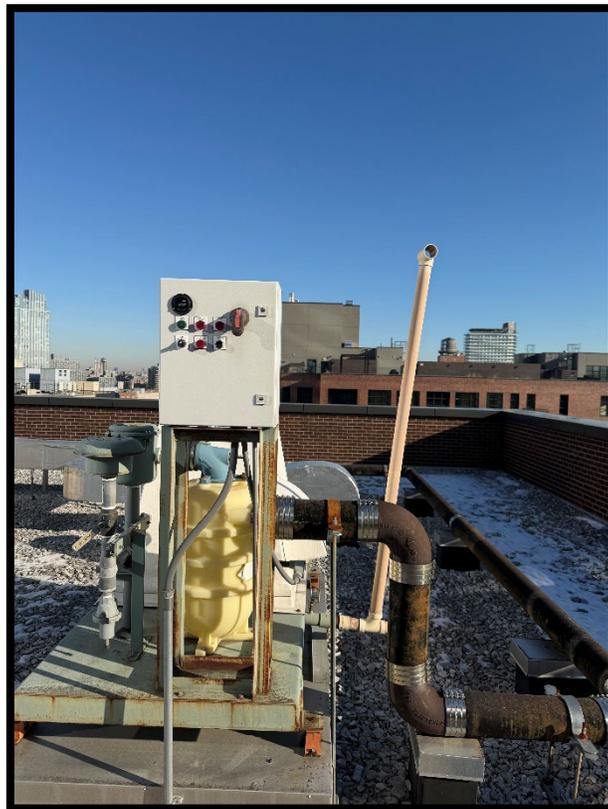
Photograph 12: Photo of the SSDS Blower 1 (west) configuration.

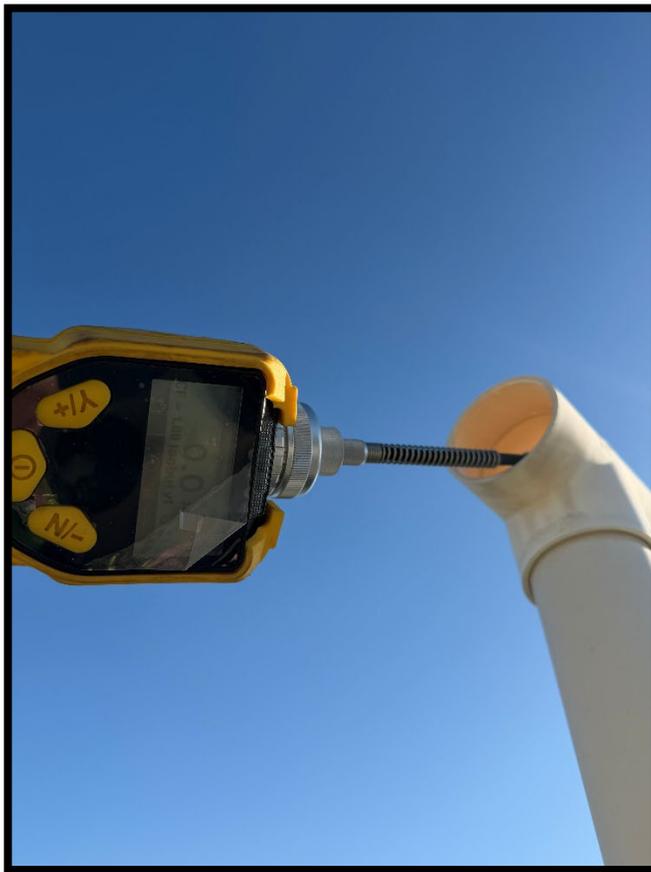
Photograph 13: View of 0.0ppm PID reading at SSDS Blower 2 (east).

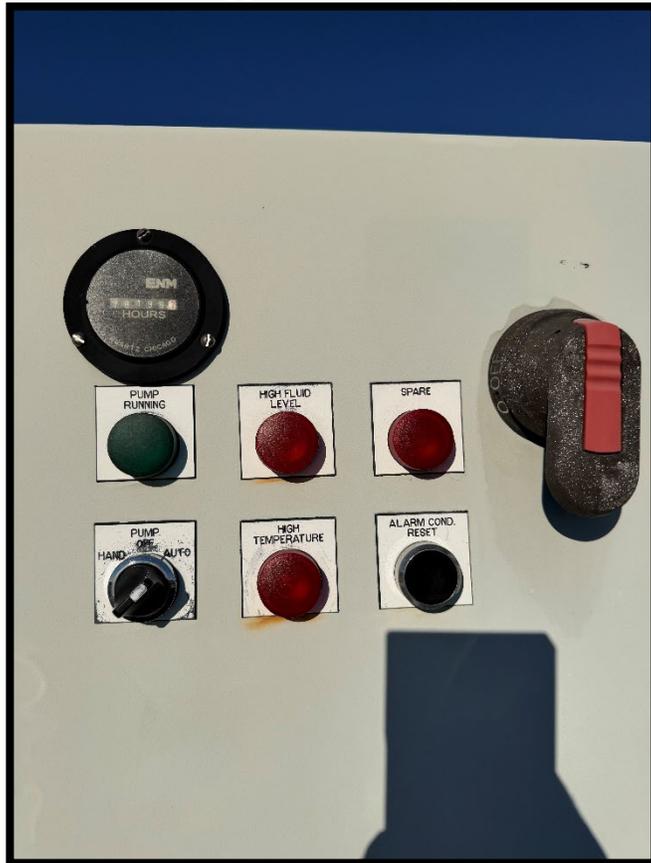
Photograph 14: Photo of SSDS Blower 2 (east) control panel.

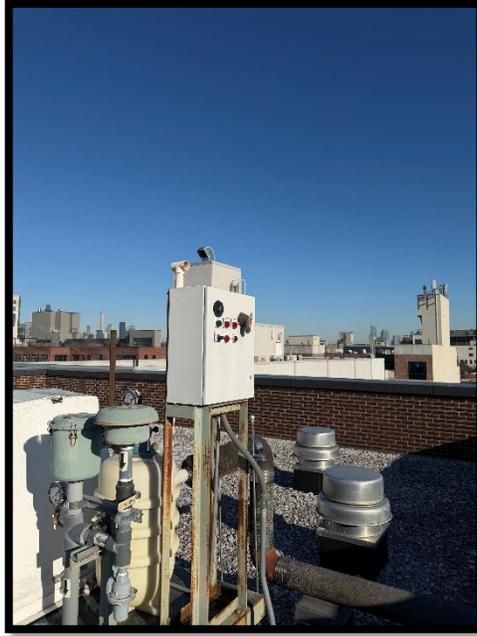
Photograph 15: Photo of the SSDS Blower 2 (east) configuration.

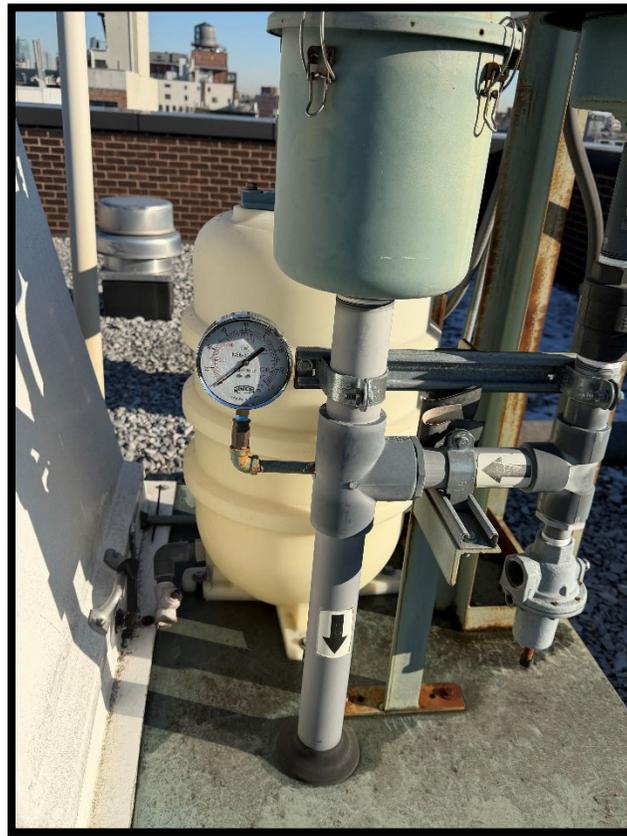
A. Aboveground Piping on Roof				
1 Inspect aboveground piping for cracks, leaks and support issues.	✓			
2 Inspect vacuum/pressure gauges and flowmeters for proper operation.		✓		VACUUM PRESSURE GAUGES NEED TO BE REPLACED

Photograph 16: Photo of SSDS Blower 2 (east) inlet filter and gauge to be replaced.
