MEMORANDUM

Subject: Monthly Progress Report
Former Cleaner Sales and Equipment Corp. NYSDEC Site No. 224177

Project No.: PE1022

Figure 1.
Site Sub-Slab Depressurization System and Monitoring Points
135 Kent Avenue, Brooklyn, NY

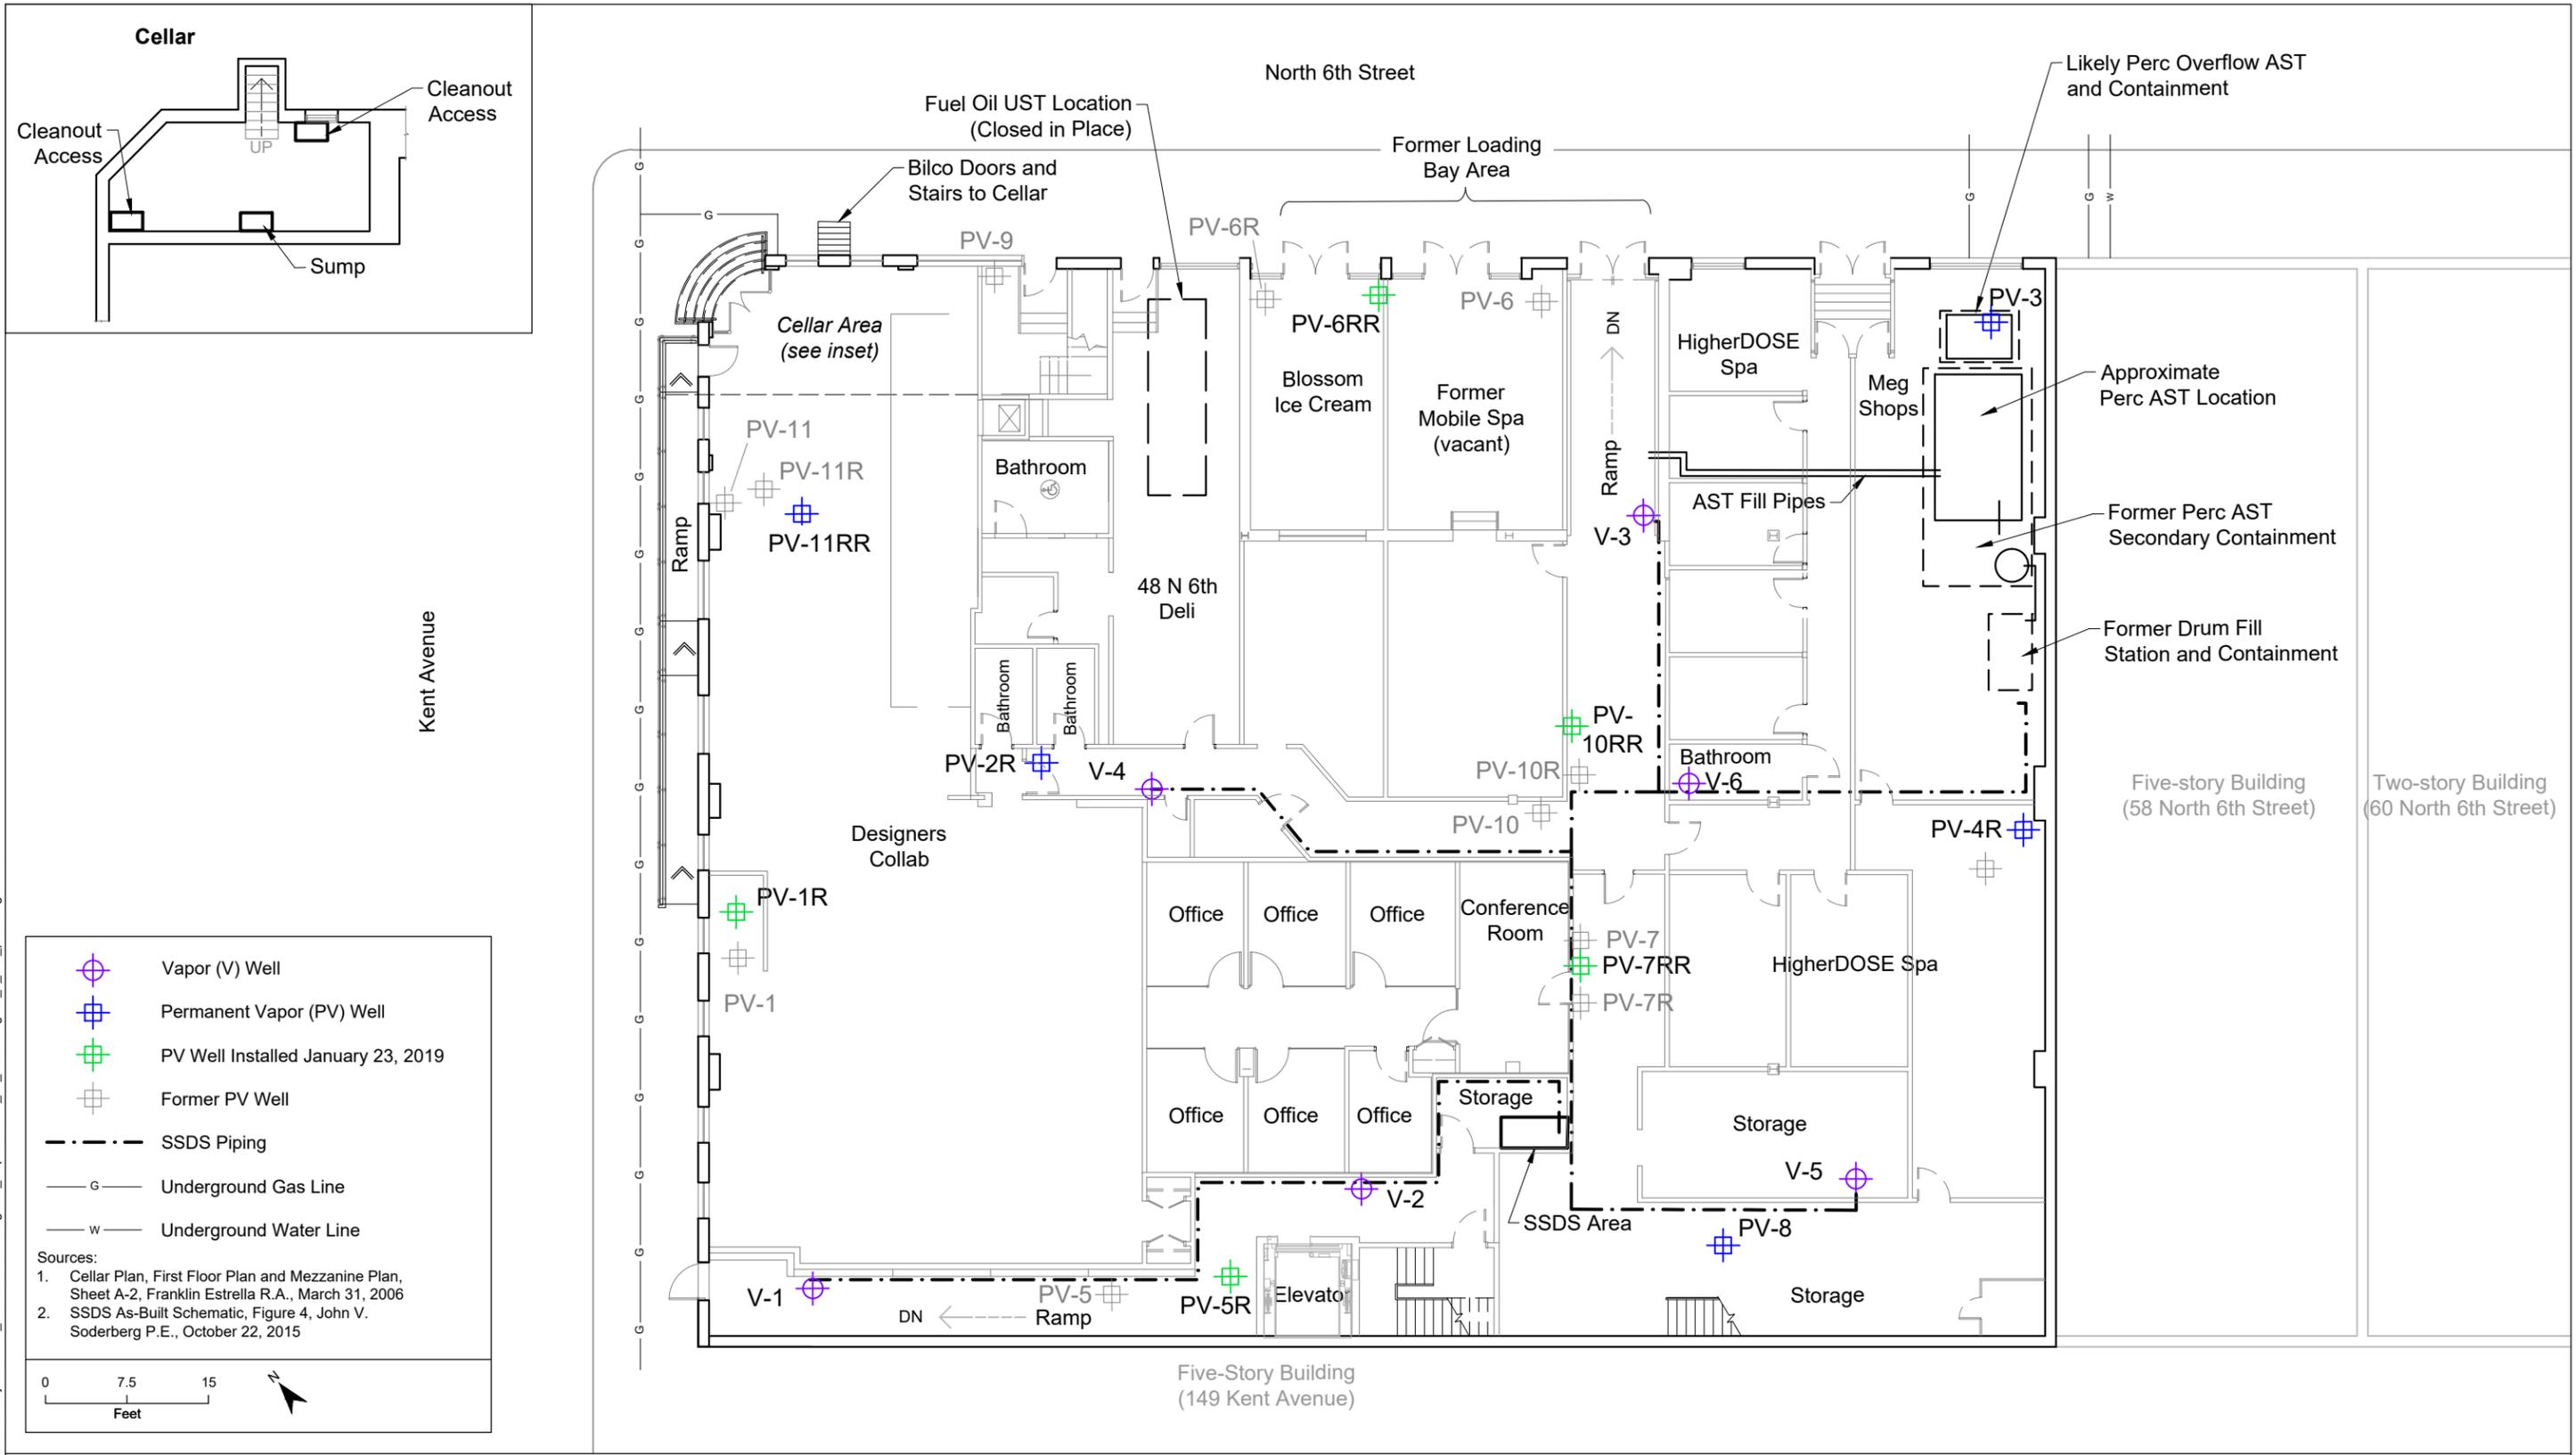
The Site plan, included as Figure 1, shows the locations of VMPs labeled as PV-x (permanent vapor wells) and SSDS suction points labeled as V-x (vapor wells). PV-2R was covered over during slab repair and was not accessible for monitoring; monitoring point replacement is scheduled for November 11, 2021. Integral noted that the Sensaphone SSDS alarm system telephone connection was restored. Integral replaced the Sensaphone batteries and reprogrammed it to notify Integral should the SSDS stop running.

The November 2021 monthly monitoring event is scheduled for November 11, 2021. Monitoring point PV-2RR will be installed prior to the monitoring event. The SSDS system is currently operating. Additional details regarding September 2021 activities will be provided in the next monitoring report, due December 10, 2021.
