Periodic Review Report

Marcus Garvey Apartments
NYSDEC BCP #C224198
650 Rockaway Avenue
Brooklyn, New York

May 12, 2023

**Roux Environmental Engineering
and Geology, D.P.C.**
209 Shafter Street
Islandia, New York 11749

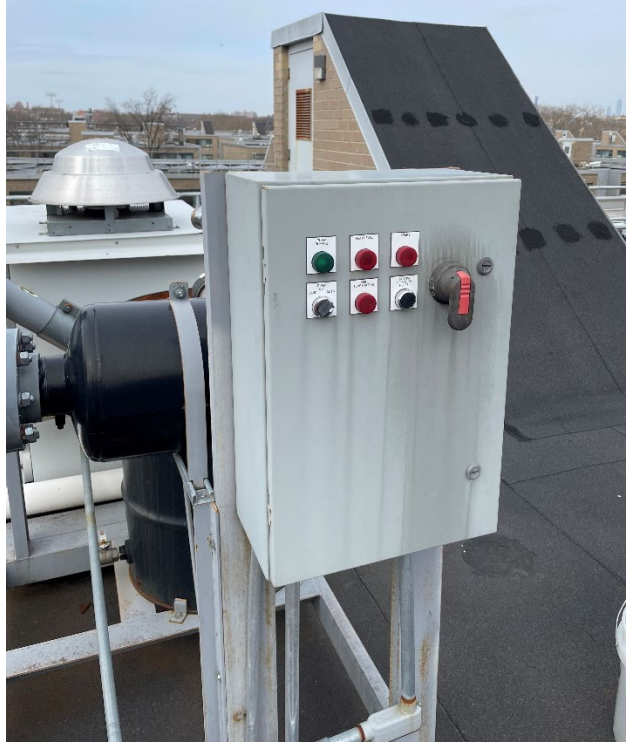
Photo 1: View of Blower A (southern) SSDS control panel with functioning “pump running” bulb shown as functional.

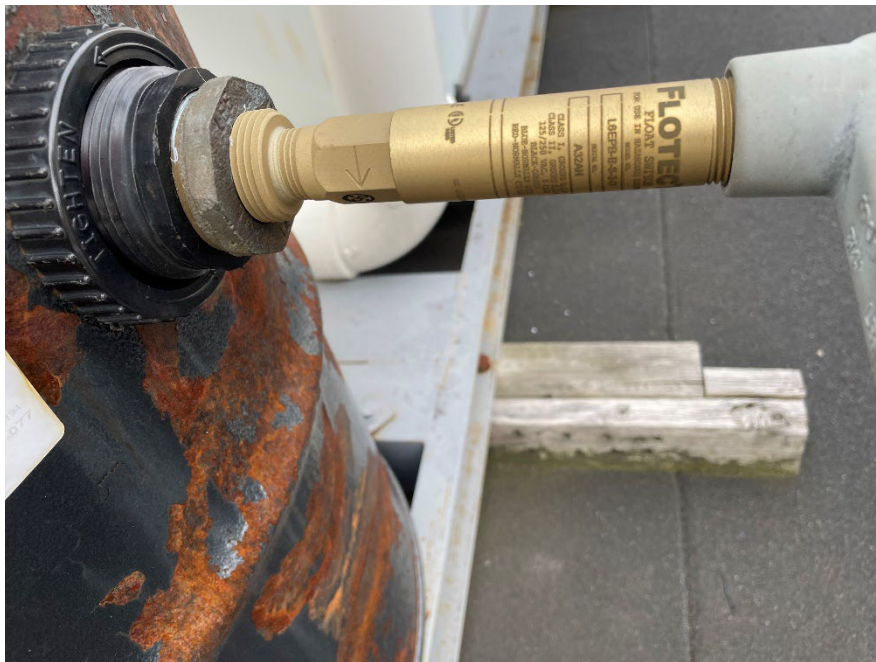
Photo 2: View of new float switch that was installed as part of the routine maintenance performed on Blower A throughout the reporting period.

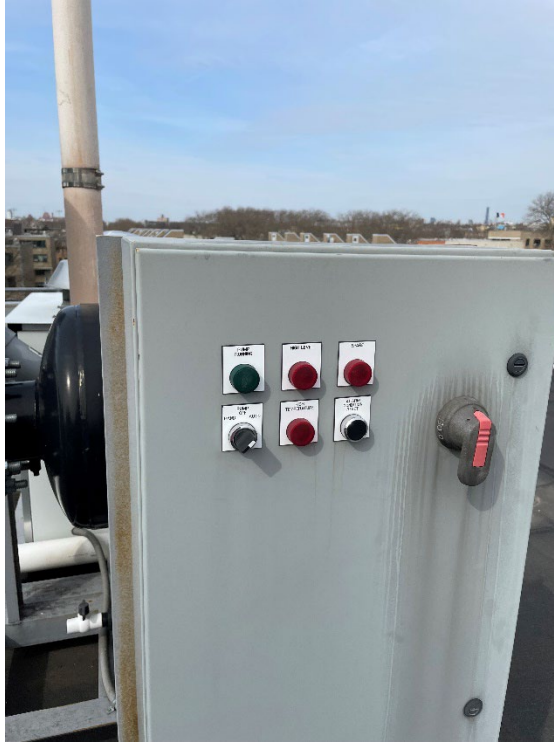
Photo 3: View of Blower B (northern) SSDS control panel.

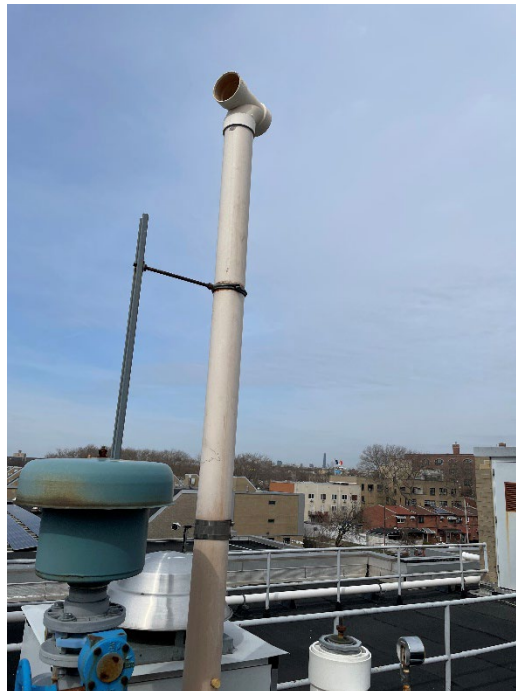
Photo 4: View of Blower B discharge stack.

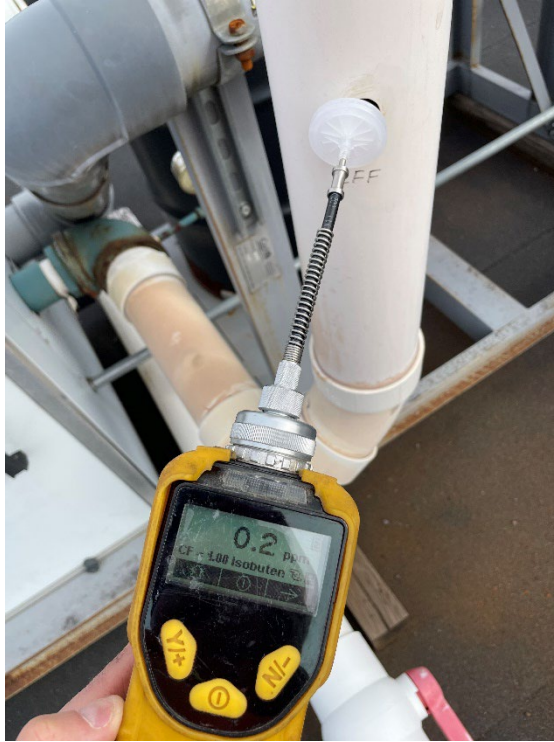
Photo 5: View of PID reading of the effluent air at Blower B discharge stack.

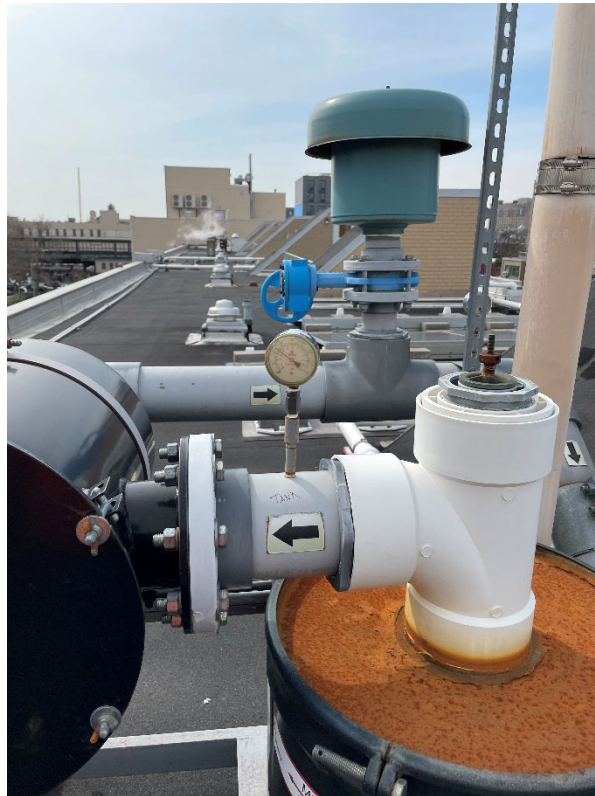
Photo 6: Photo of knockout/condensate tank influent gauge on the Blower B unit.

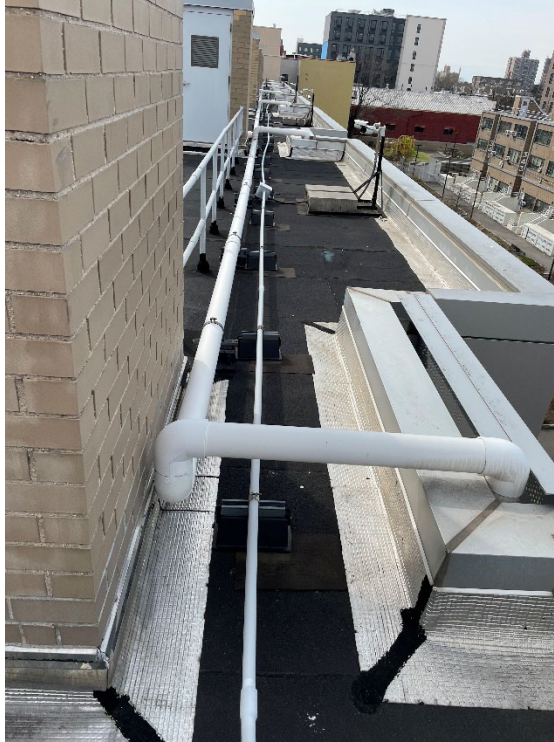
Photo 7: Looking south, photo showing SSDS piping run along the roof with legs heading down the residential side of the building.

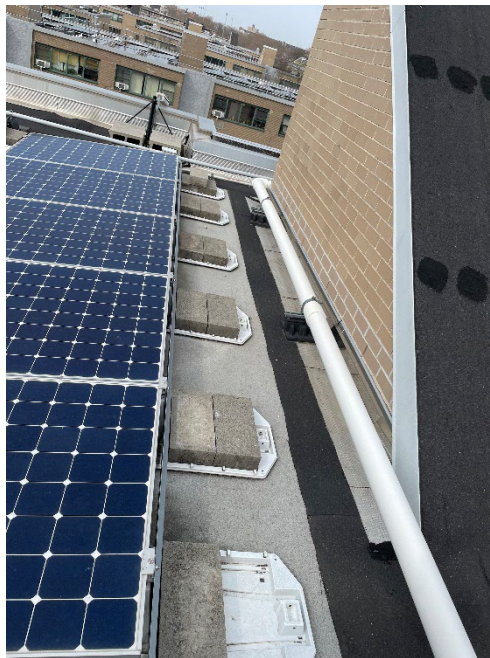
Photo 8: Looking west, photo showing SSDS piping run along the roof with legs leading towards the residential building side.

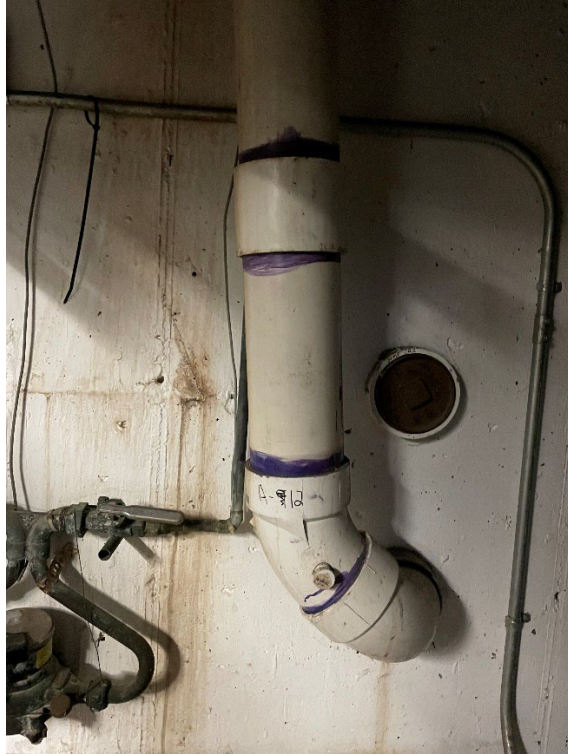
Photo 9: Looking south, view of monitoring point SVMP-A2 in the boiler room.

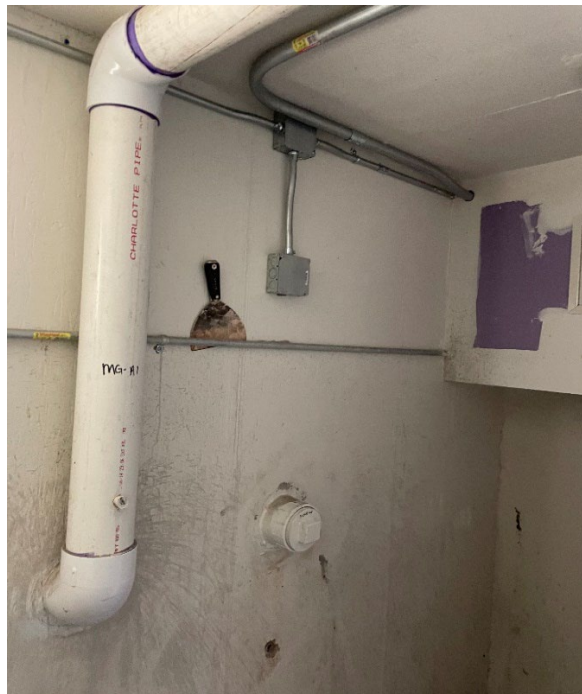
Photo 10: Photo of SVMP-A5 during annual inspection with adjacent suction point MG-A1. The suction point showed significant a vacuum measurement during inspection (Appendix F).

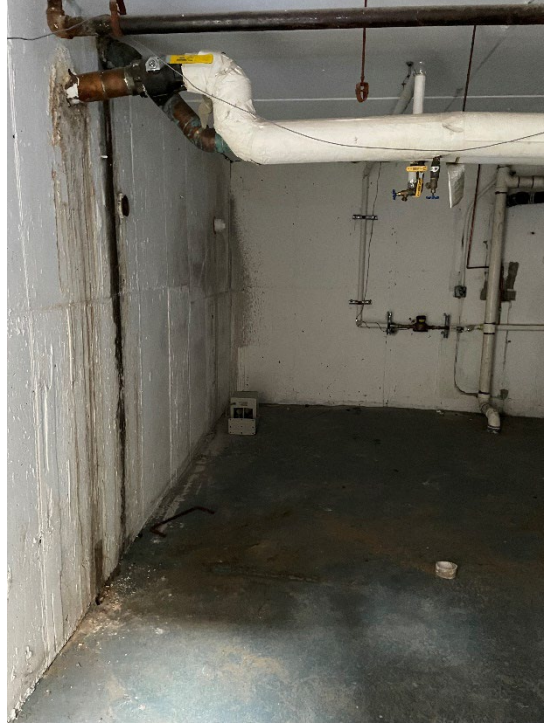
Photo 11: Looking west, view of SSDS legs belonging to the Building B blower (southern basement area); SVMP-B3 is located on the south wall.

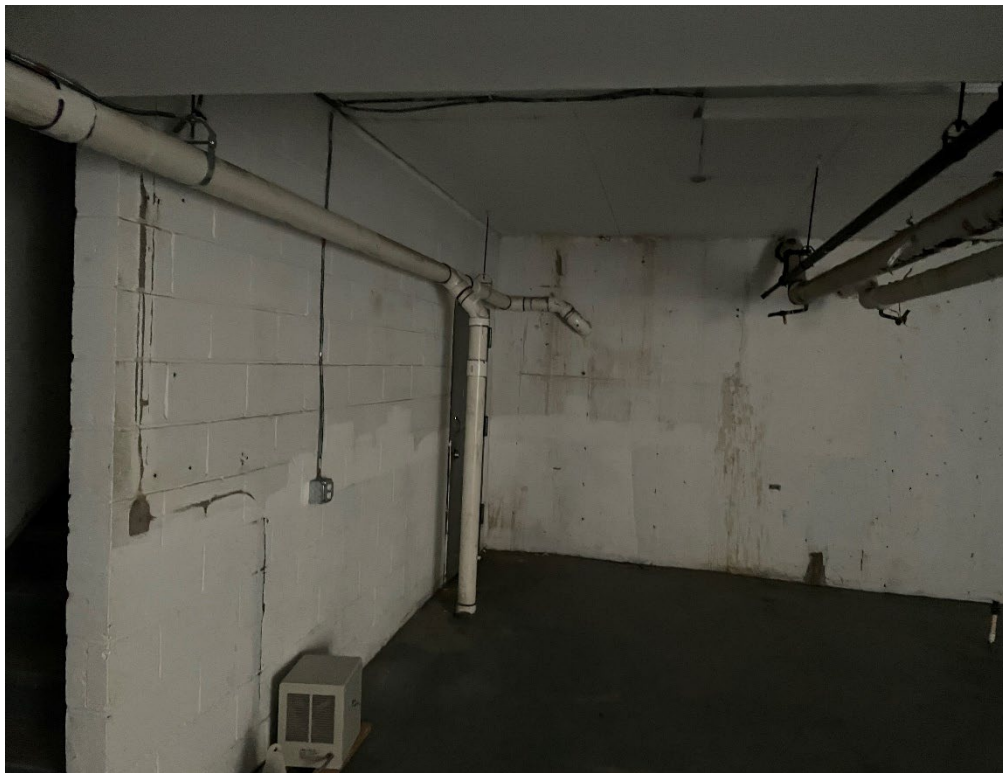
Photo 12: Photo of the southern basement located under the commercial spaces; network of legs and suction points MG10 through MG-12.

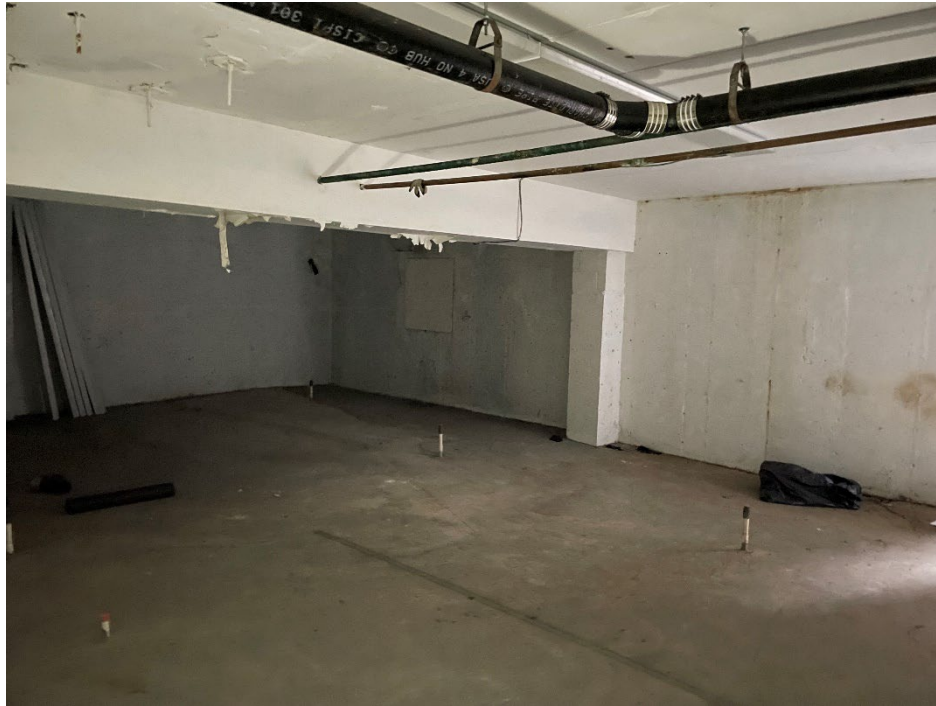
Photo 13: Photo showing intact concrete composite cover system located in the southern commercial space basement.

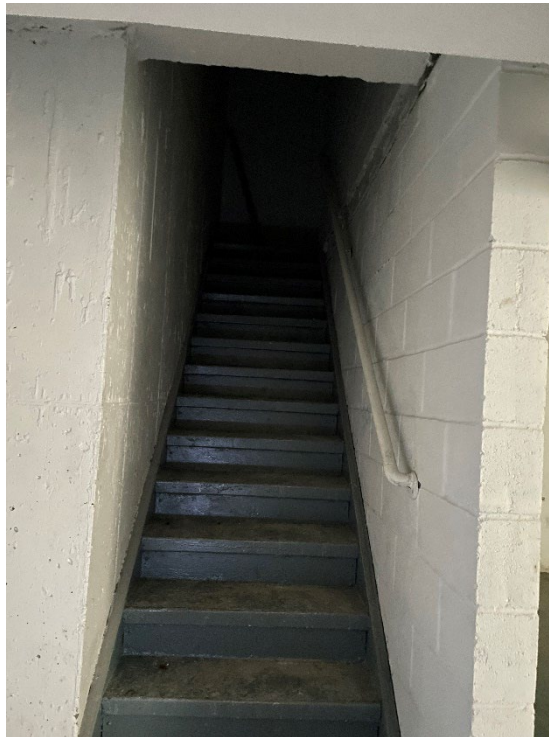
Photo 14: View of one of the basement staircases leading to the first floor; concrete wall partition separates the staircase from upstairs office space.

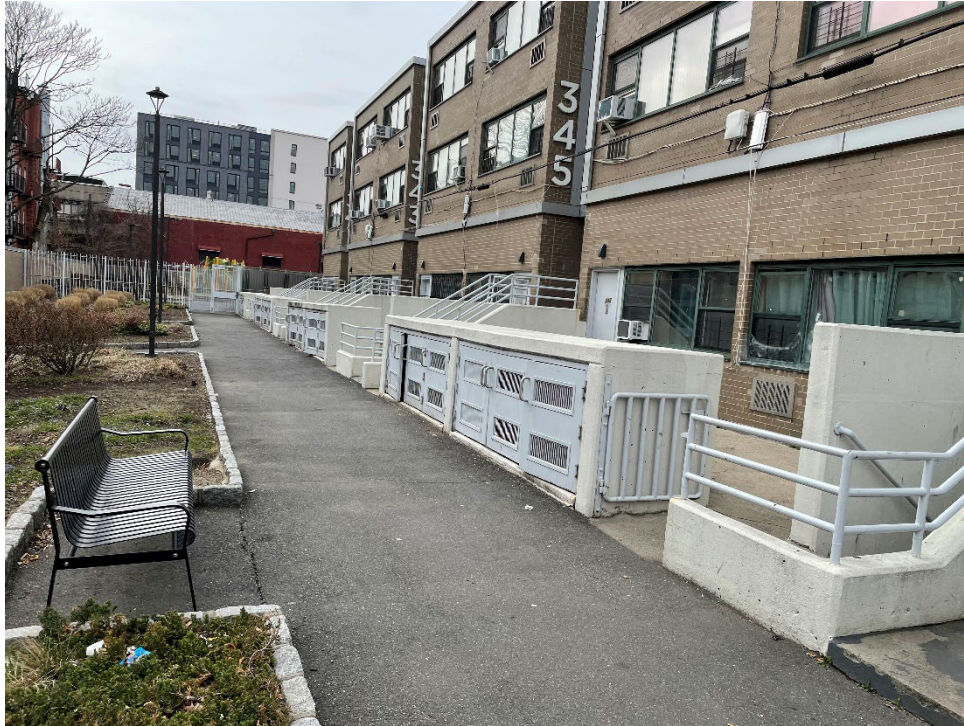
Photo 15: Looking north, showing residential side of the site and stairwells leading to basements where SVMP's are located.

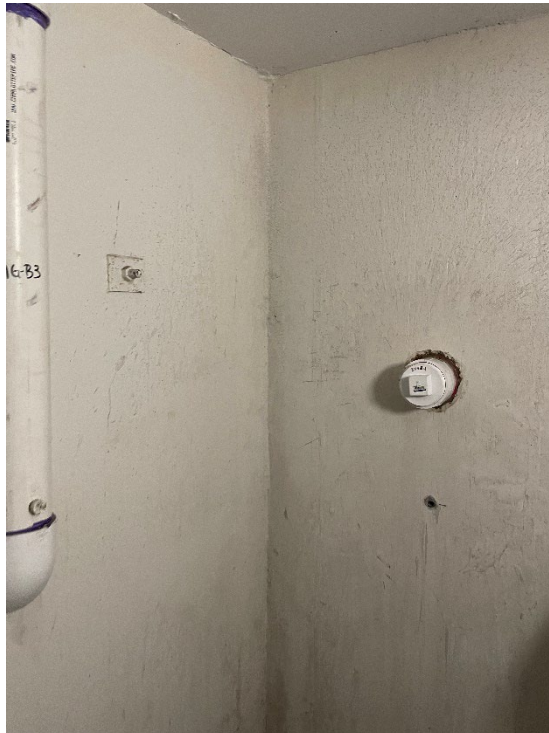
Photo 16: Photo showing monitoring point SVMP-B4 and suction point MG-B3 during site inspection.

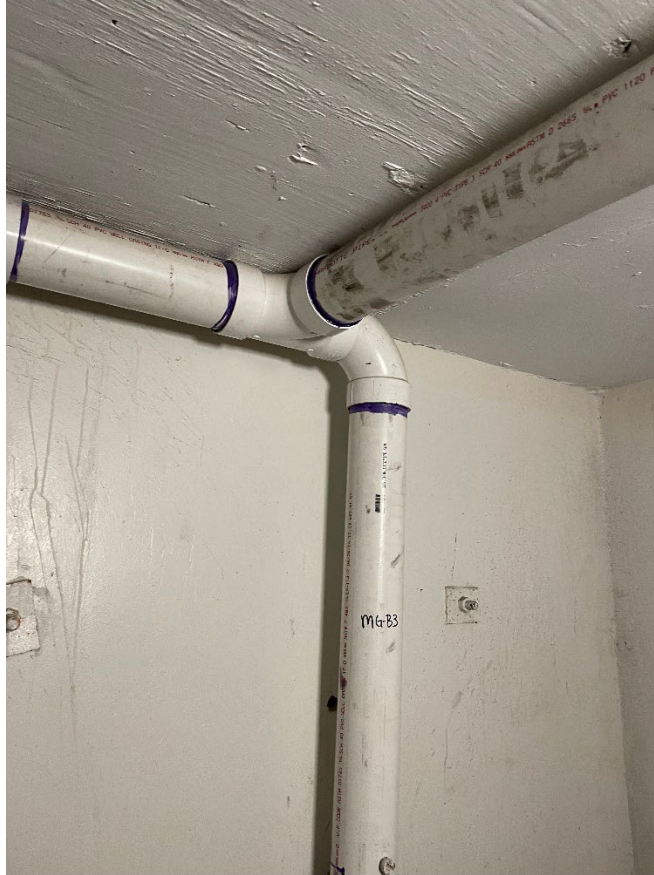
Photo 17: Photo showing suction point MG-B3 leg distribution.

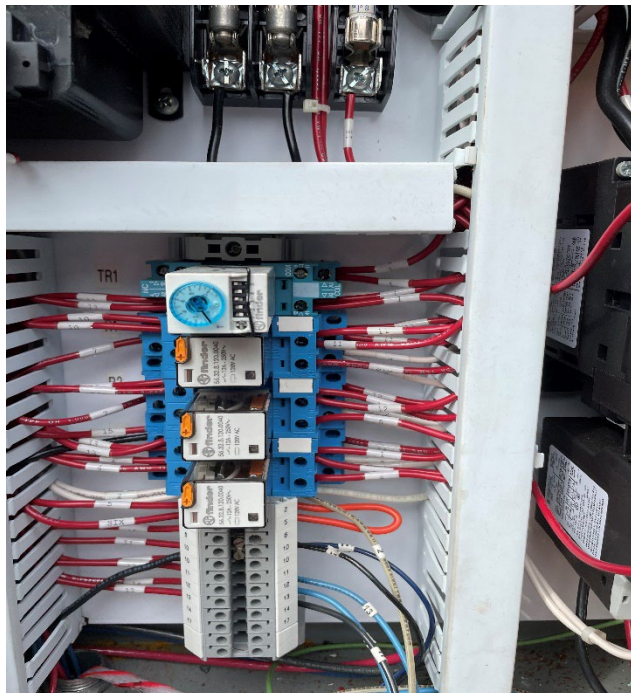
Photo 18: Inspection of the inside of the Blower A control panel electrical board.

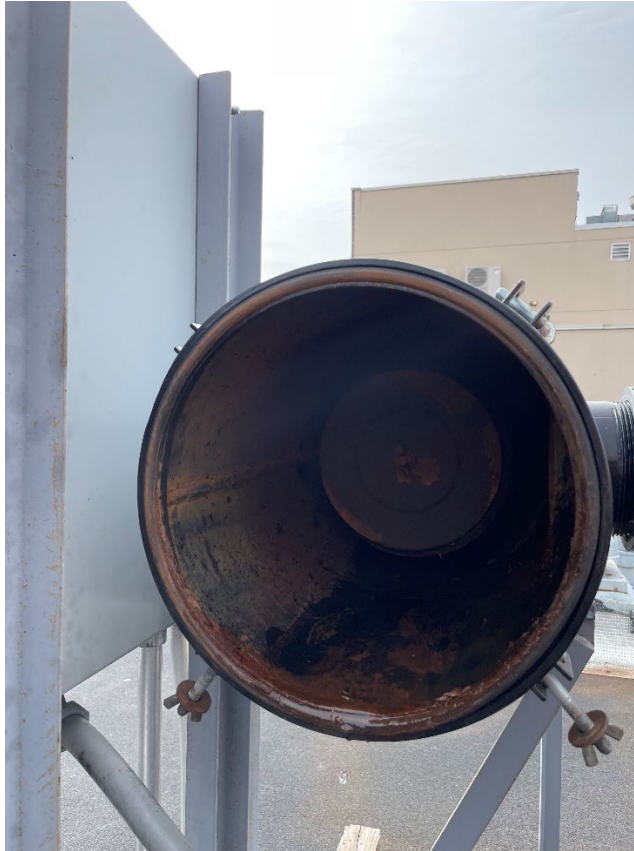
Photo 19: Photo during inspection and replacement of the air intake filter.

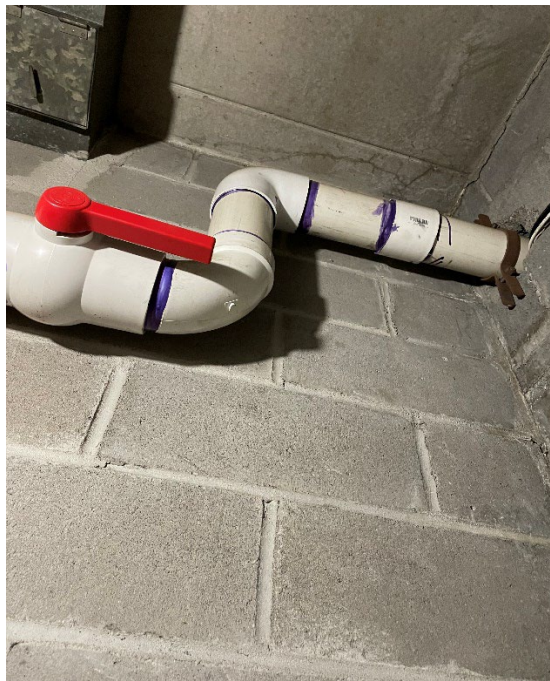
Photo 20: SSDS piping run leading down from the first floor and into the boiler room wall; valve is in the full open position.
