# Periodic Review Report

Marcus Garvey Apartments  
NYSDEC BCP #C224198  
650 Rockaway Avenue  
Brooklyn, New York

July 19, 2024

**Roux Environmental Engineering  
and Geology, D.P.C.**  
209 Shafter Street  
Islandia, New York 11749

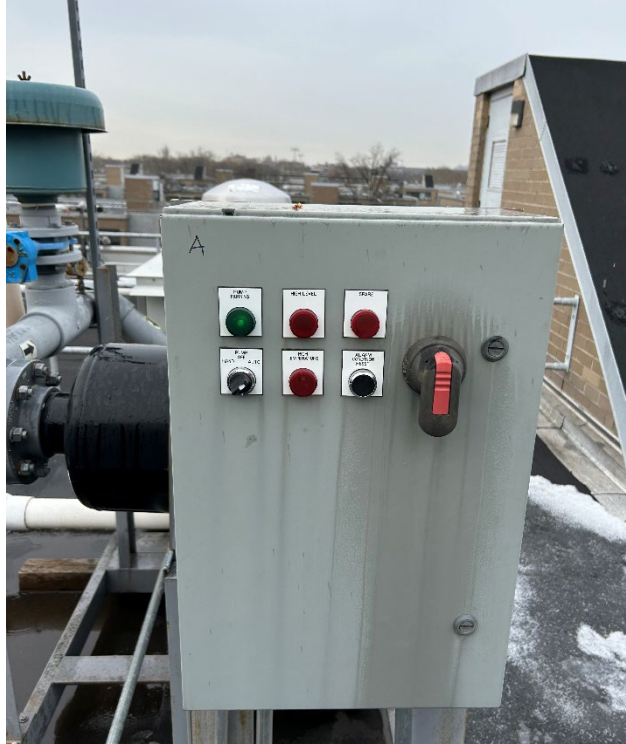
Photo 1: View of Blower A (southern) SSDS control panel with functioning “pump running” bulb shown as functional.

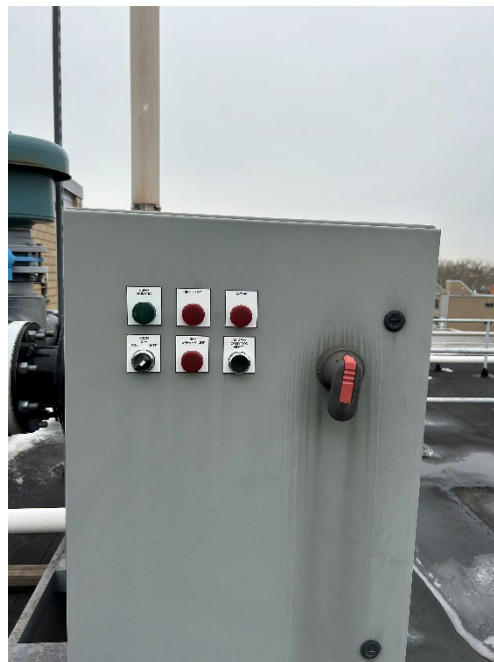
Photo 2: View of Blower B (northern) SSDS control panel.

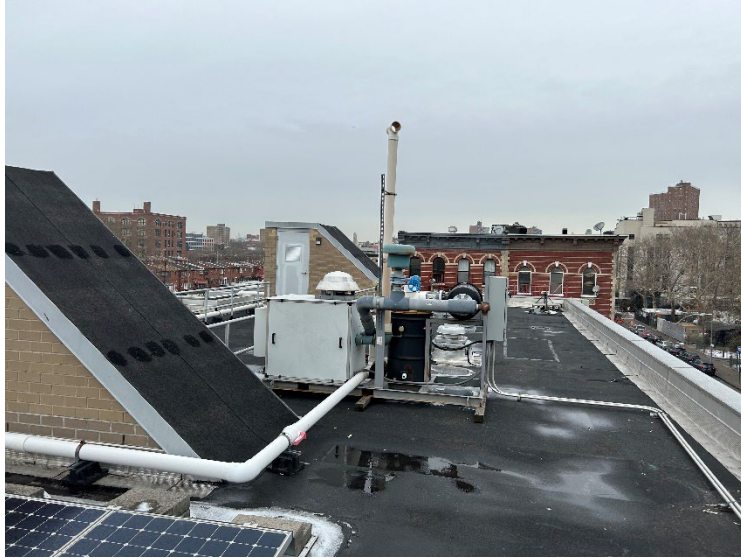
Photo 3: View of Blower B discharge stack.

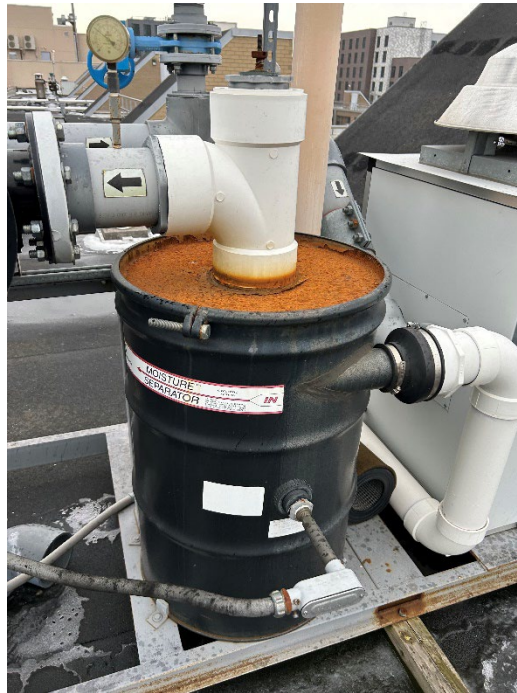
Photo 4: Photo of knockout/condensate tank influent gauge on the Blower B unit.

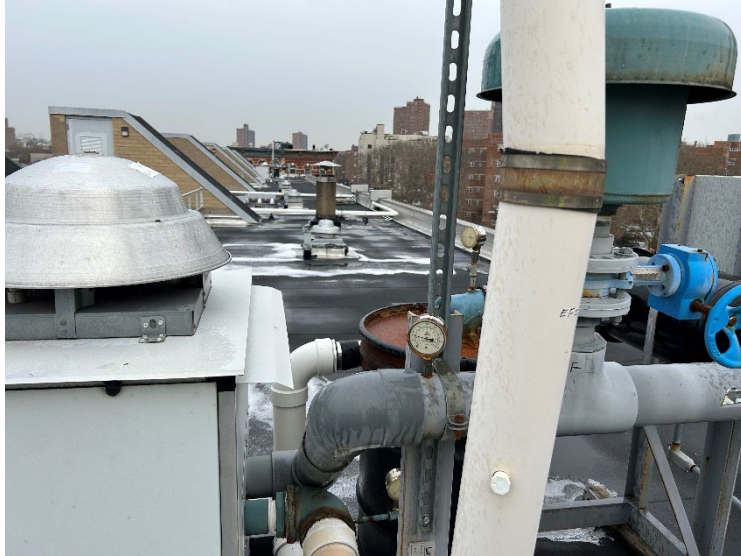
Photo 5: Photo of inlet gauge and piping at Blower B.

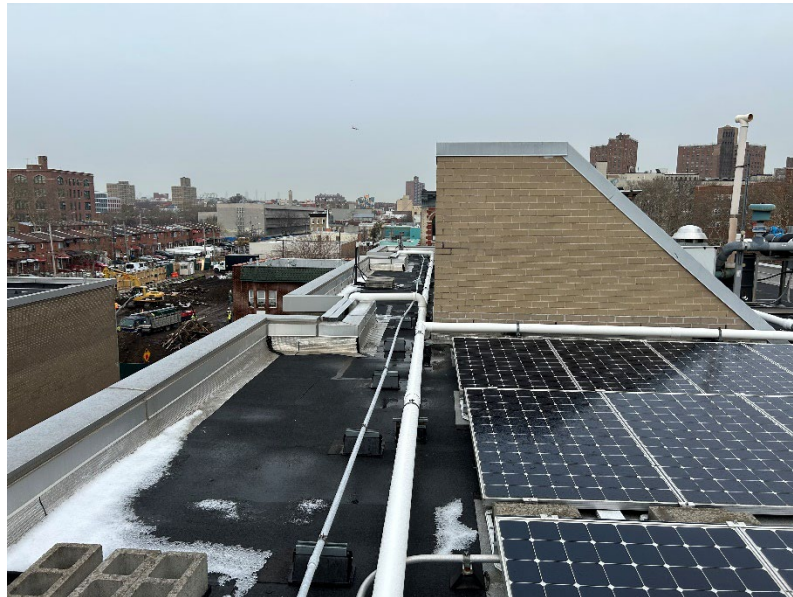
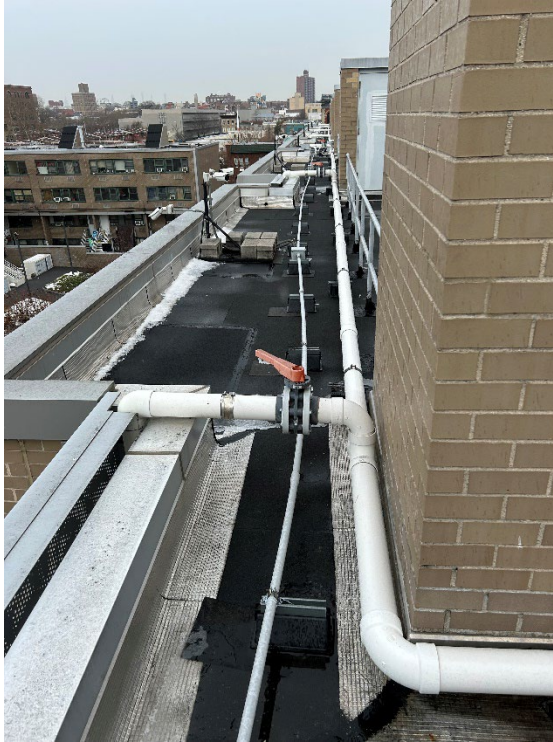
Photo 6: View showing SSDS piping run along the roof with legs heading down the side of the building.

Photo 7: View showing SSDS piping run along the roof with legs heading down the side of the building.

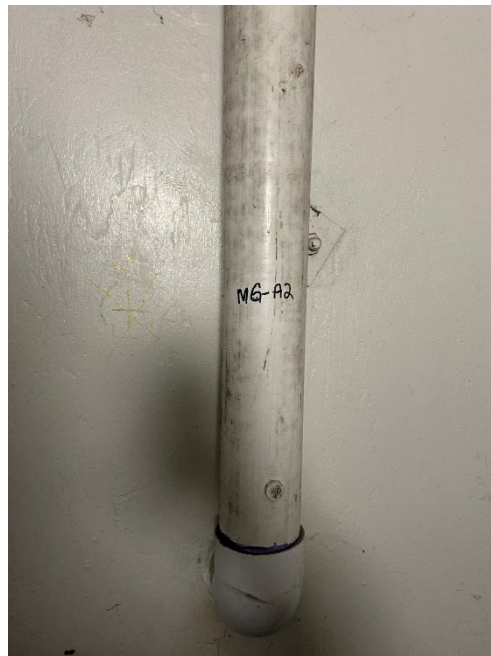
Photo 8: Photo of suction point MG-A2.

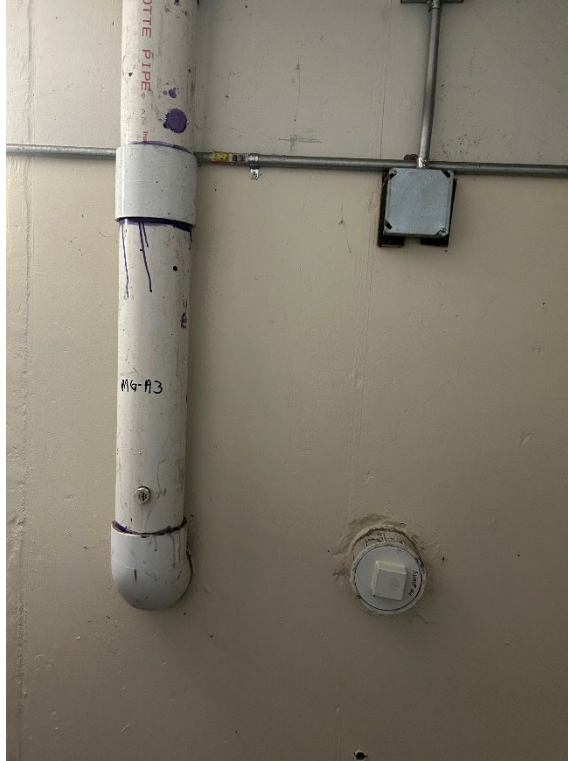
Photo 9: Photo of SVMP-A4 during annual inspection with adjacent suction point MG-A3.

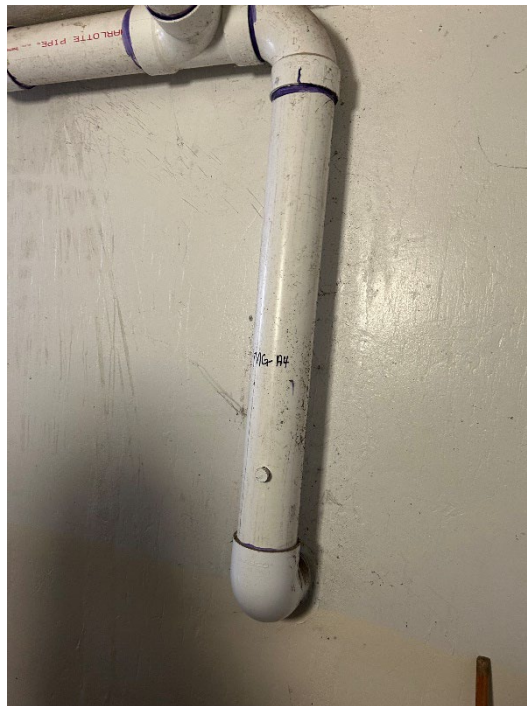
Photo 10: Photo of suction point MG-A4.

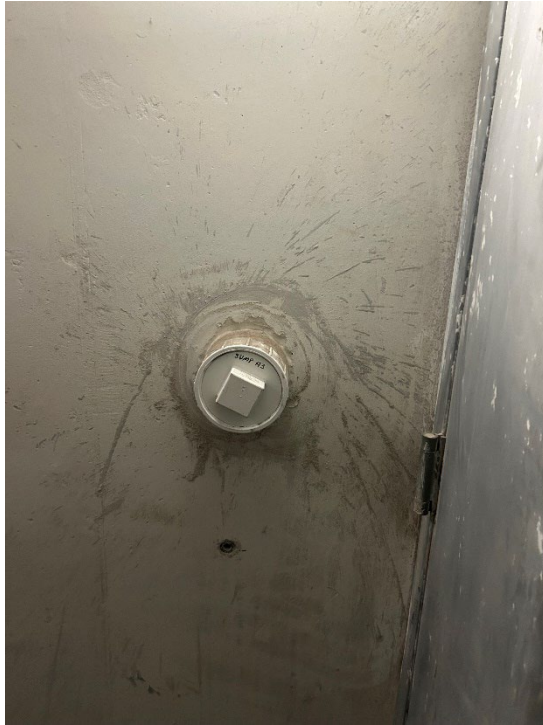
Photo 11: Photo of SVMP-B3 during annual inspection.

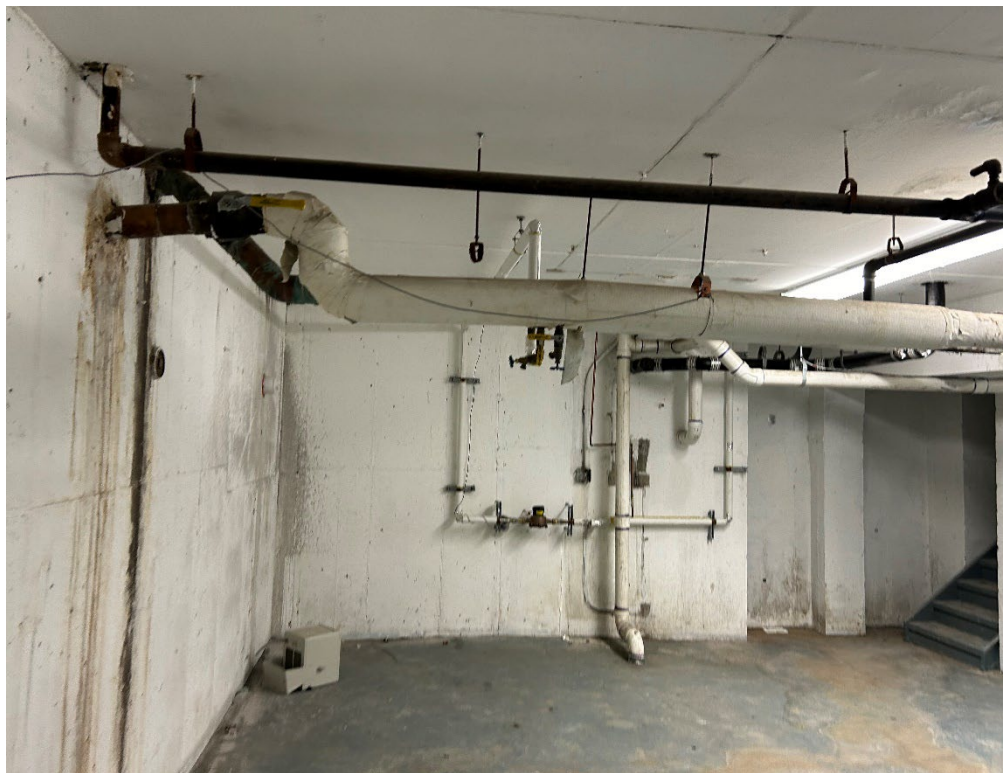
Photo 12: : Looking west, view of SSDS legs belonging to the Building B blower (southern basement area); SVMP-B3 is located on the south wall.

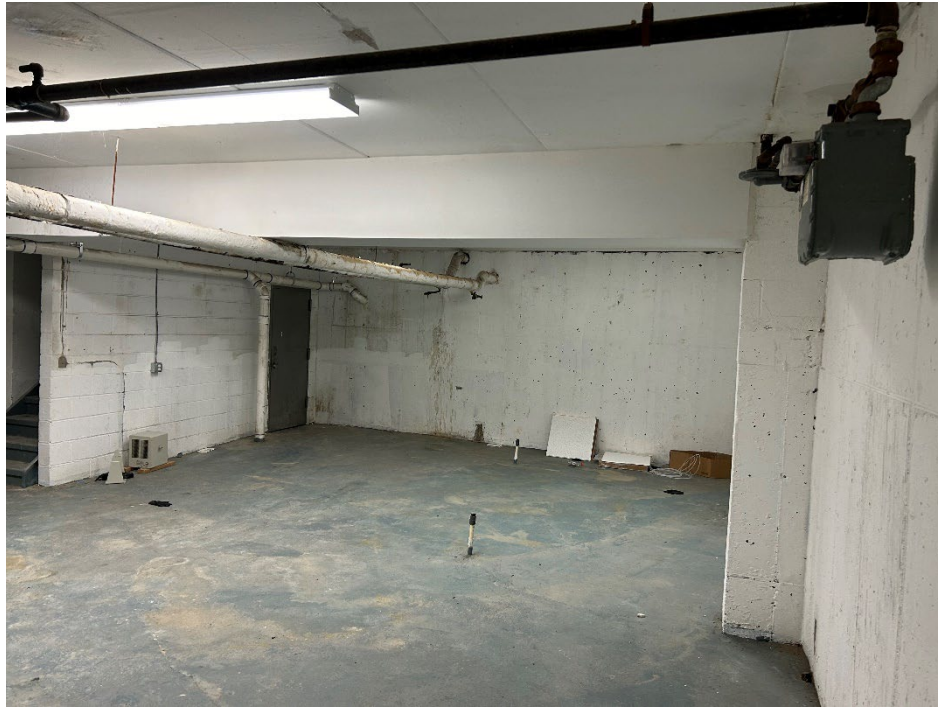
On January 23, 2024, Roux performed a Site-wide inspection to meet the requirements for this reporting period. This inspection determined that all Site Cover system elements described herein were observed to be performing as designed during the reporting period of the PRR and are protective of human health and the environment. The completed Site Inspection Checklist is provided in Appendix C and photographs taken during the Site-wide inspection are provided in the Photo Log included in Appendix D.

Photo 13: Photo showing intact concrete composite cover system located in the southern commercial space basement.

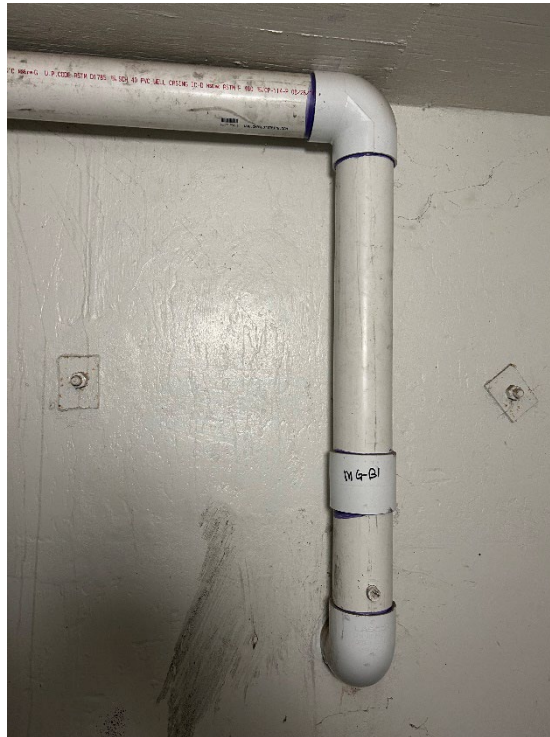
Photo 14: Photo of suction point MG-B1.

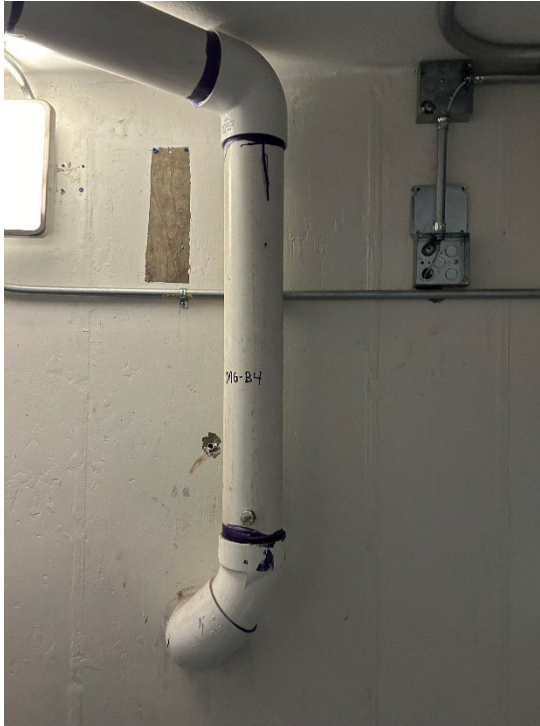
Photo 15: Photo of suction point MG-B4.

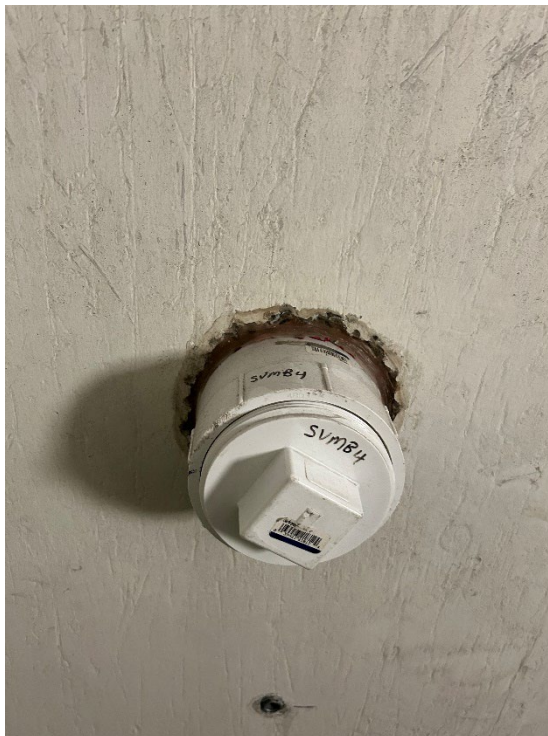
Photo 16: Photo showing monitoring point SVMP-B4 during site inspection.

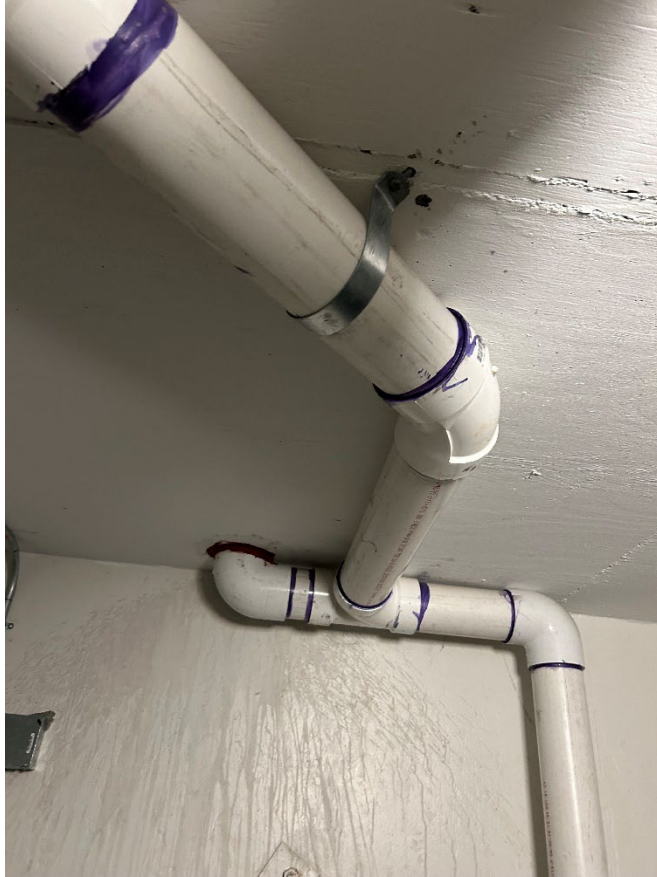
Photo 17: Photo showing suction point MG-B7 leg distribution.

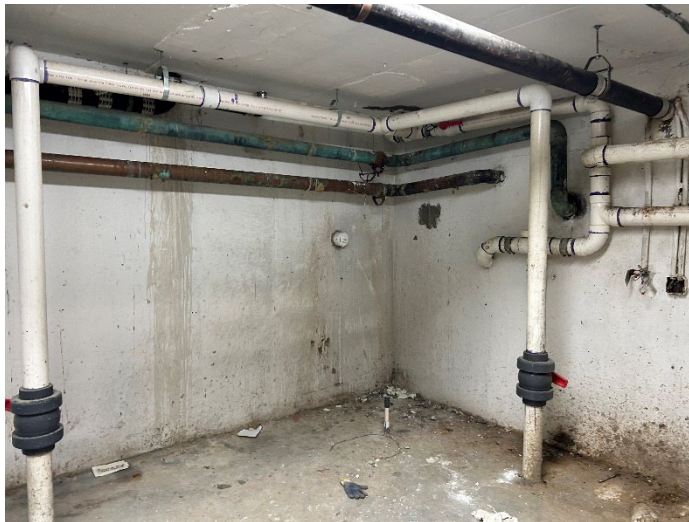
Photo 18: Photo of the southern basement located under the commercial spaces; network of legs and suction points.

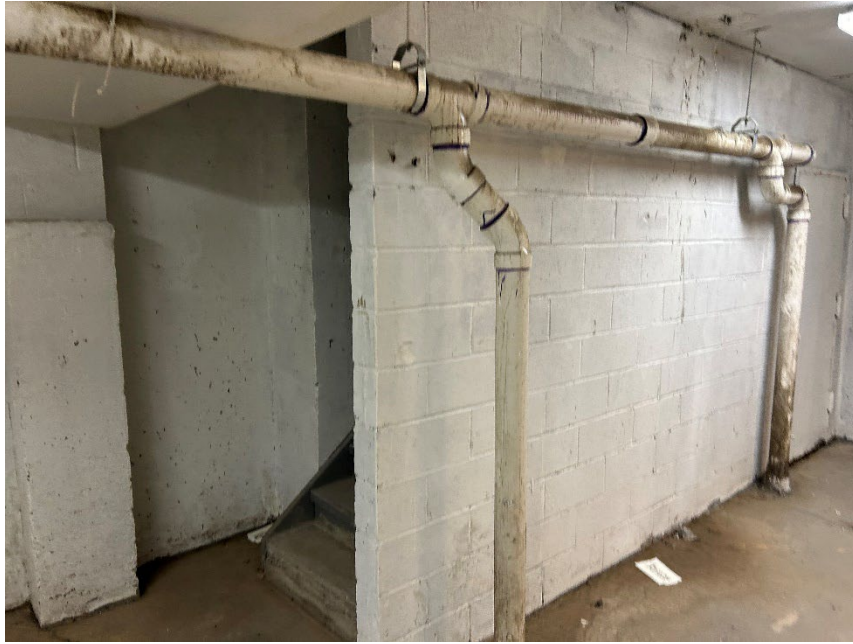
Photo 19: Photo of the southern basement located under the commercial spaces; network of legs and suction points and of one of the basement staircases.

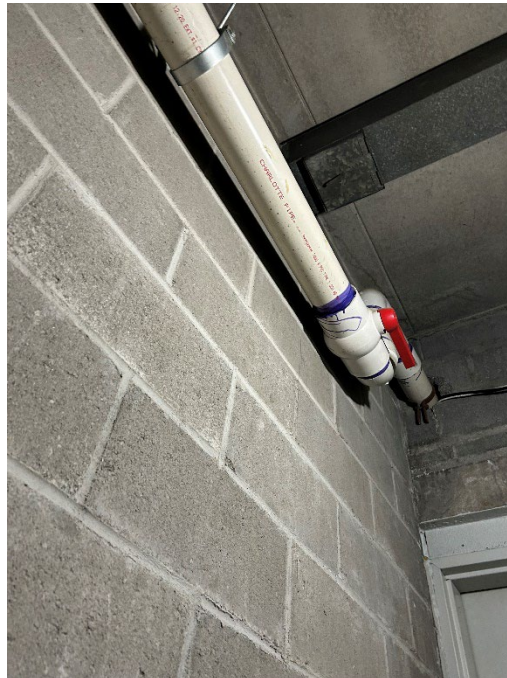
Photo 20: SSDS piping run leading down from the first floor and into the boiler room wall; valve is in the full open position.

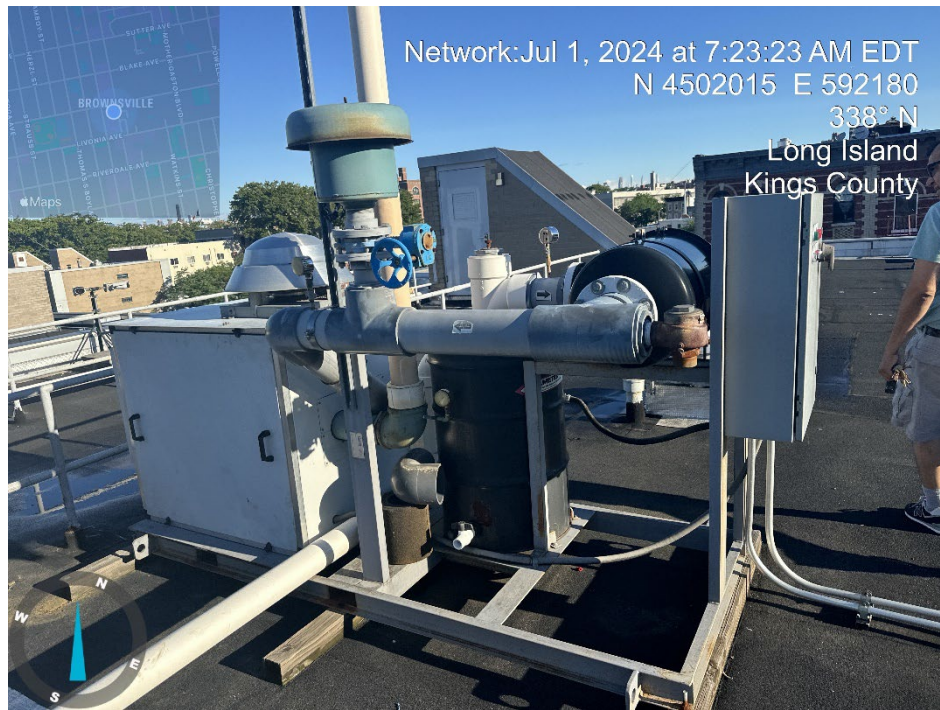
Photo 21: Overview of SSDS Blower B after maintenance and re-start.

The SSDS Blower B motor was replaced by an electrician hired by building management during the week of June 24, 2024. The SSDS Blower B motor replacement was complete on Friday, June 28, 2024, and Roux was at the Site on Monday, July 1, 2024, to confirm start up and that the blower was running within acceptable operating parameters. On July 12<sup>th</sup>, NYSDEC was notified that the SSDS Blower B had been restored to service on June 28, 2024.

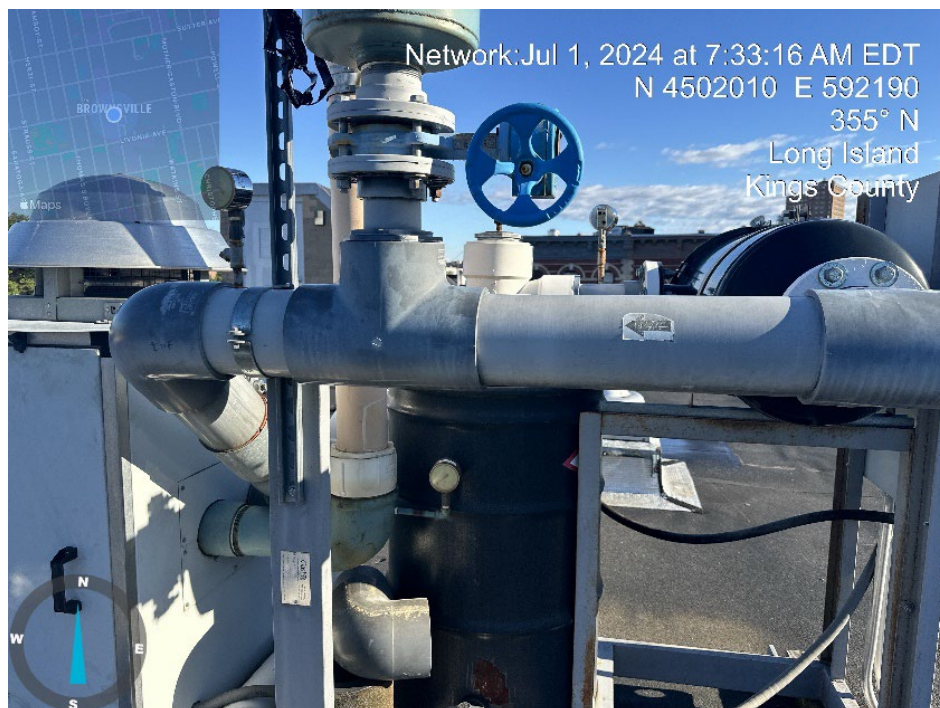
Photo 22: Photo of the gauge and piping at the Blower B unit.

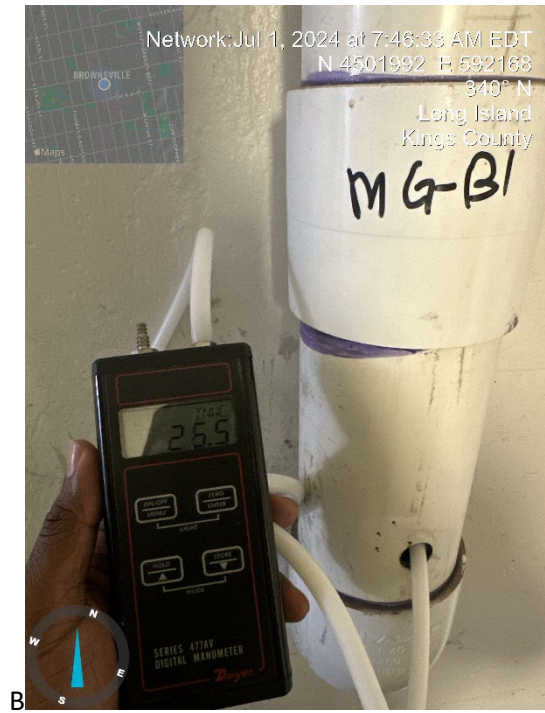
Photo 23: Photo of manometer reading of suction point MG-B1.

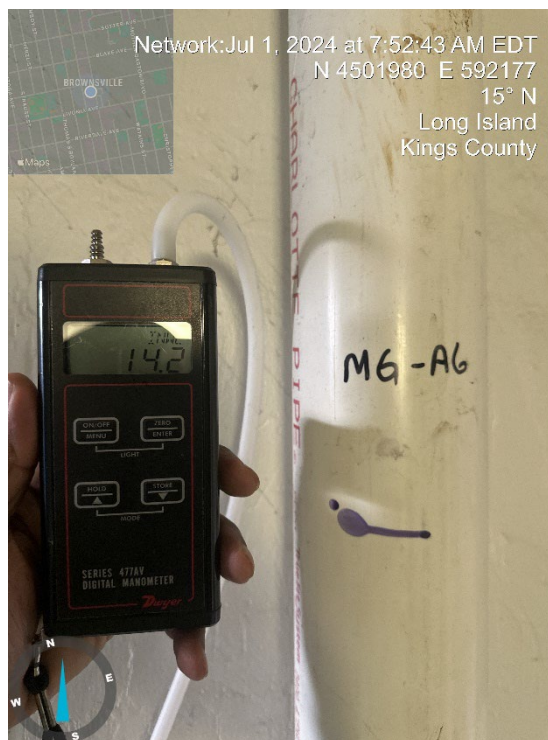
Photo 24: Photo of manometer reading of suction point MG-A6.

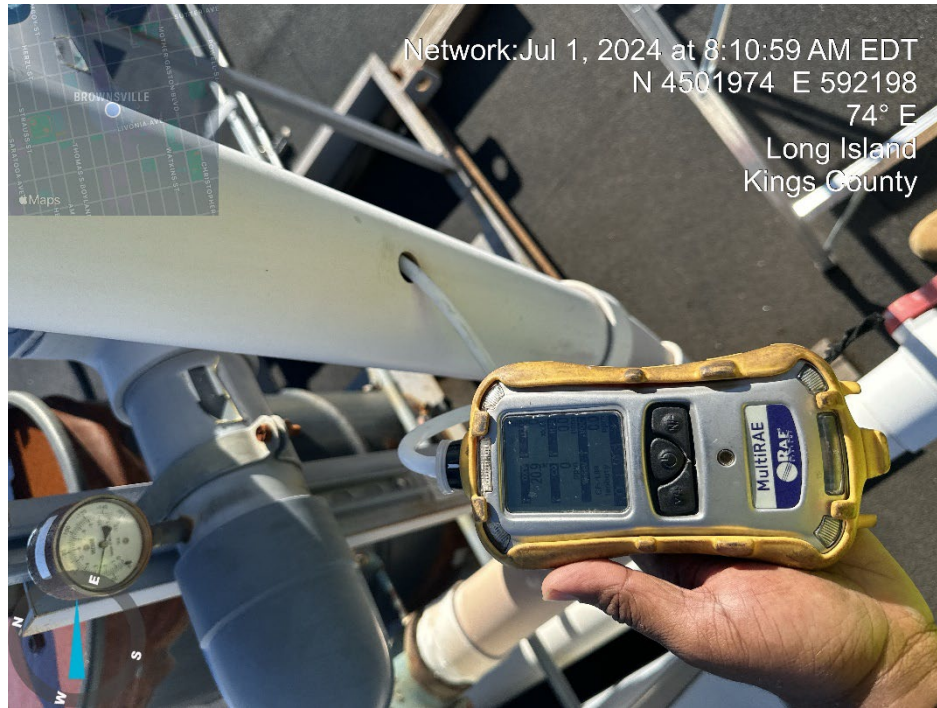
Photo 25: Photo of five gas meter at Blower B after re-start.

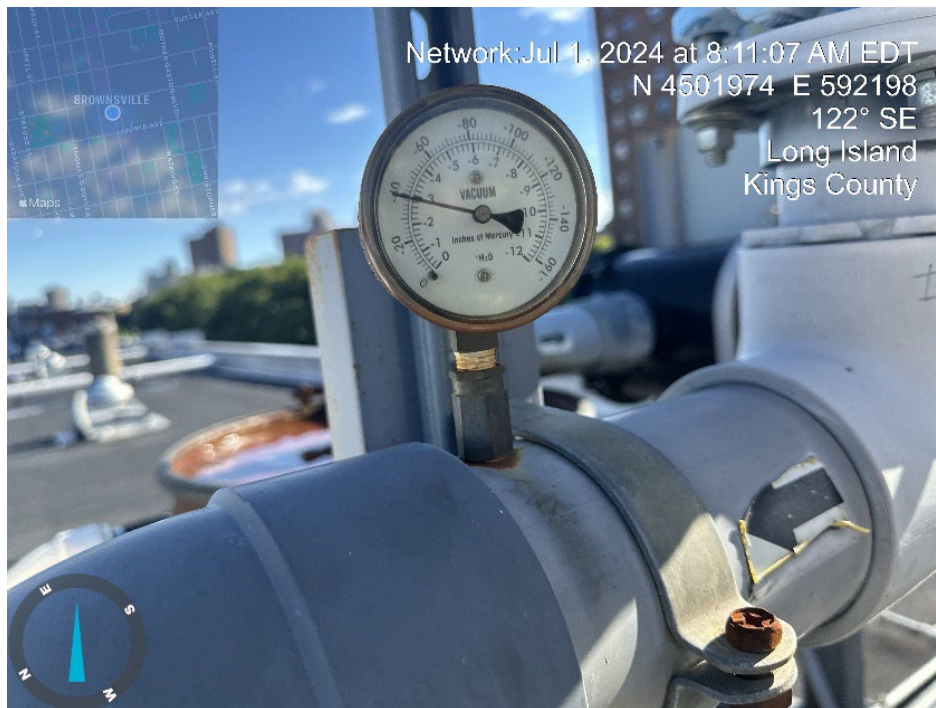
Photo 26: Photo of the gauge on the Blower unit

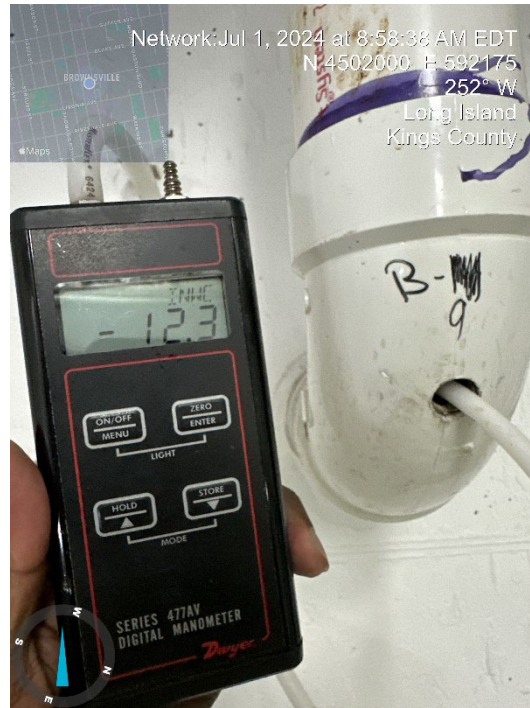
Photo 27: Photo of manometer reading of suction point MG-B9.

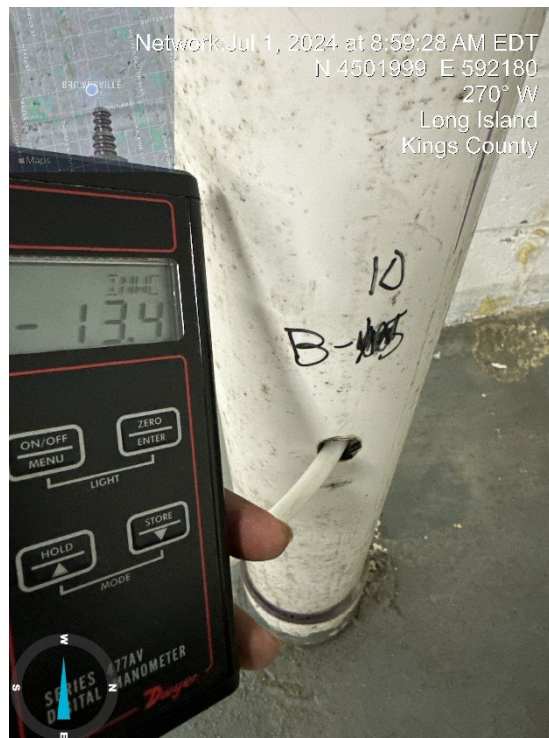
Photo 28: Photo of manometer reading of suction point MG-B10
