Periodic Review Report

Marcus Garvey Apartments
NYSDEC BCP #C224198
650 Rockaway Avenue
Brooklyn, New York

May 12, 2025

**Roux Environmental Engineering
and Geology, D.P.C.**
209 Shafter Street
Islandia, New York 11749

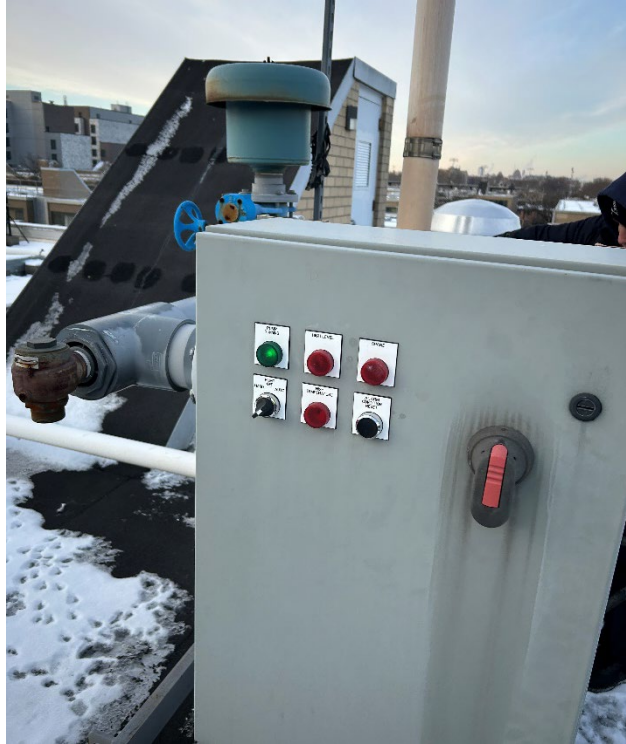
Photo 1: View of Blower B (northern) SSDS control panel with functioning “pump running” bulb shown as functional.

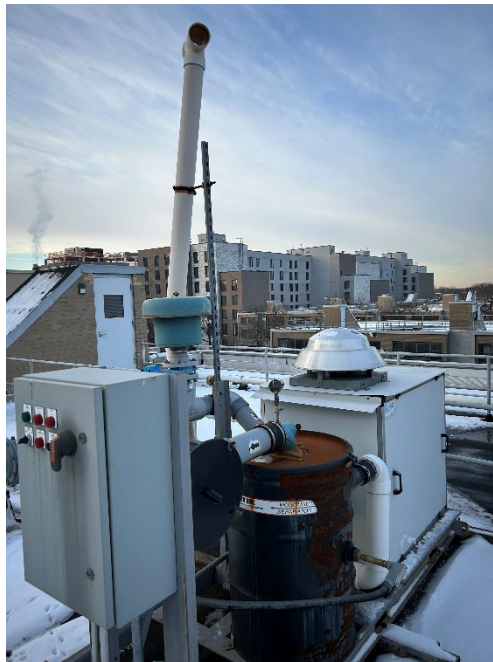
Photo 2: Overview of Blower A (southern) SSDS control panel and discharge stack.

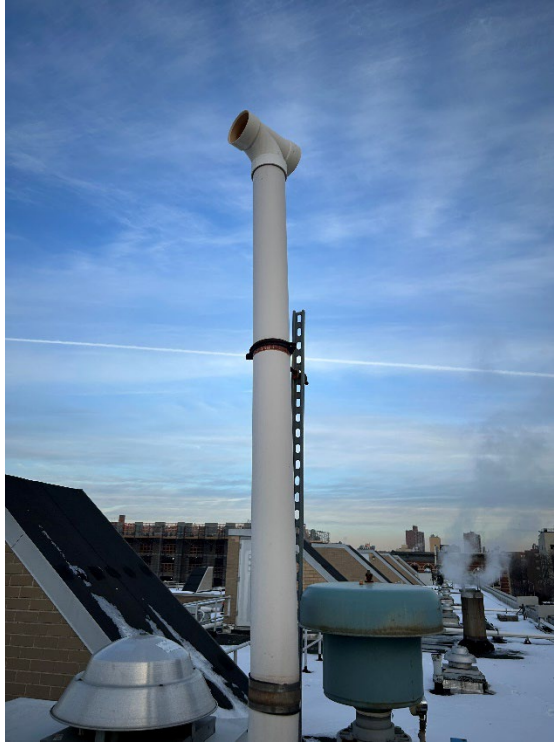
Photo 3: View of Blower A discharge stack.

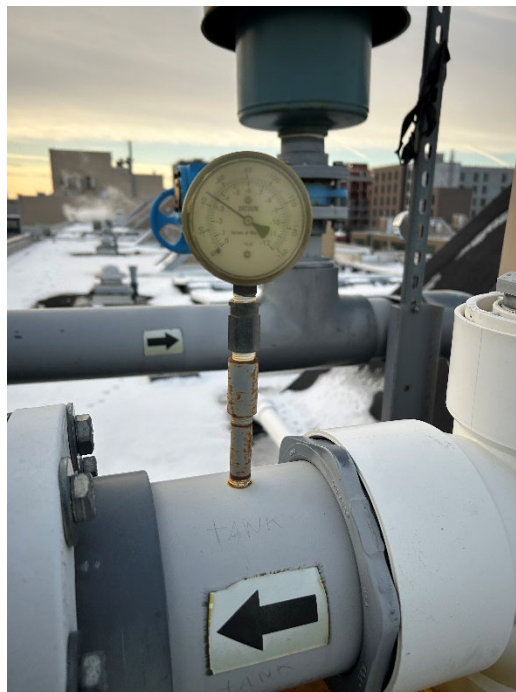
Photo 4: Photo of knockout/condensate tank influent gauge on the Blower A unit.

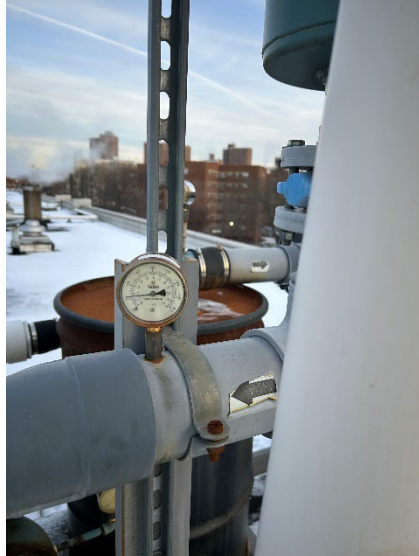
Photo 5: Photo of inlet gauge at Blower A.

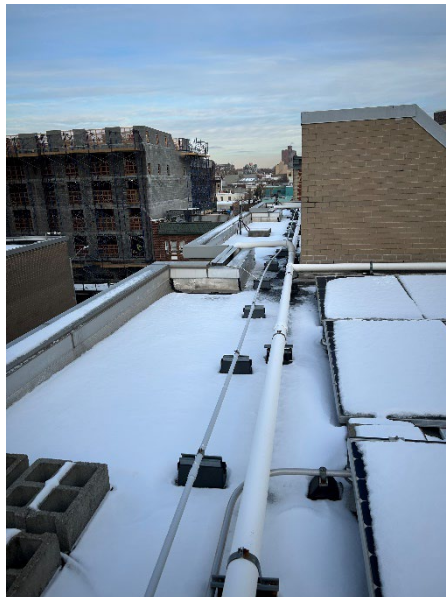
Photo 6: View showing Blower B SSDS piping run along the roof with legs heading down the side of the building.

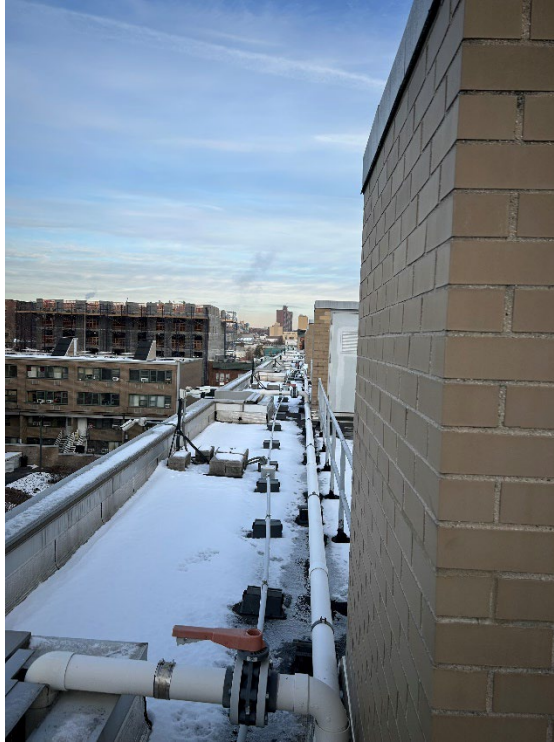
Photo 7: View showing Blower A SSDS piping run along the roof with legs heading down the side of the building.

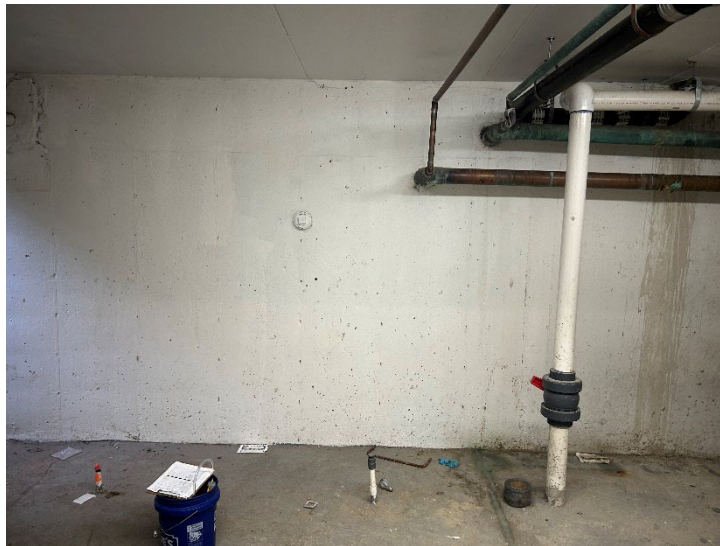
Photo 8: Photo of SVMP-B2 during annual inspection.

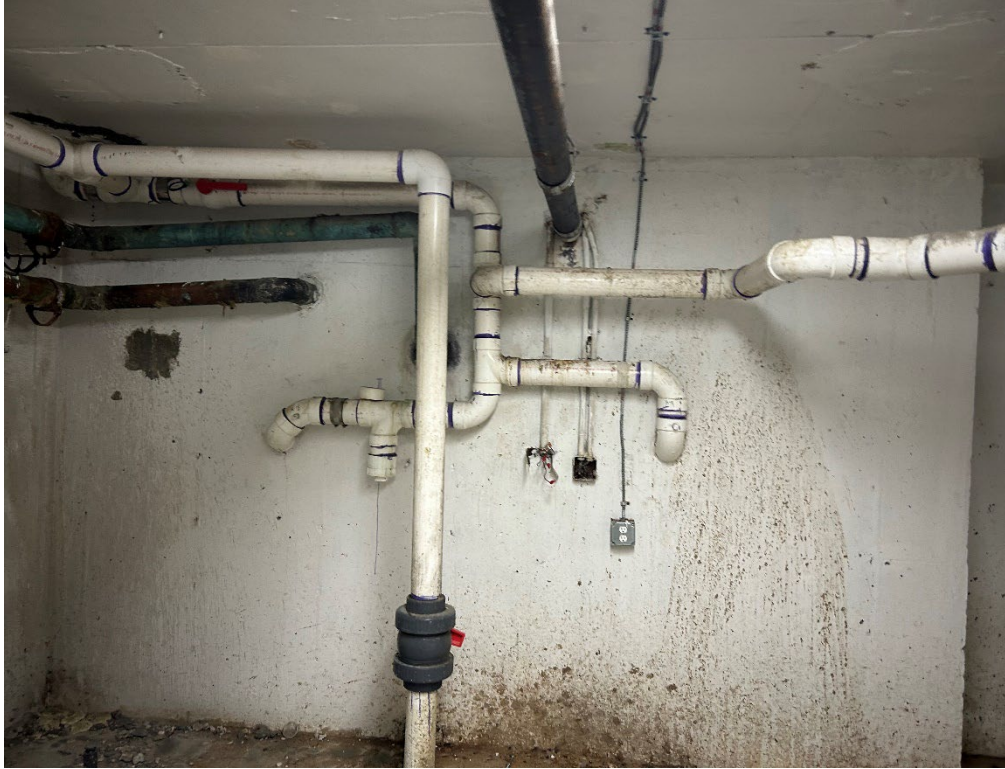
Photo 9: View of SSDS blower legs in the southern basement area.

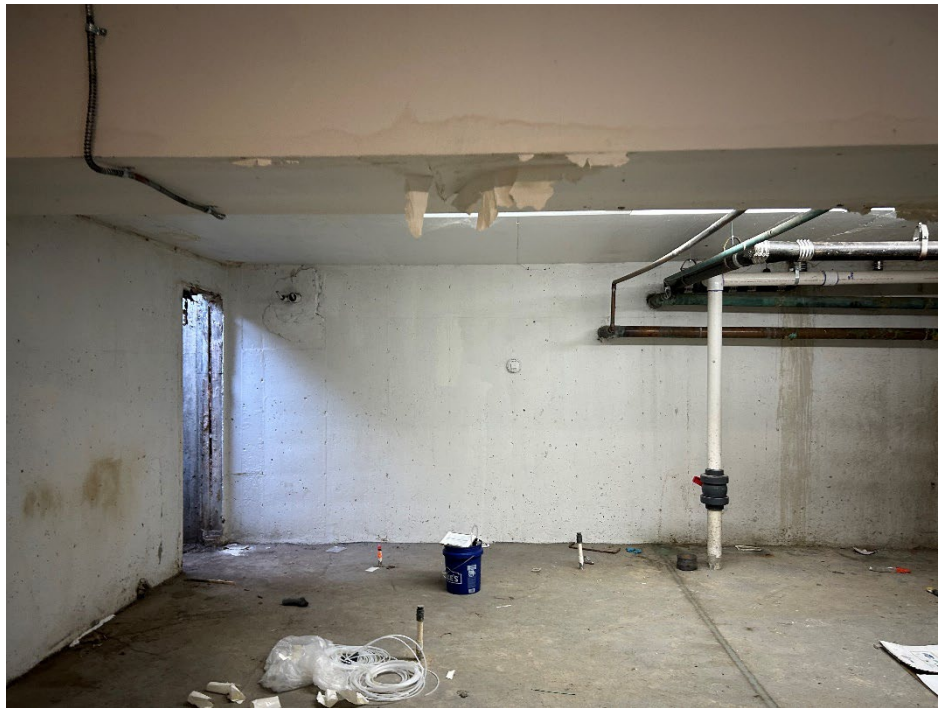
Photo 10: Photo showing intact concrete composite cover system located in the southern commercial space basement.

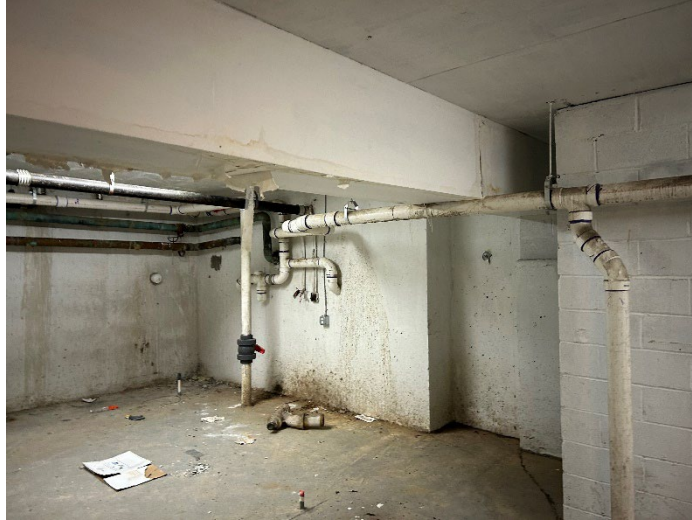
Photo 11: Photo of the southern basement located under the commercial spaces;
network of legs and suction points.

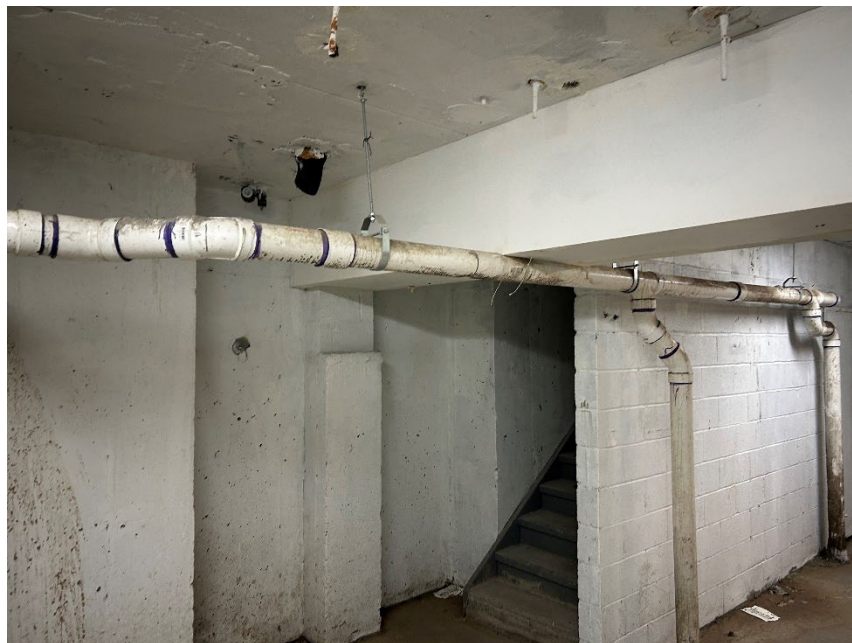
Photo 12: Photo of the southern basement located under the commercial spaces;
network of legs and suction points and of one of the basement staircases.

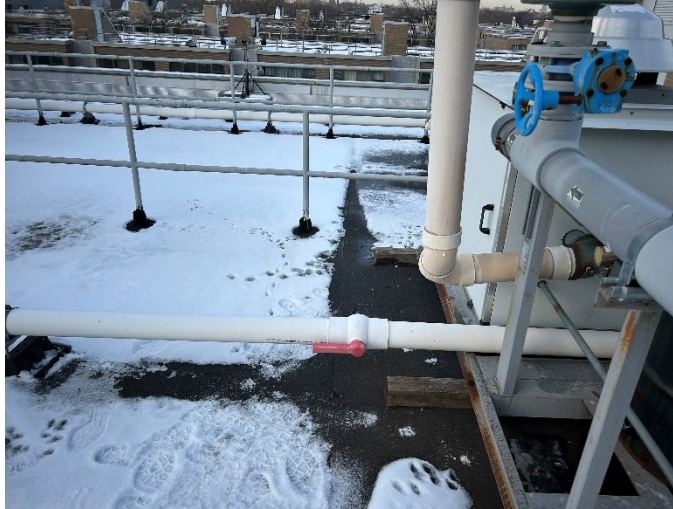
Photo 13: SSDS piping run along the roof from Blower A; valve is in the full open position.

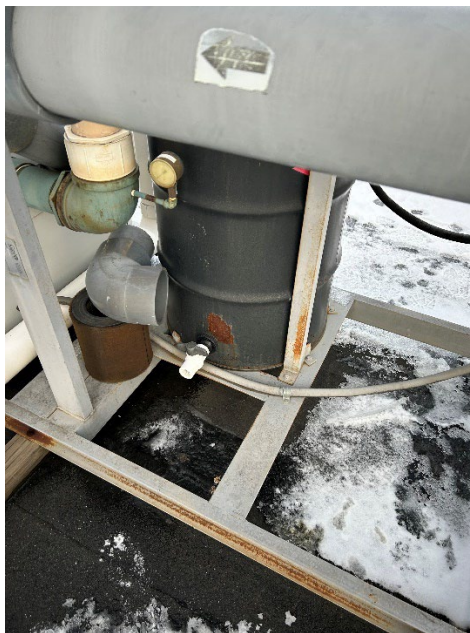
Photo 14: Photo of the outlet valve of the Blower B unit.
