DAILY STATUS REPORT

NYSDEC BCP Site No:	C224219	Date:	10/17/2024	
Project Name:	450 Union Street, Brooklyn, NY

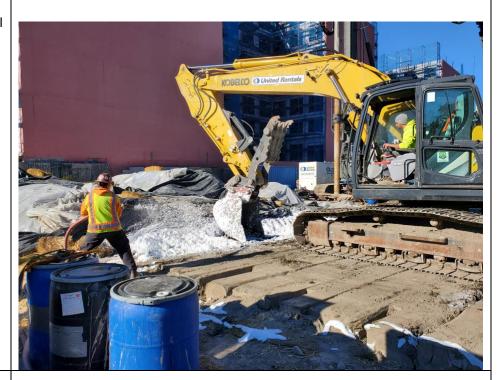
Photo 1:

GSI applying foam while moving swell material, view facing southwest.

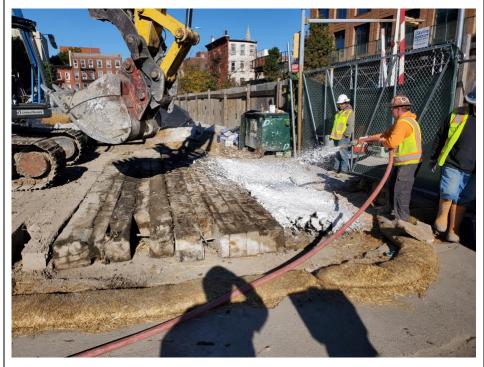
Photo 2:

GSI applying foam while moving swell material, view facing northwest

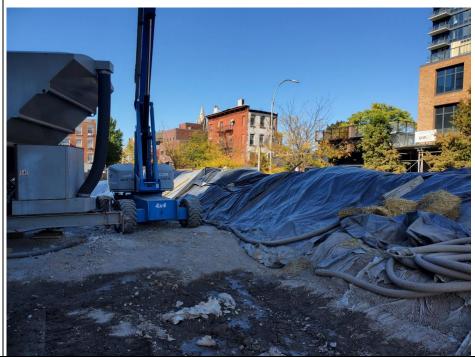
Photo 3:
Poly sheeting placed atop ISS spoils and secured at the end of the day, facing northwest.

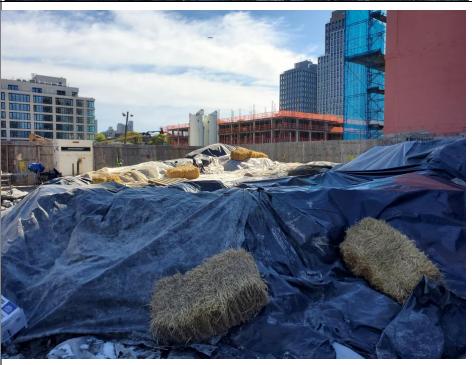
Photo 4:
Poly sheeting placed atop of ISS spoils and secured at the end of the day, facing southeast.

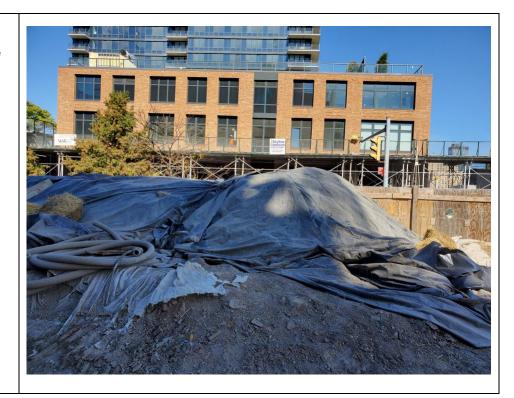
Photo 5: Poly sheeting placed on top of berm with ISS material and secured at the end of the day, facing north.
