APPENDIX H

Project Photo Log

Photograph Log

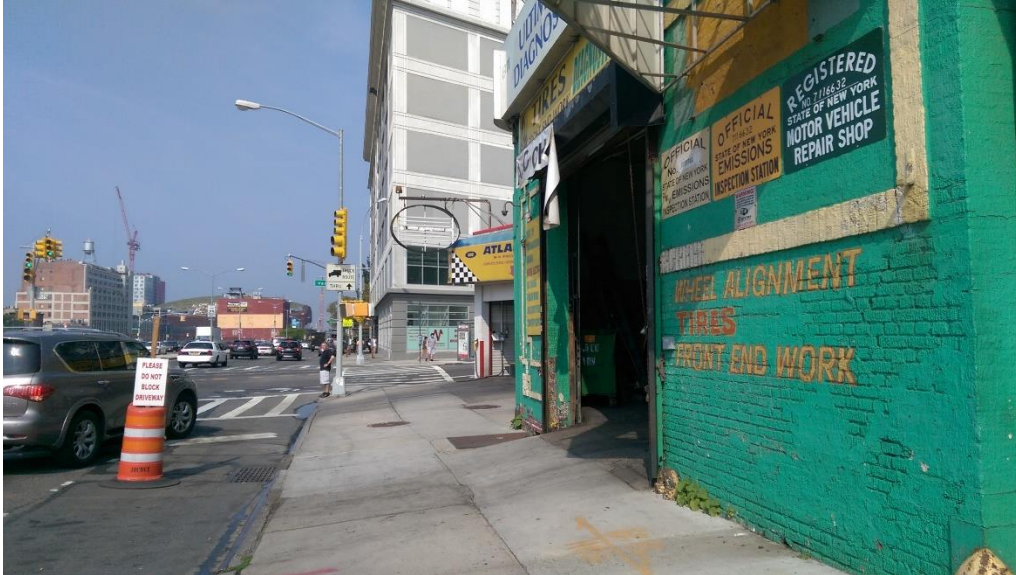
Photo 1: View of entrance to site from Atlantic Avenue pre-demolition (facing west). Taken on 02/19/2015

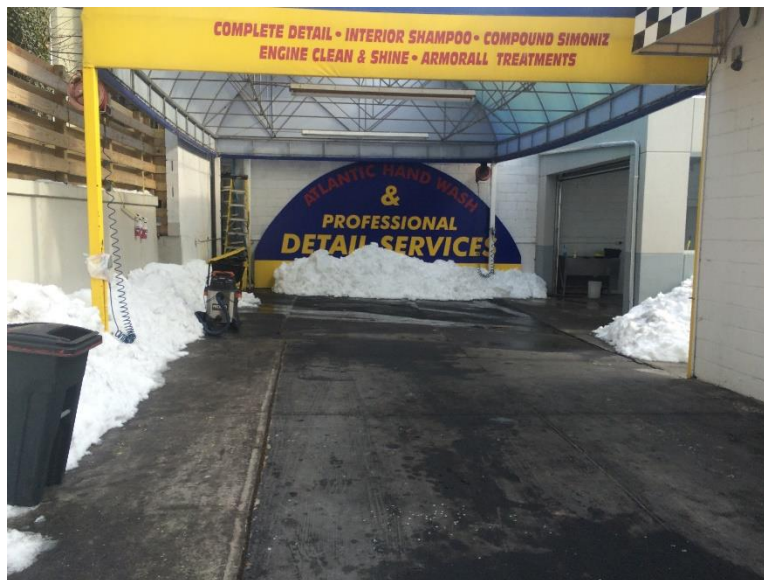
Photo 2: View of the northeastern part of the site pre-demolition (facing north). Taken on 01/26/2016

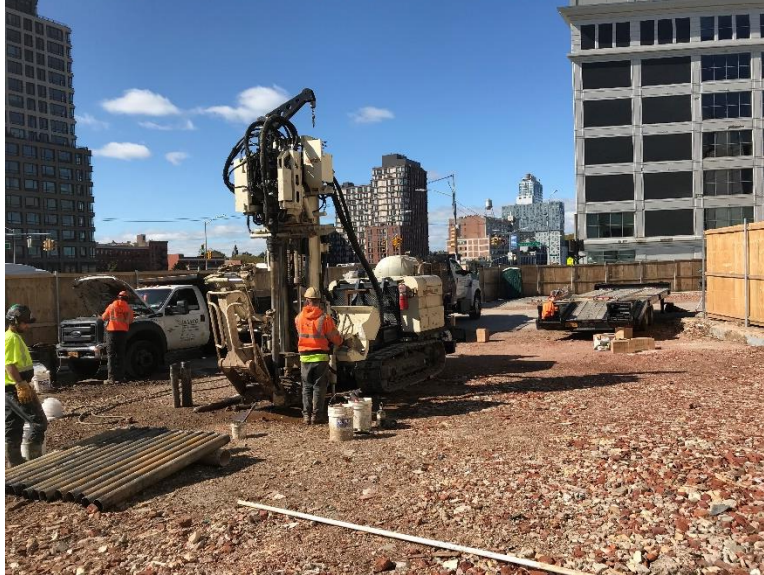
Photo 3: AARCO advancing groundwater injection point IP-10 (facing west). Taken on 10/18/2019.

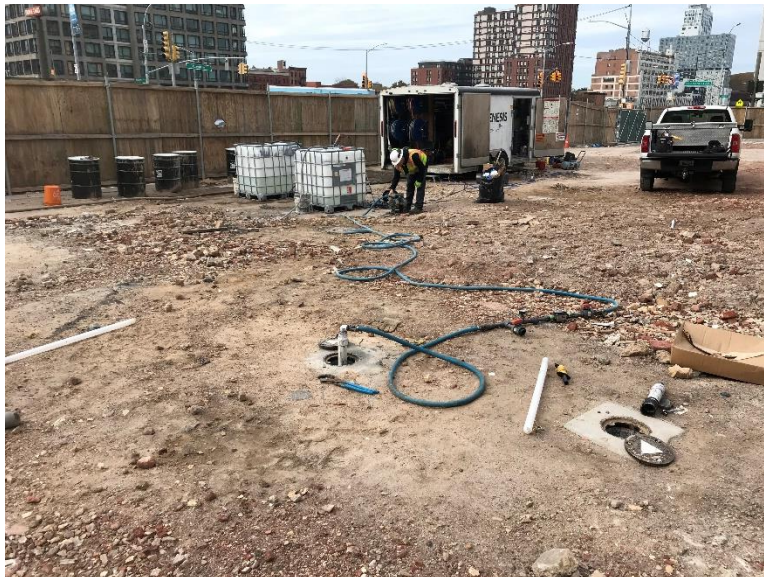
Photo 4: Regenesis injecting Nutrisulfate at injection point IP-13 (facing southwest). Taken on 11/07/2019.

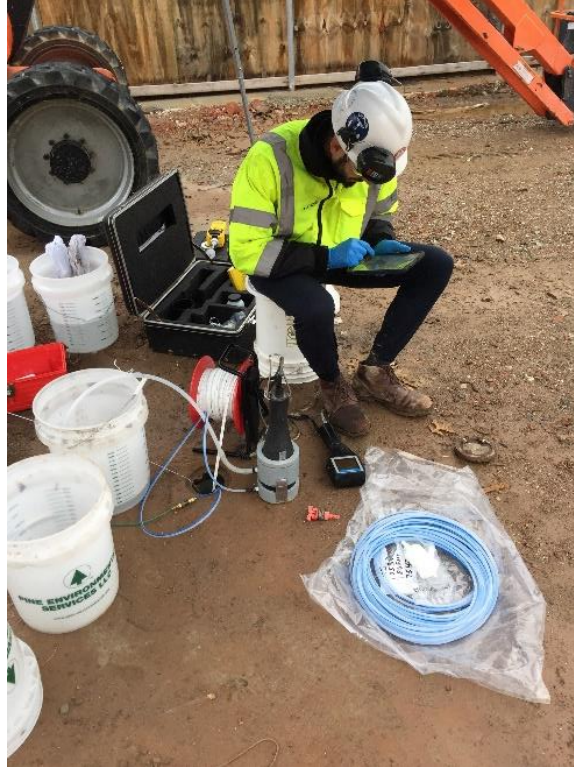
Photo 5: Langan conducting post-injection low-flow groundwater sampling of monitoring well MW-111 (facing south). Taken on 12/10/2019.

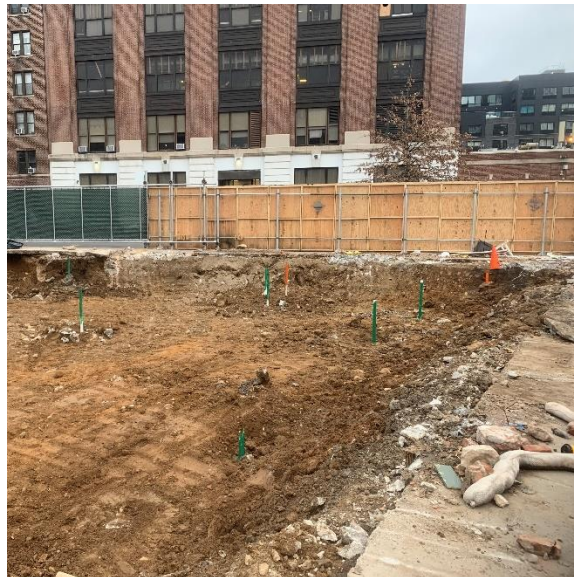
Photo 6: General view of the initial excavation area in the southeastern section of the site (facing east). Taken on 01/07/2020.

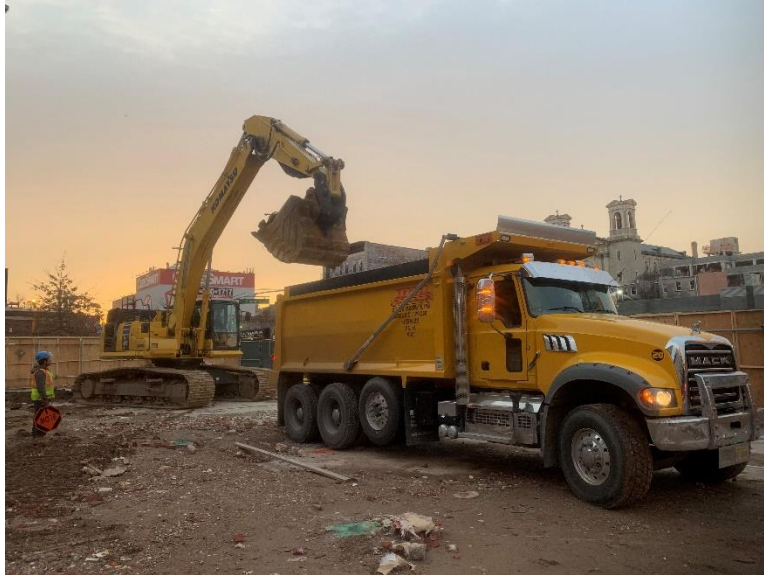
Photo 7: Off-loading of non-hazardous historic fill material from grid WC-05 (facing southeast). Taken on 01/07/2020.

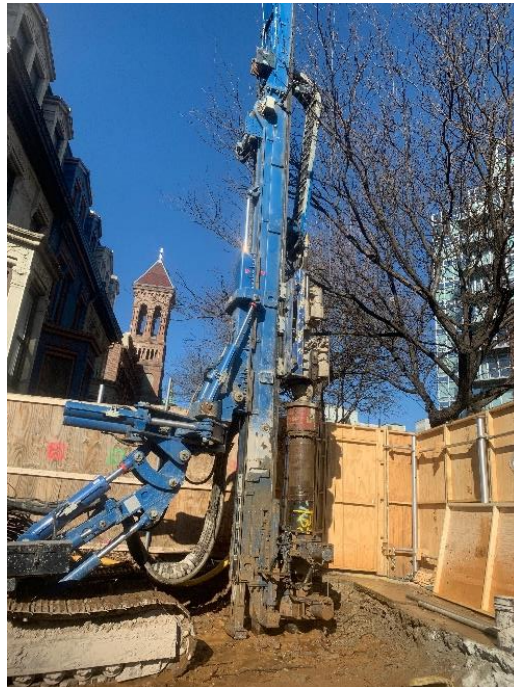
Photo 8: Pile drilling in the southeastern section of the site (facing north). Taken on 01/20/2020.

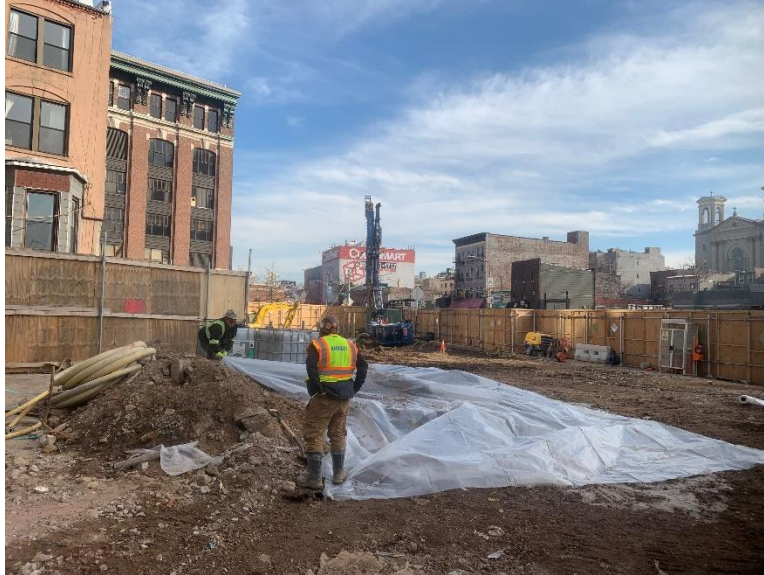
Photo 9: Kingdom preparing stockpile for soil generated during air rotary drilling (facing east). Taken on 01/24/2020.

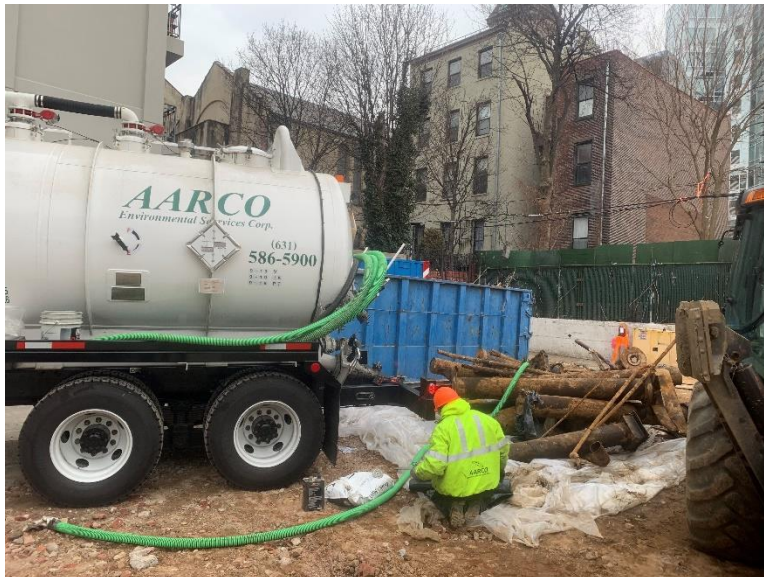
Photo 10: AARCO cleaning and disposing of hydraulic pistons encountered during mass excavation (facing northeast). Taken on 01/31/2020.

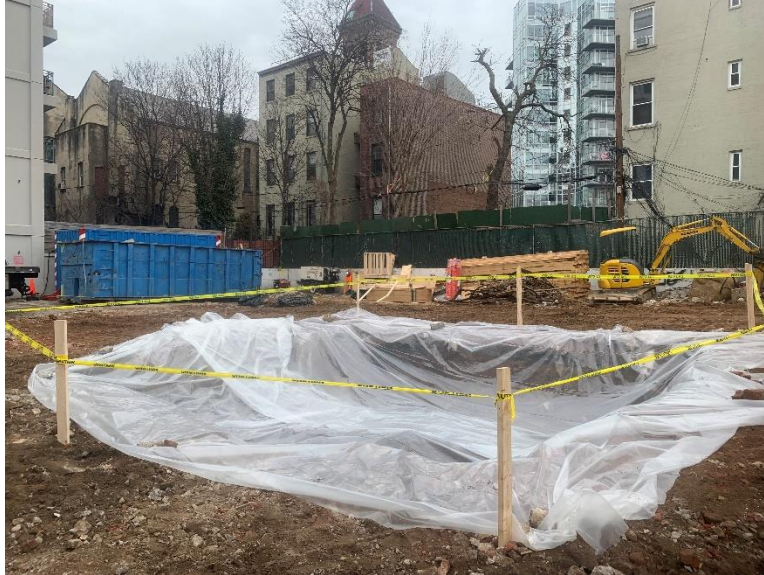
Photo 11: Excavation of hazardous lead-impacted hot spot, SB-107A, taped off and covered with poly-sheeting (facing northeast). Taken on 02/04/2020.

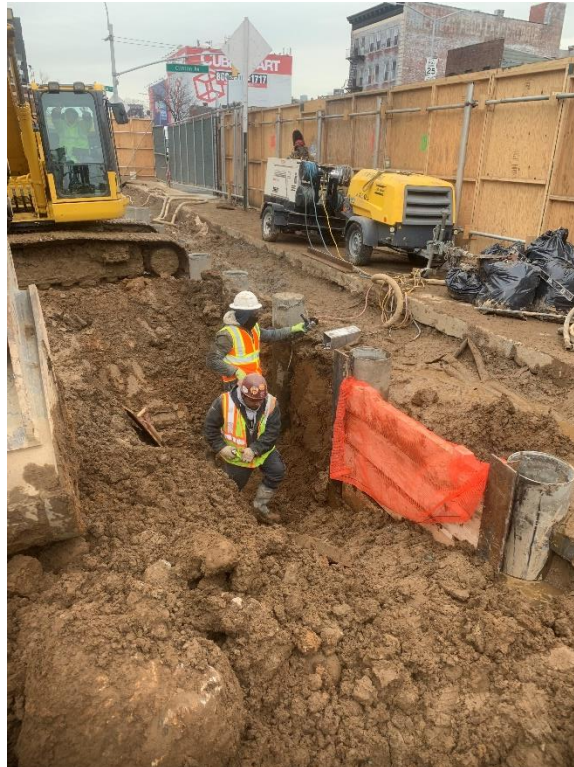
Photo 12: Excavation of non-hazardous historic fill material for the installation of lagging (facing southeast). Taken on 02/05/2020.

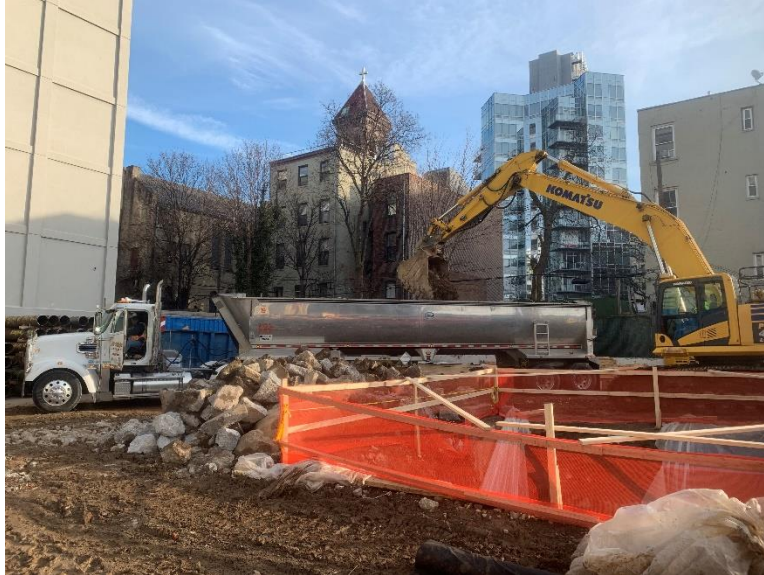
Photo 13: Off-loading of hazardous lead-impacted historic fill material from WPSB-01 and SB-107A (facing northeast). Taken on 02/12/2020.

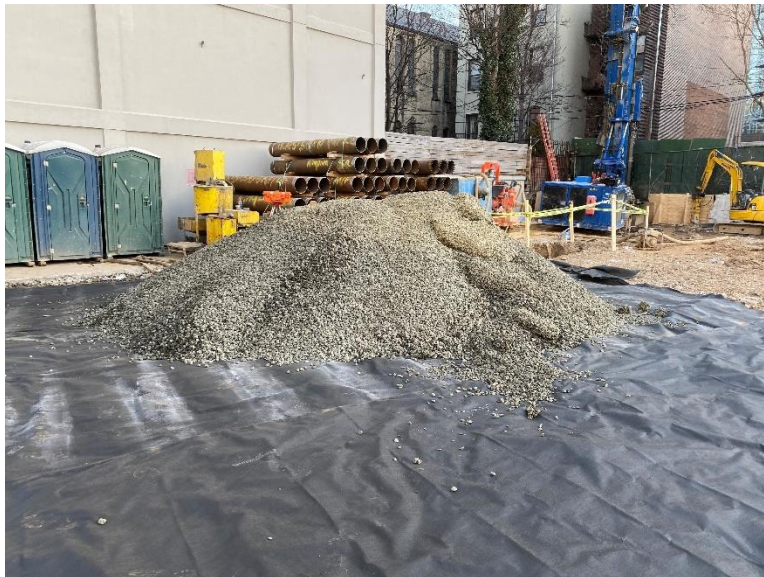
Photo 14: Imported $\frac{3}{4}$ -inch quarry stone to be used for the site entrance track pad (facing north). Taken on 02/20/2020.

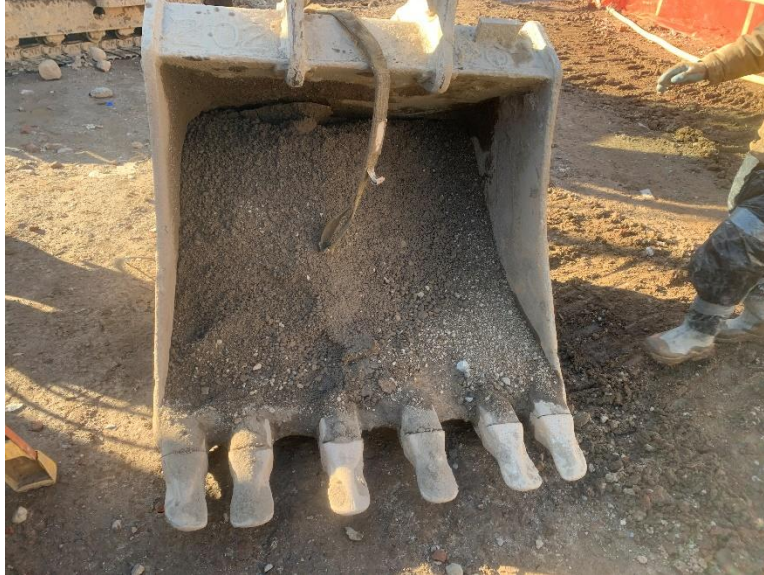
Photo 15: Collected air rotary drilling spoils prior to stockpiling (facing west). Taken on 02/27/2020.

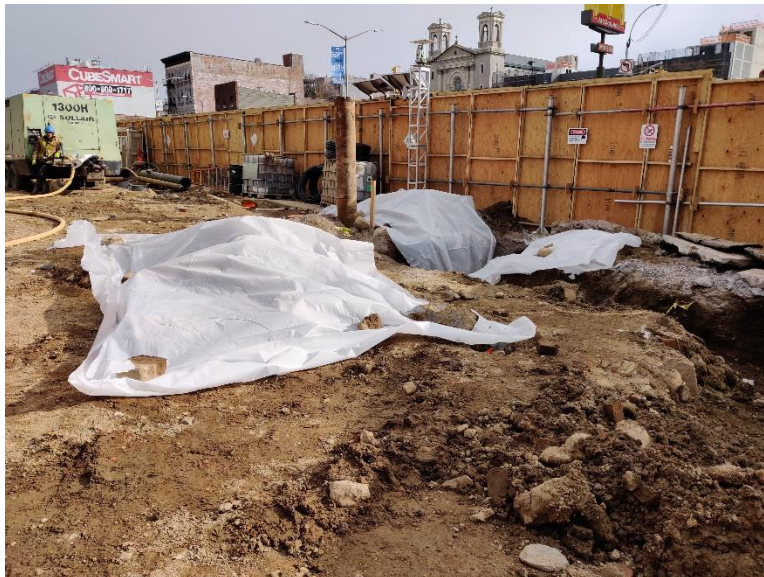
Photo 16: Stockpiles of non-hazardous historic fill material covered with poly sheeting in southwestern corner of the site (facing southeast). Taken on 02/29/2020.

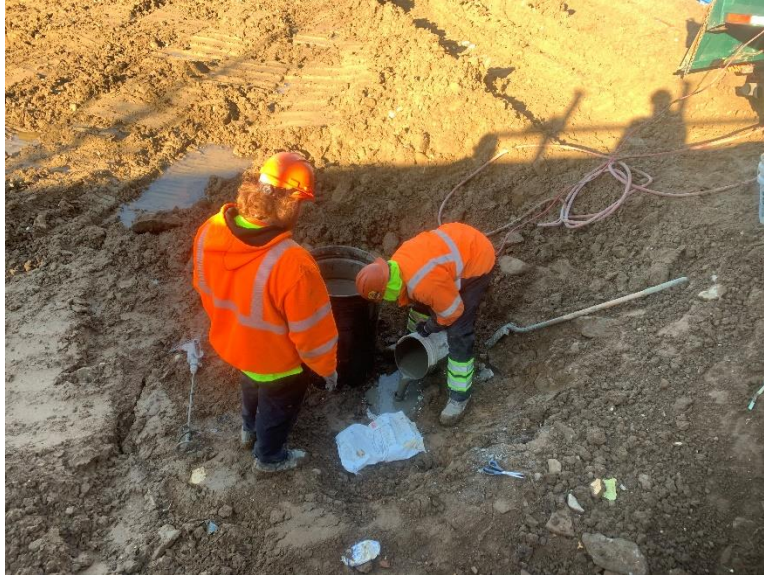
Photo 17: Decommissioning of injection point (IP-11) in the southeastern section of the site (facing west). Taken on 03/04/2020.

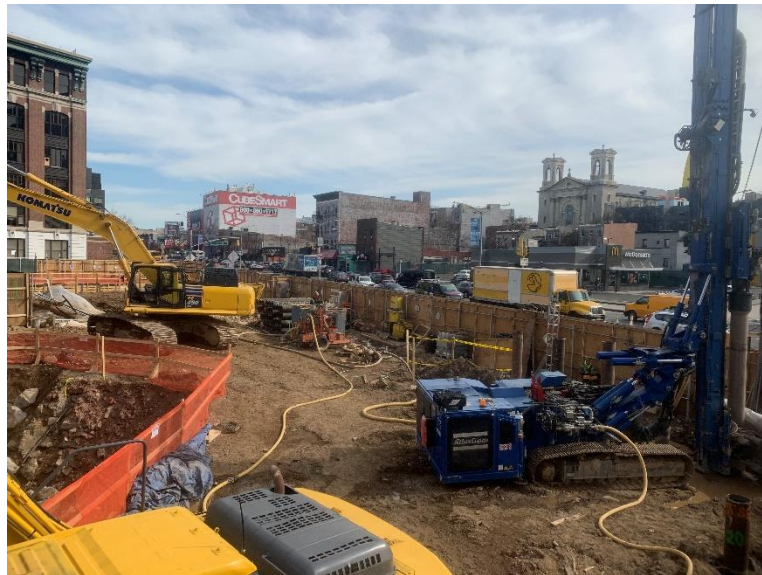
Photo 18: General view of the site (facing southeast). Taken on 03/05/2020.

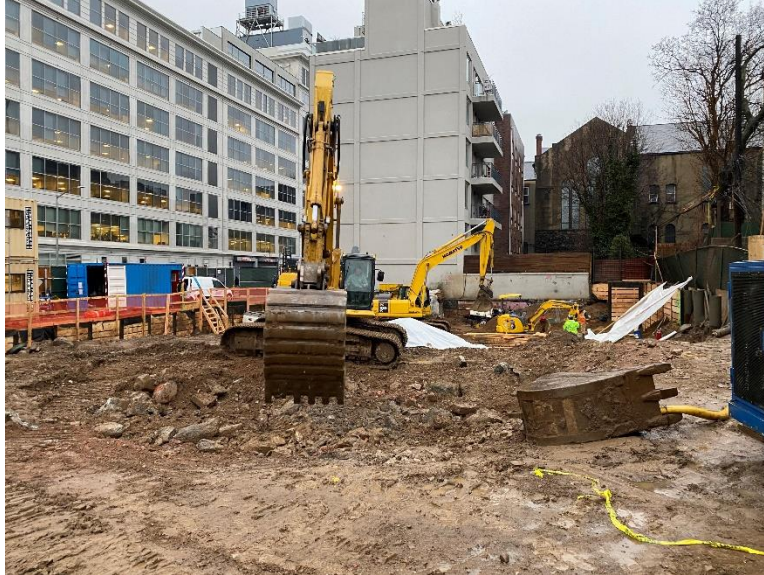
Photo 19: Kingdom excavating non-hazardous soil in the central section of the site (facing north). Taken on 03/13/2020.

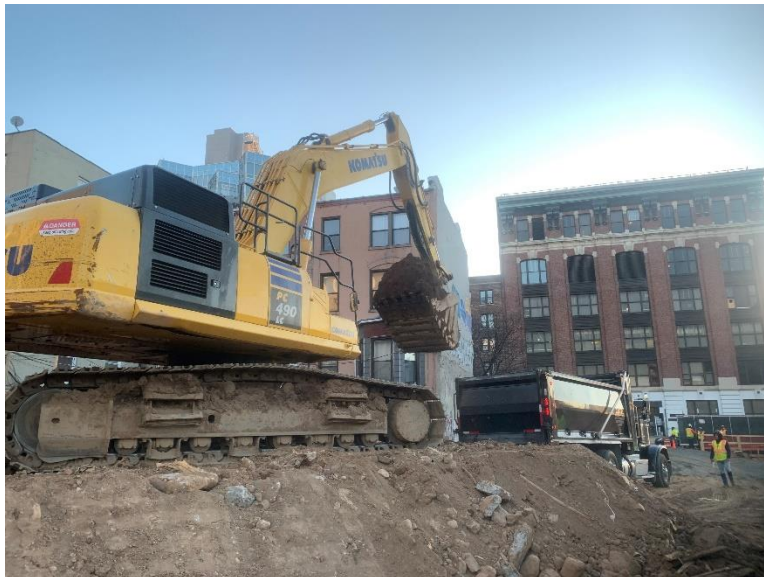
Photo 20: Off-loading of non-hazardous historic fill material (facing east). Taken on 03/16/2020.

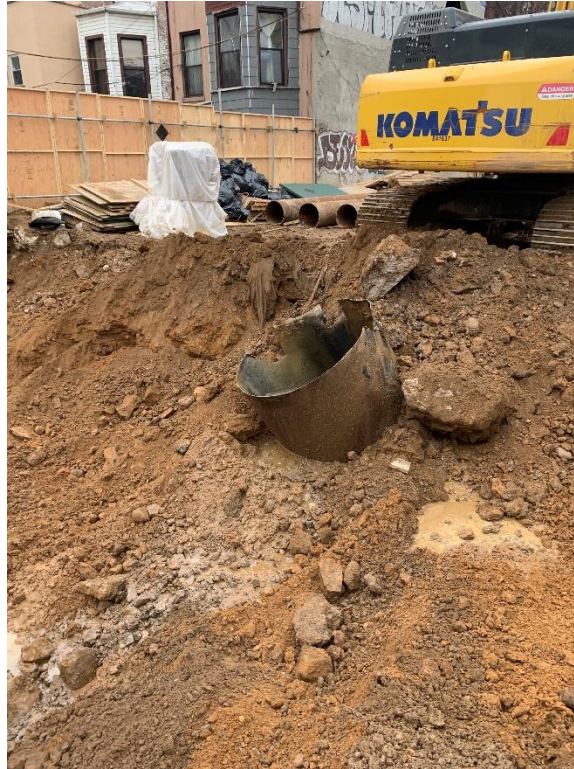
Photo 21: View of the encountered 550-gallon underground storage tank (UST) located in the southeastern part of the site. Taken on 03/20/2020.

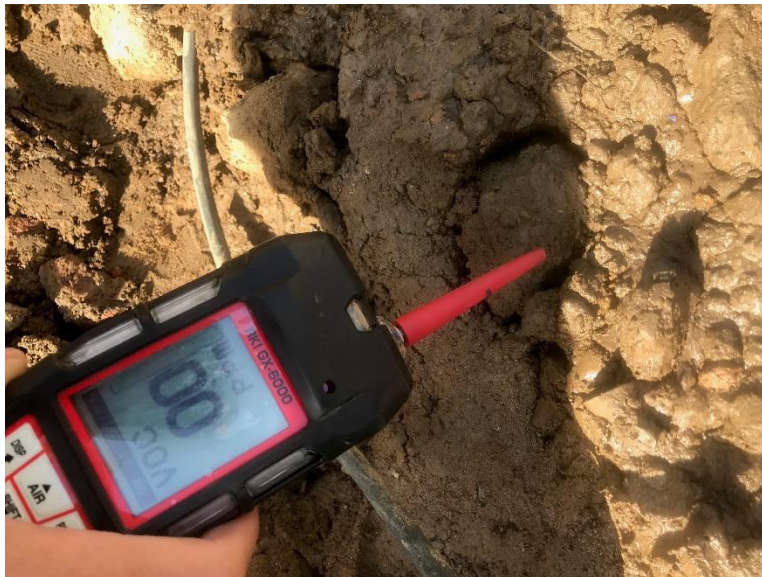
Photo 22: Screening of non-hazardous historic fill material within the encountered 550-gallon UST grave; evidence of impacts were not observed. Taken on 03/21/2020.

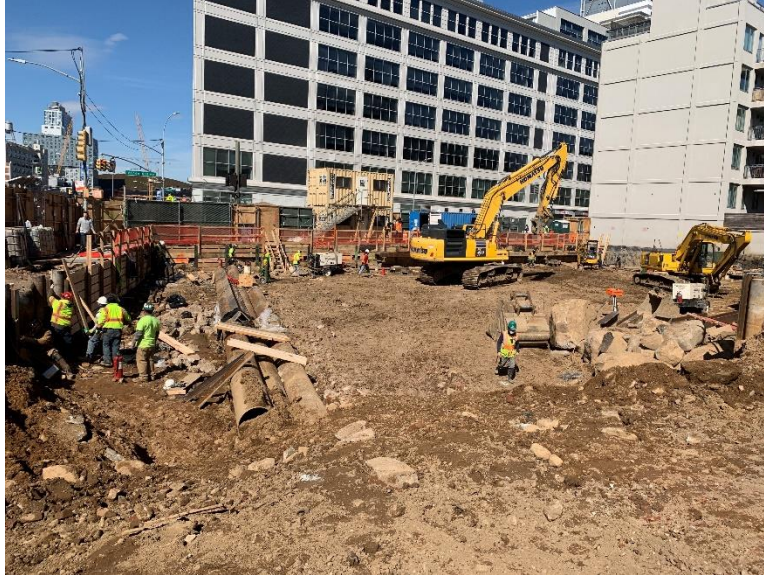
Photo 23: General site view (facing east). Taken on 03/27/2020.

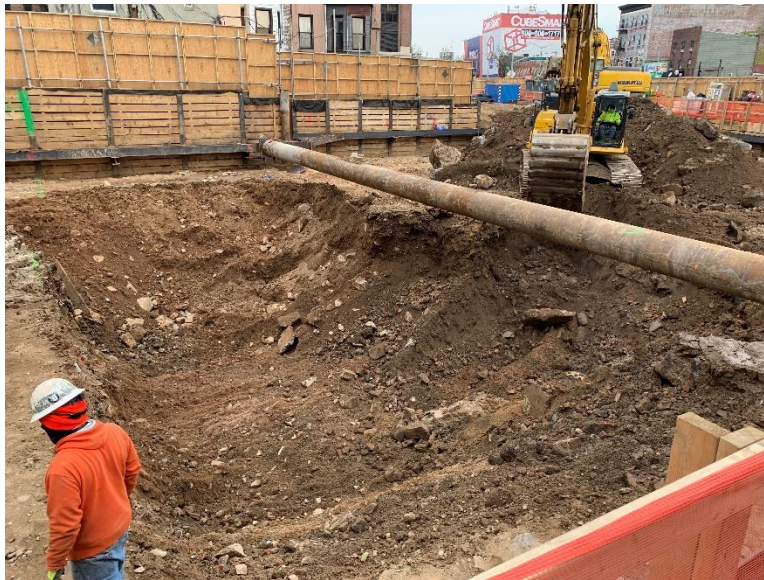
Photo 24: Excavation of non-hazardous fill from grids WC02 and WC03 for future off-site disposal (facing southeast). Taken on 04/23/2020.

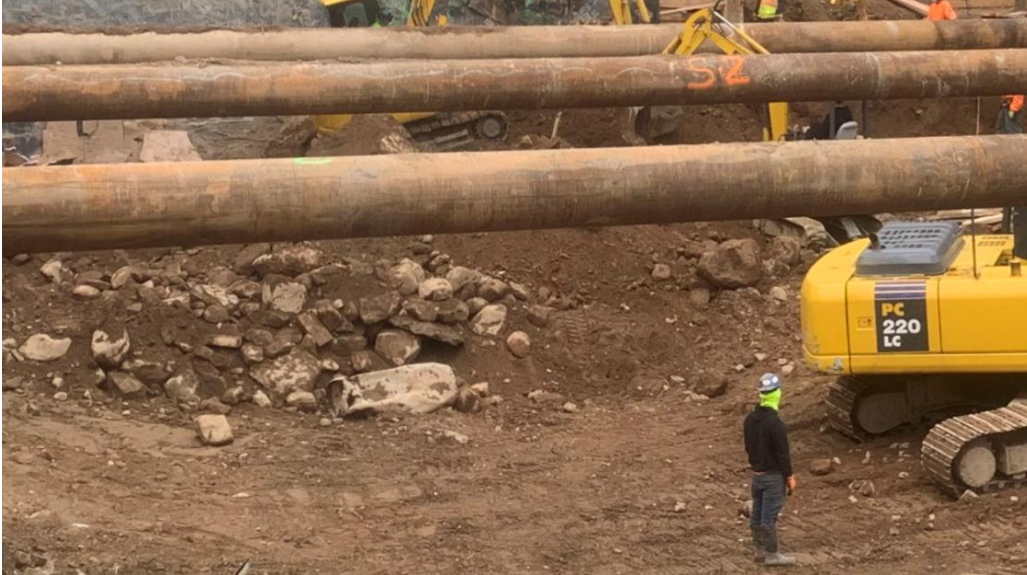
Photo 25: View of the encountered 100-gallon UST located in the northwest part of the site. Taken on 04/27/2020.

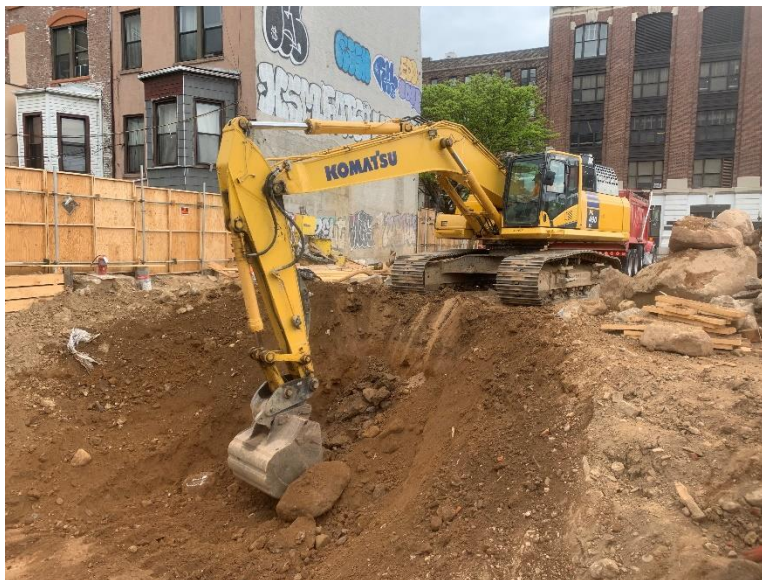
Photo 26: Excavation of non-hazardous fill for off-loading in the south-central section of the site (facing northeast). Taken on 05/18/2020.

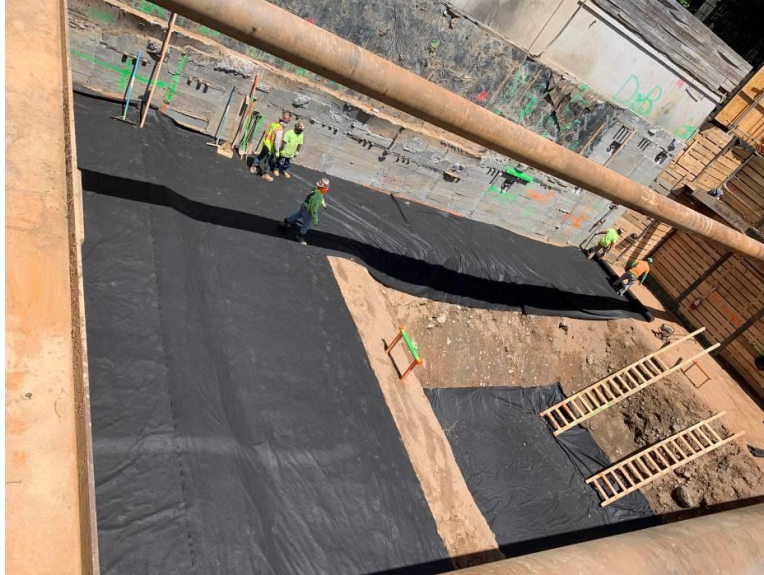
Photo 27: Installation of geotextile fabric prior to quarry stone placement in the northwestern section of the site (facing northeast). Taken on 05/21/2020.

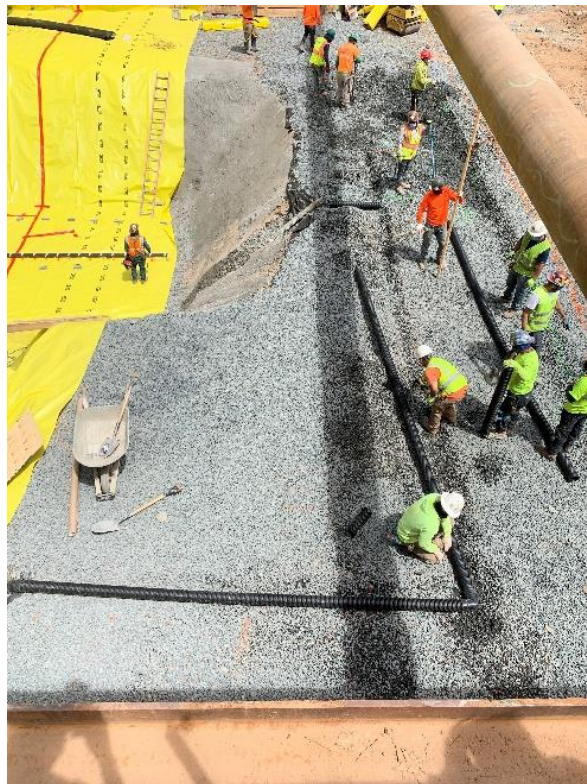
Photo 28: Installation of four-inch sub-membrane depressurization system (SMDS) piping on top of a six-inch-thick stone subgrade and geotextile fabric in the northwestern part of the site (facing east). Taken on 05/22/2020.

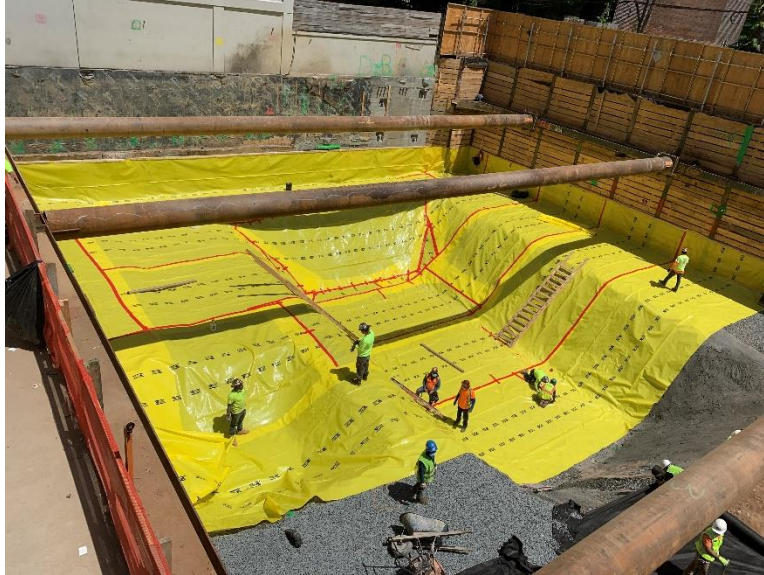
Photo 29: Installation of the vapor barrier in the northern part of the site (facing north).
Taken on 05/21/2020.

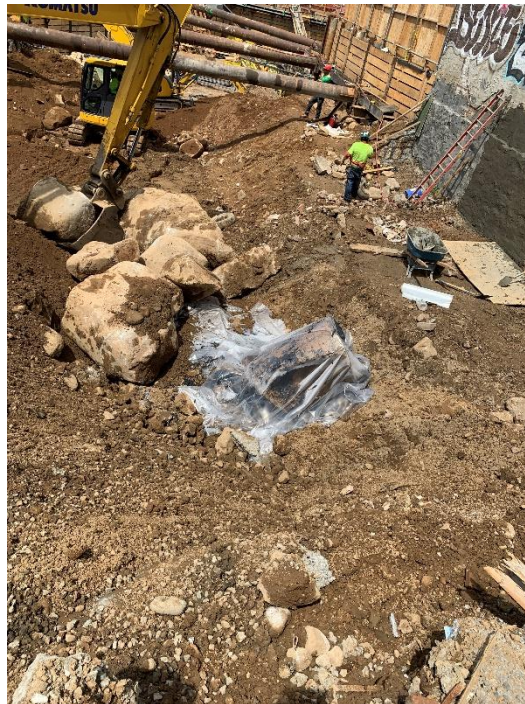
Photo 30: View of the encountered 550-gallon UST covered with polyethylene sheeting
located in the northeastern part of the site. Taken on 06/04/2020.

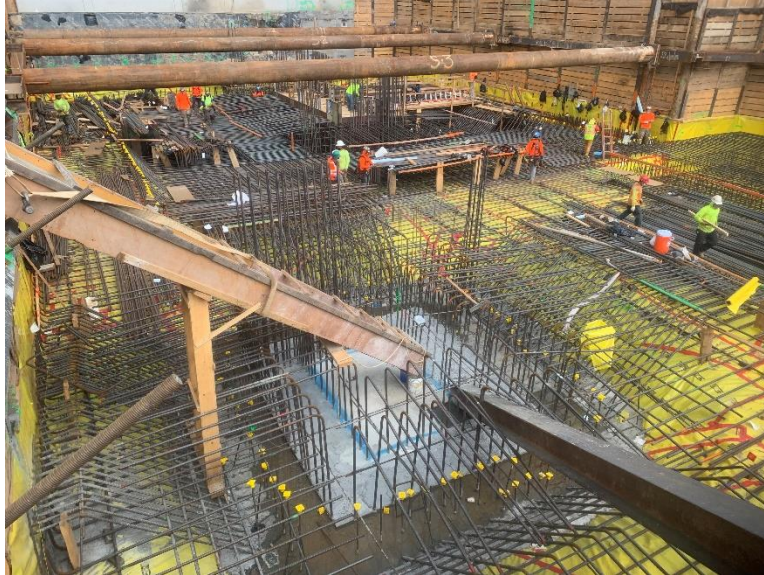
Photo 31: Installation of rebar in the western part of the site (facing north). Taken on 06/06/2020.

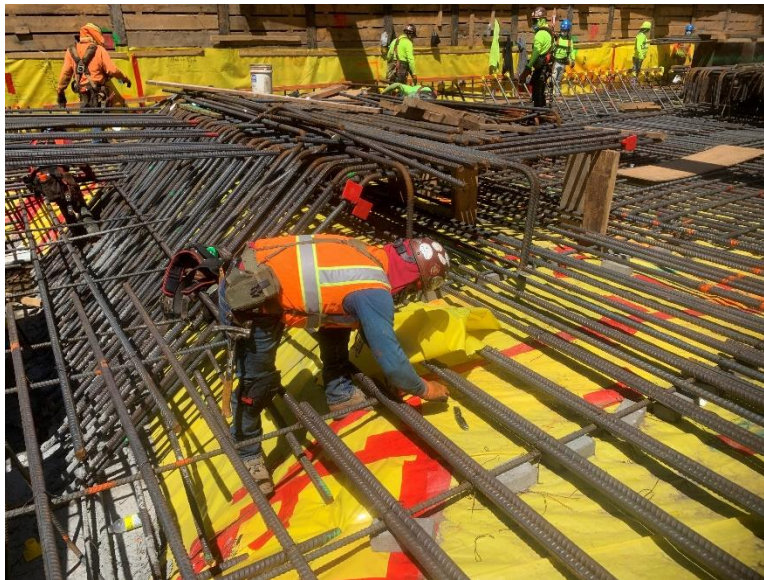
Photo 32: View of vapor barrier repair using Stego® Tape (facing northwest). Taken on 06/08/2020.

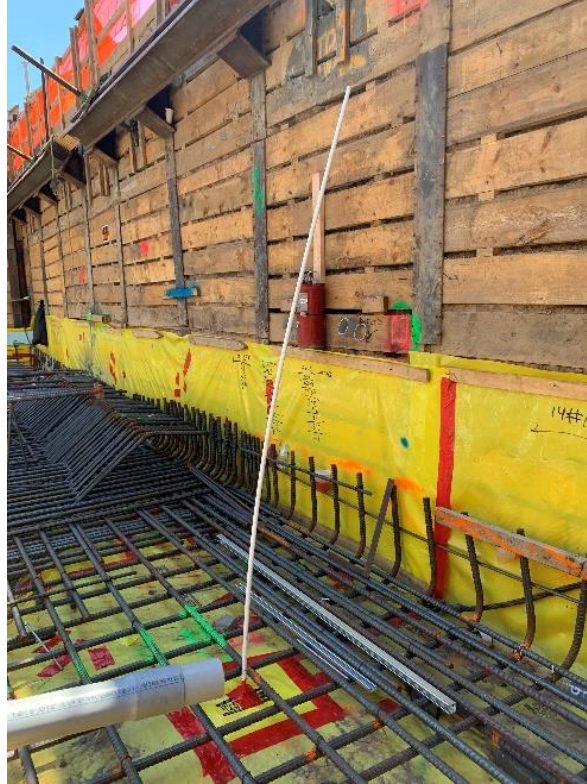
Photo 33: View of vapor monitoring point (VMP) installation in the western part of the site. Taken on 06/12/2020.

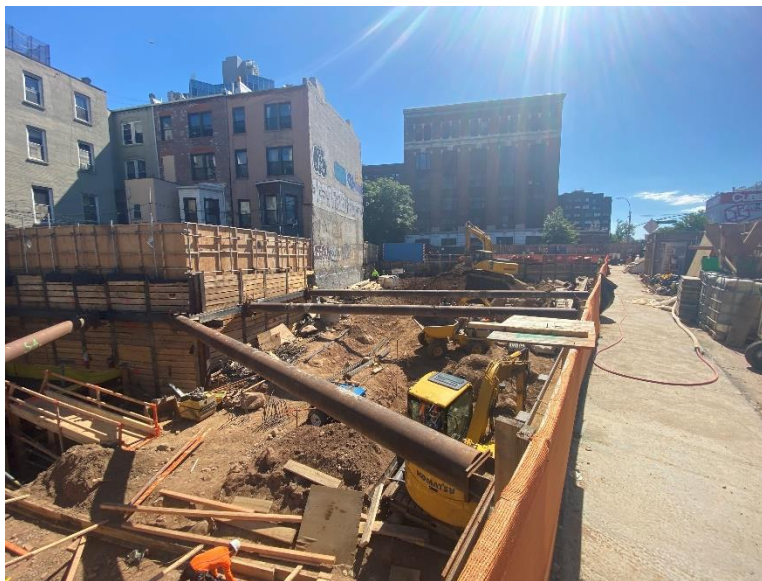
Photo 34: General view of the eastern part of the site (facing north). Taken on 06/13/2020.

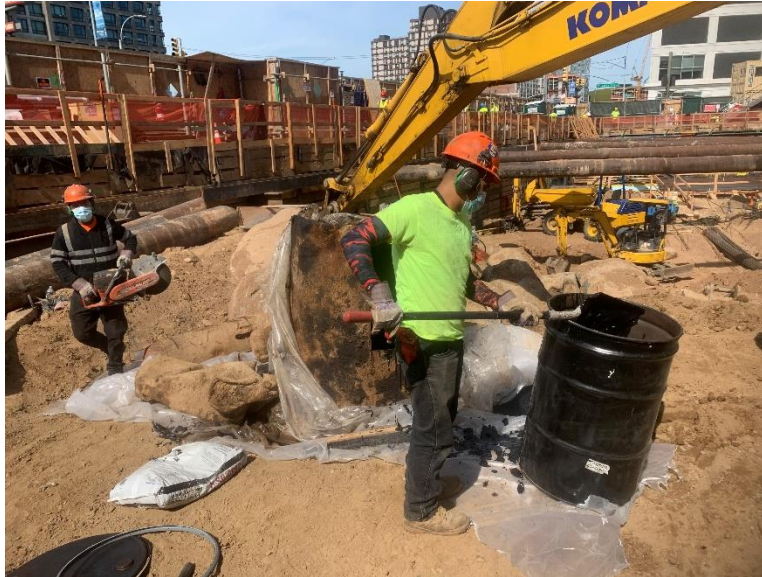
Photo 35: Cleaning of USTs identified during excavation prior to off-site disposal (facing north). Taken on 06/15/2020.

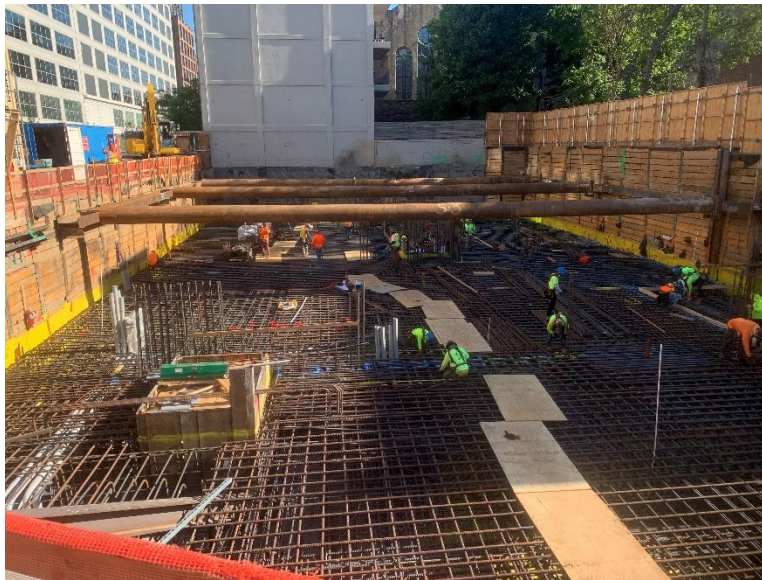
Photo 36: General view of the site (facing north). Taken on 06/16/2020.

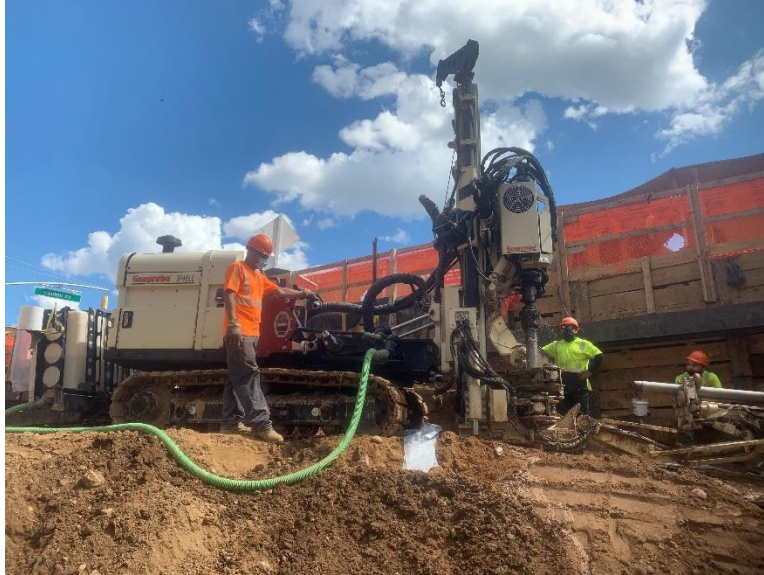
Photo 37: Advancement of MW-203 (facing southeast). Taken on 07/14/2020.

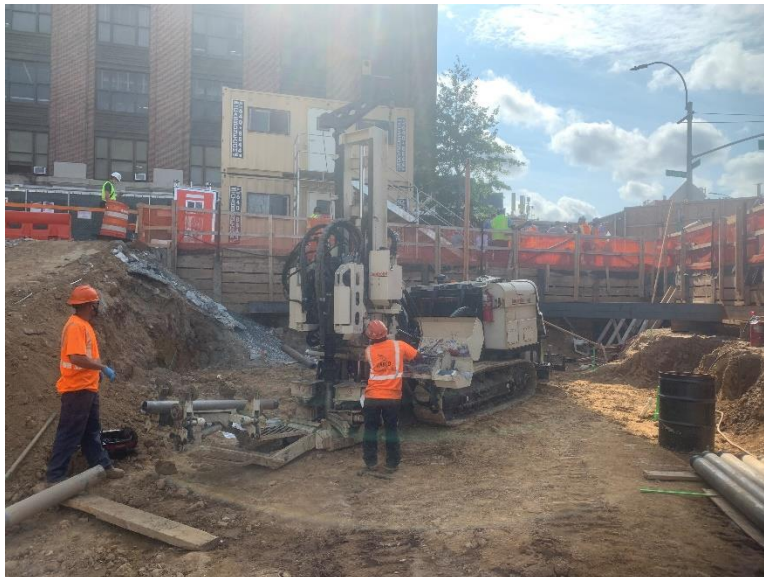
Photo 38: Photo 2: AARCO advancing soil vapor extraction (SVE) well SVE-5 (facing southeast). Taken on 07/15/2020.

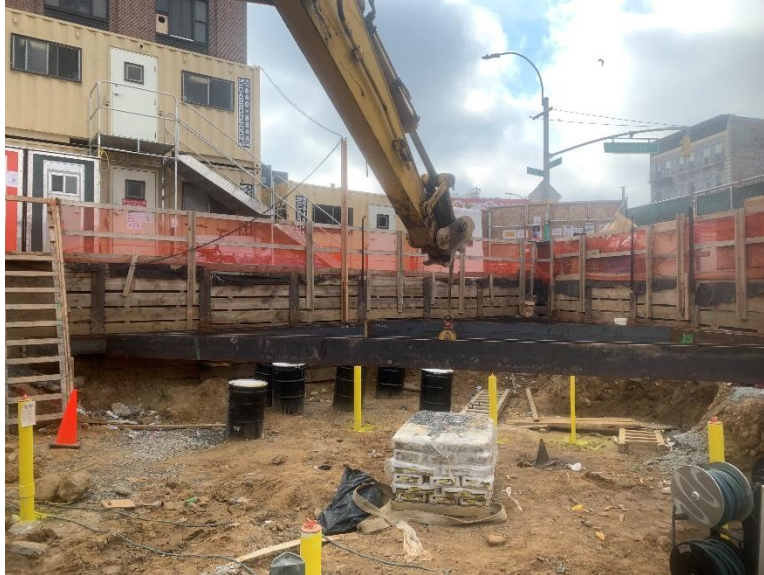
Photo 39: General view of installed groundwater monitoring wells and SVE wells (facing southeast). Taken on 08/11/2020.

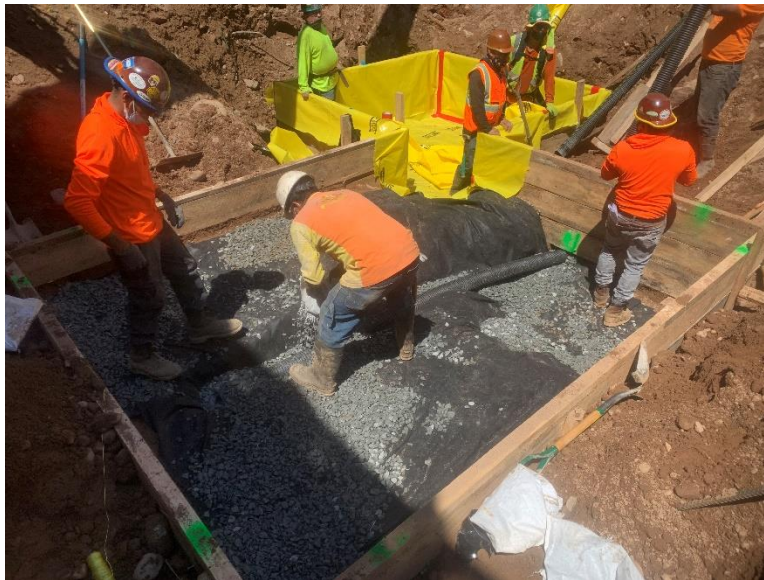
Photo 40: General view of SMDS installation in the eastern part of the site (facing northwest). Taken on 08/18/2020.

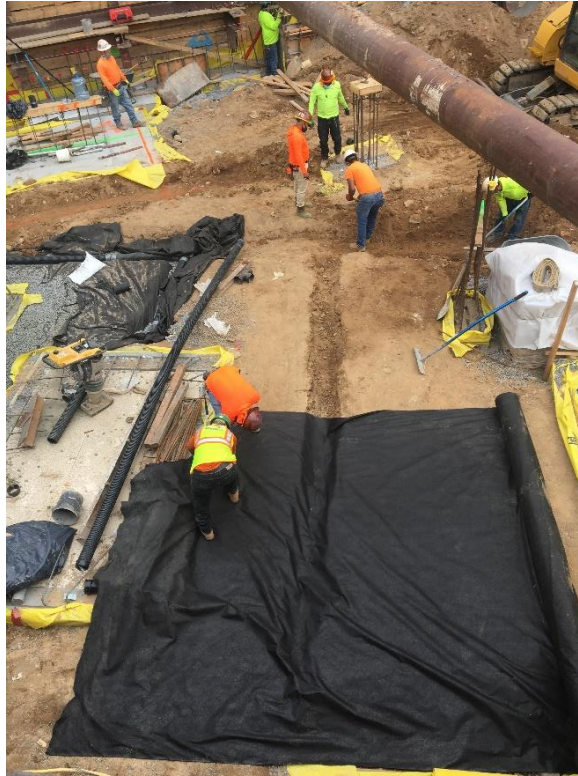
Photo 41: Excavation of SMDS piping and placement of geotextile fabric in the central part of the site (facing north). Taken on 08/31/2020.

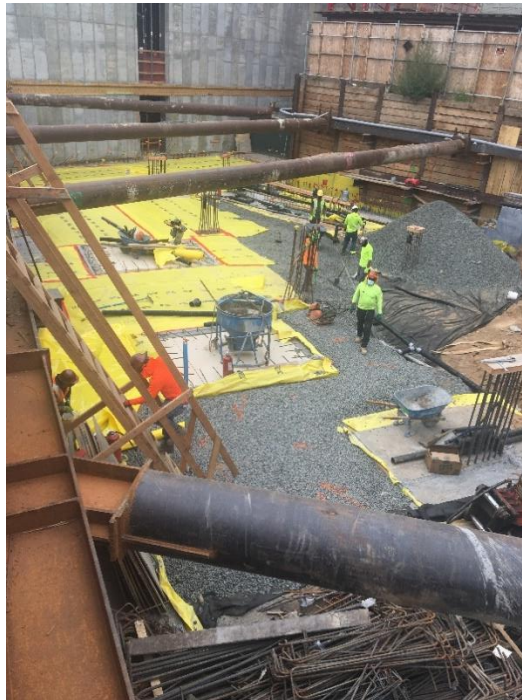
Photo 42: Placement of 3/4-inch clean stone and vapor barrier in the central part of the site (facing northwest). Taken on 08/31/2020.

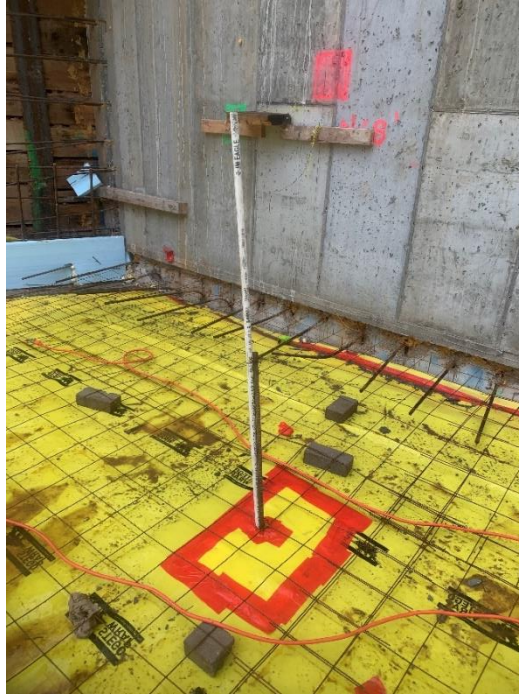
Photo 43: Installation of VMP-C3 (facing southwest). Taken on 09/02/2020.

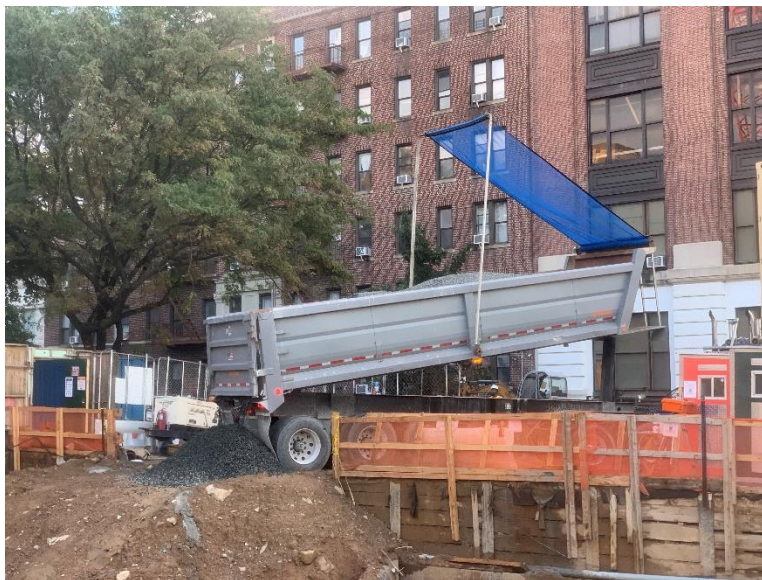
Photo 44: Import of 3/4-inch quarry stone (facing northeast). Taken on 09/11/2020.

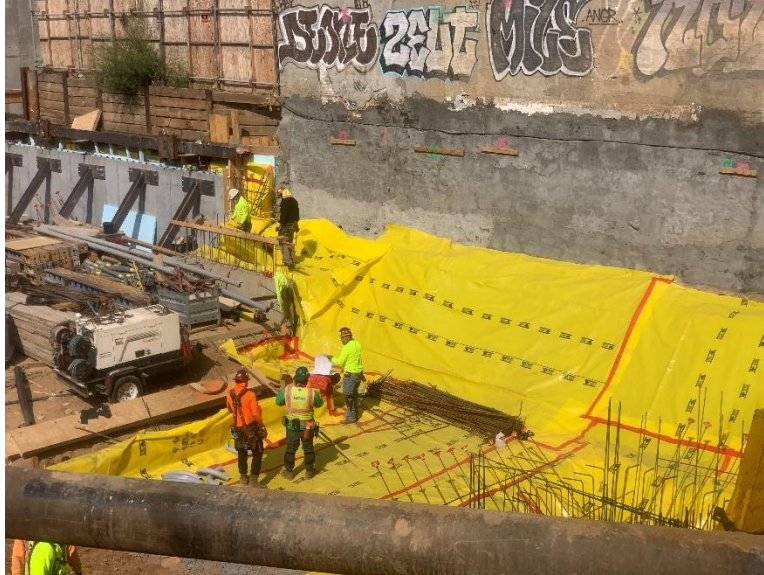
Photo 45: Vapor barrier installation in the eastern section of the site (facing northwest).
Taken on 09/21/2020.

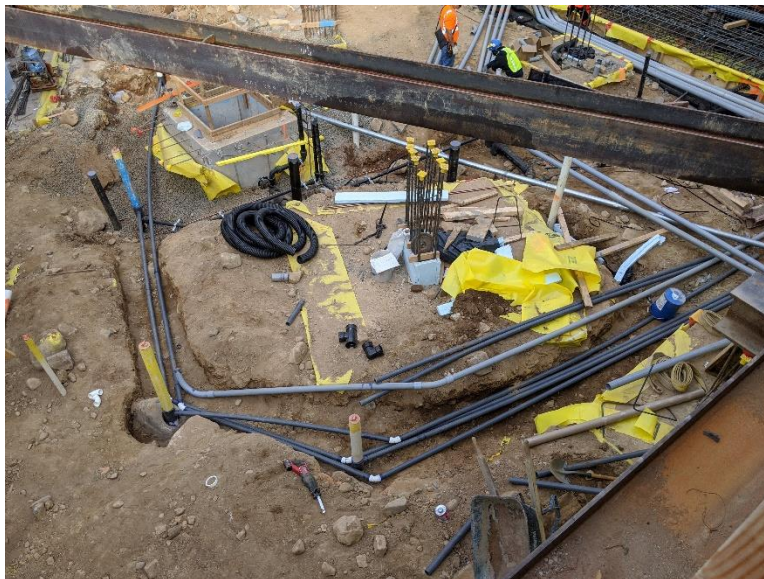
Photo 46: SVE well and piping installation in the southeastern section of the site (facing west). Taken on 09/25/2020.

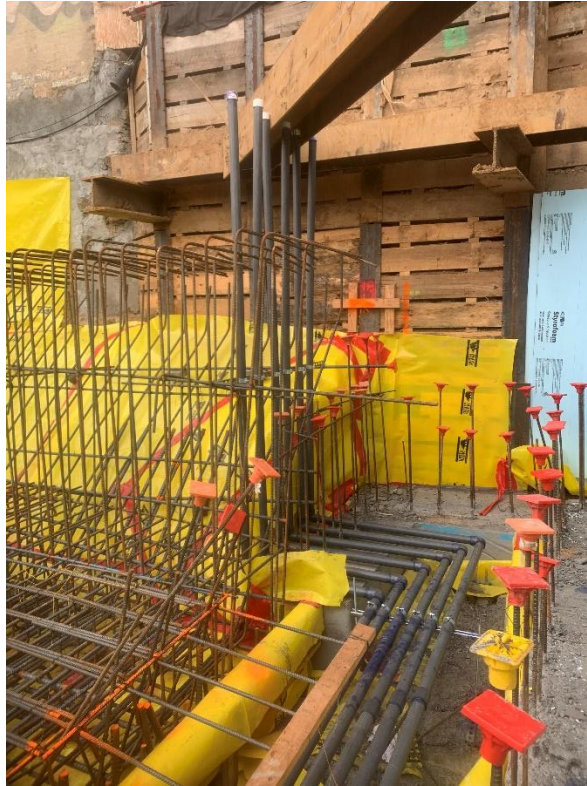
Photo 47: SVE piping installation in the eastern section of the site (facing northwest).
Taken on 09/28/2020.

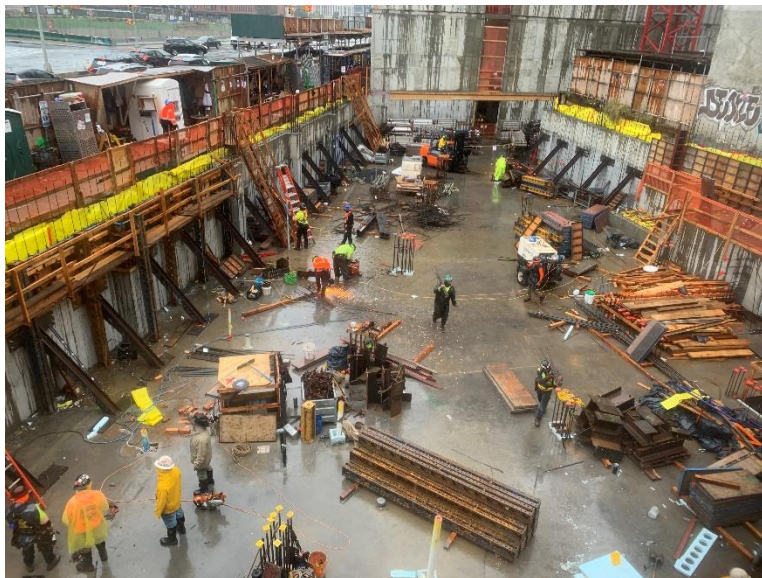
Photo 48: General view of the site from Clinton Avenue (facing west). Taken on
10/12/2020.

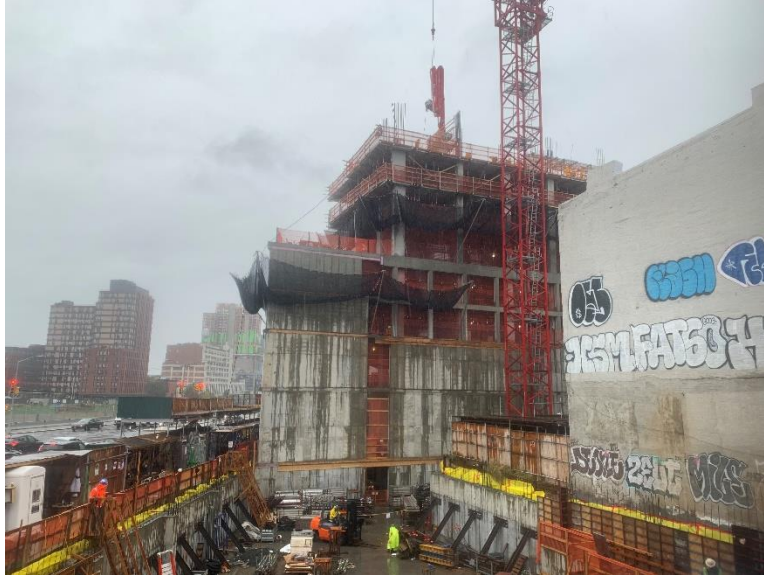
Photo 49: General view of the new building on Lot 1 from Clinton Avenue (facing west).
Taken on 10/12/2020.
