APPENDIX H

Project Photo Log

Photograph Log

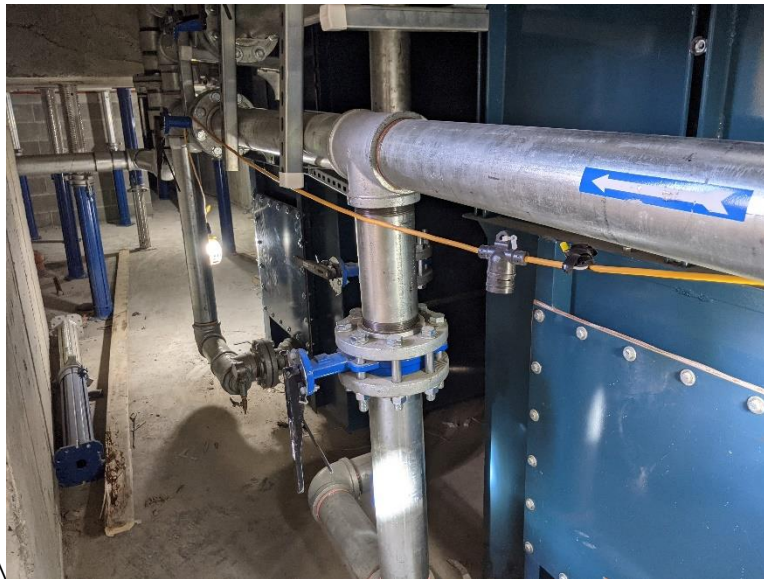
Photo 50: General view of the granular activated carbon (GAC) vessels (facing north).
Taken on 09/29/2021.

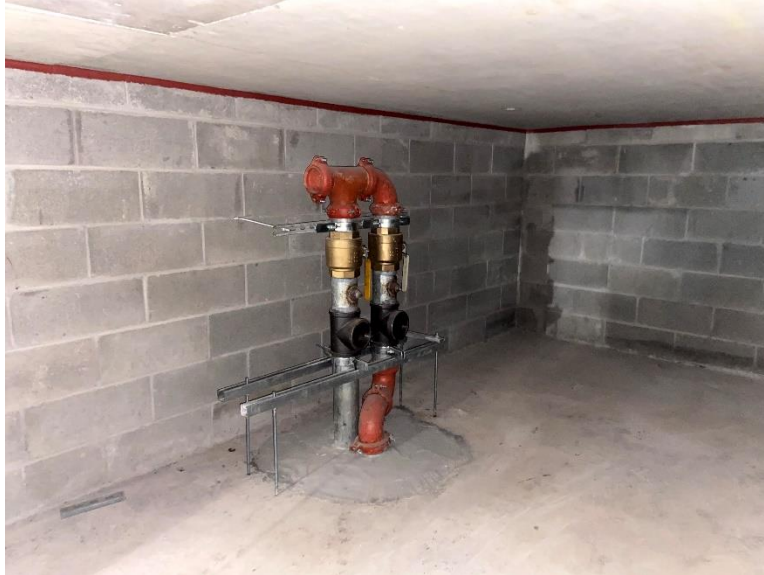
Photo 51: General view of the Vanderbilt building's SMDS manifold (facing east).
Taken on 09/29/2021.

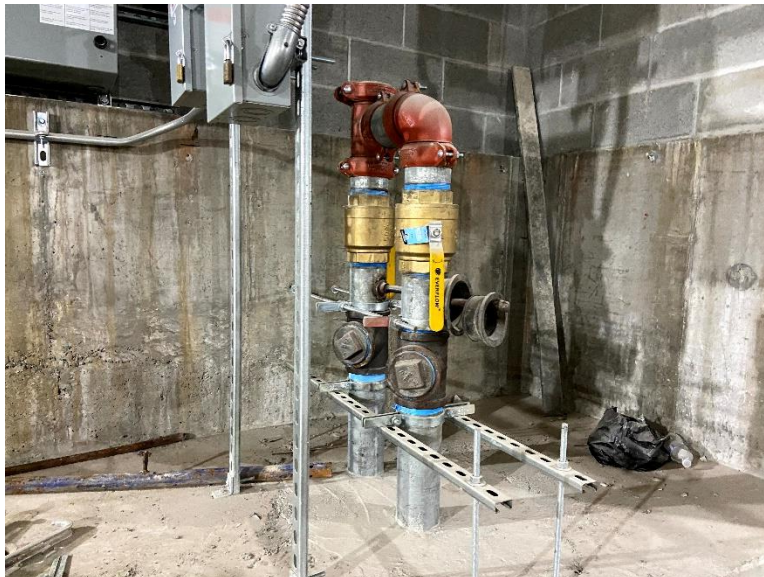
Photo 52: General view of the Clinton building's SMDS manifold (facing east). Taken on
09/29/2021.

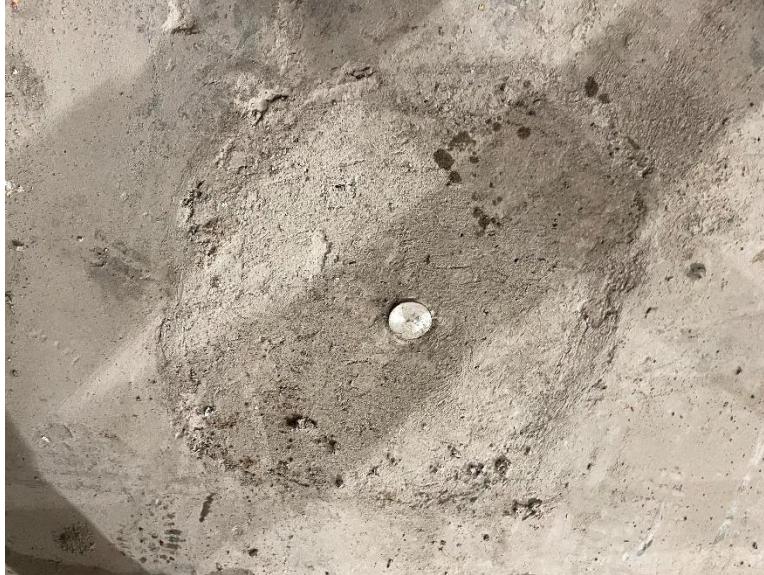
Photo 53: General view of a vapor monitoring point (facing east). Taken on 09/29/2021.

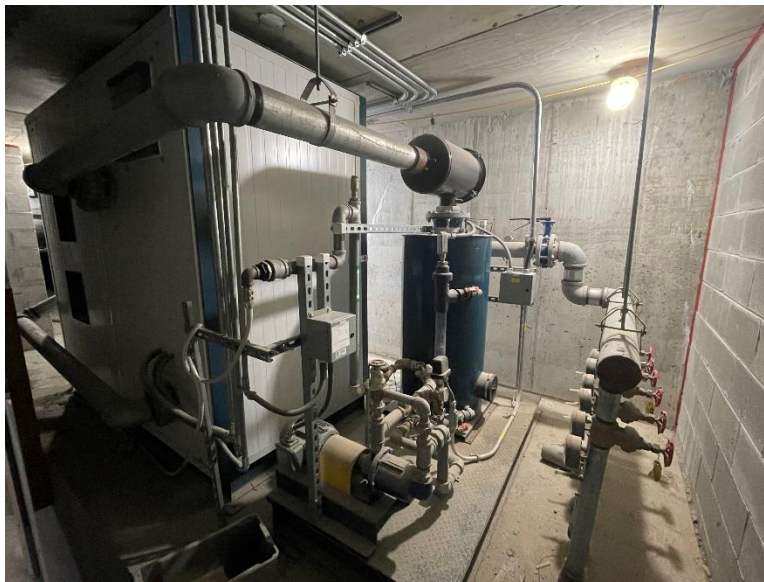
Photo 54: General view of the SVE system (facing north). Taken on 11/22/2021.

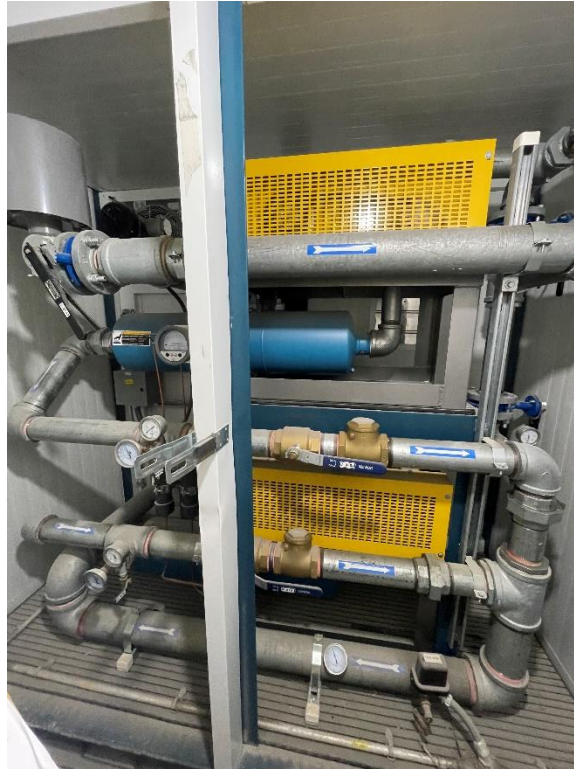
Photo 55: General view of blowers for the SVE system (facing south). Taken on 11/22/2021.
