**SUMMARY REPORT OF**

**PHASE II**

**ENVIRONMENTAL SERVICES**

**98-116 SOUTH 4th STREET  
BOROUGH OF BROOKLYN  
KINGS COUNTY, NEW YORK**

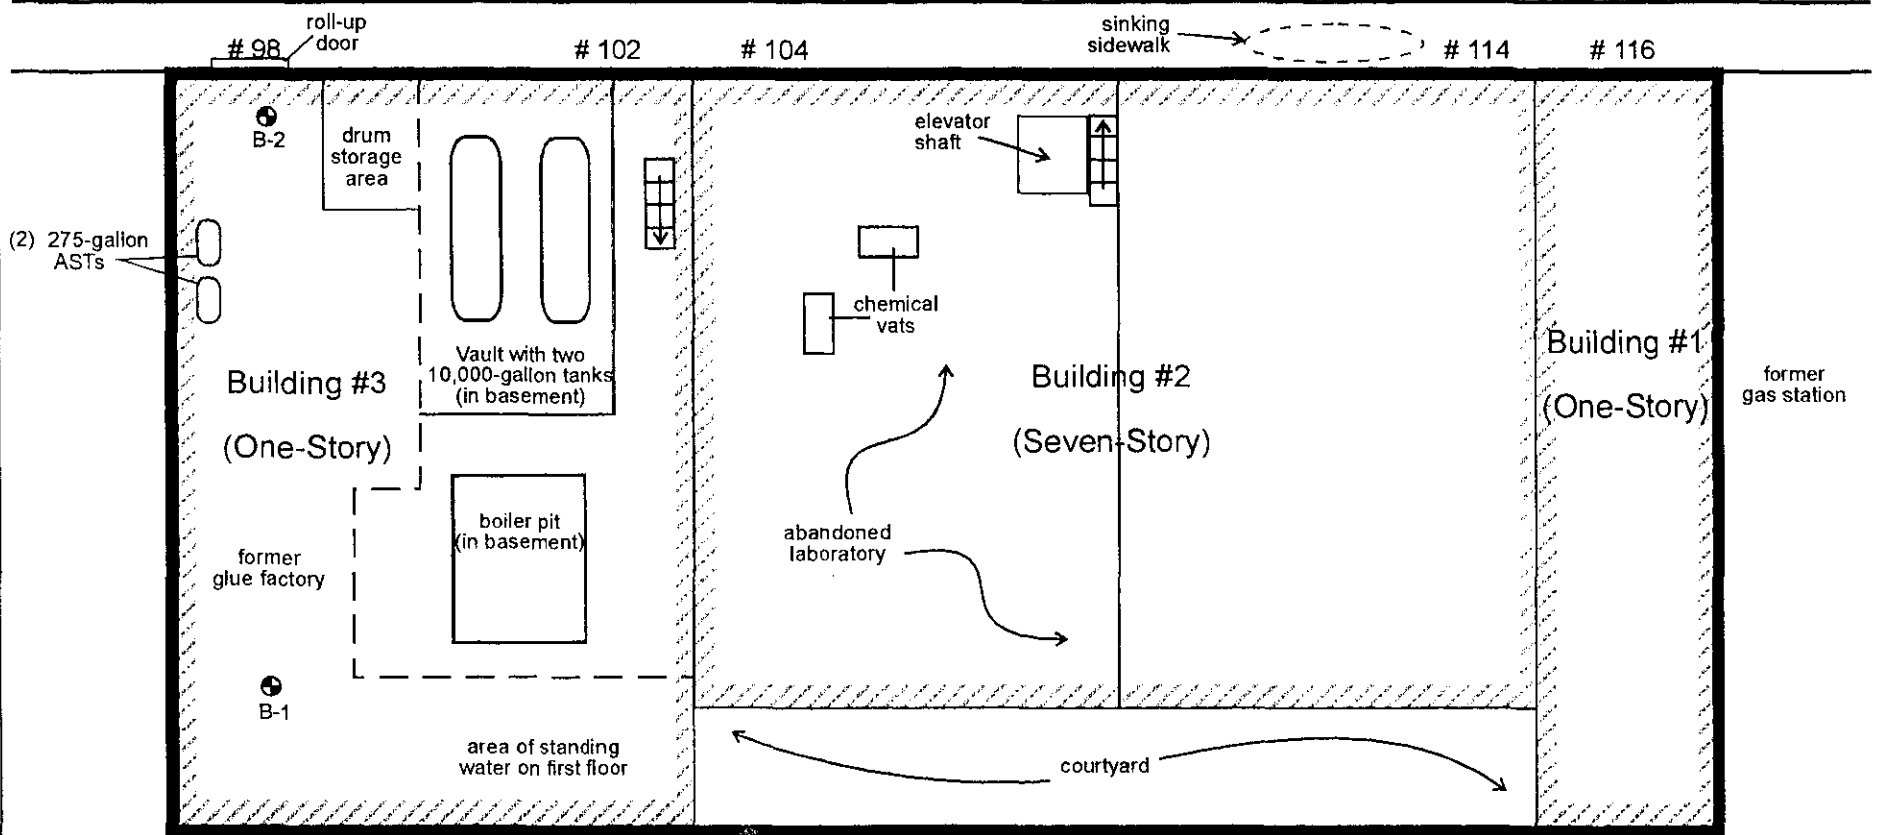
**Field Work Map**

The entire floor of the former glue factory (Building #3) is covered with a variety of materials associated with the operation of the structure as a glue factory (e.g., glues, resins, adhesives). The presence of these materials resulted in a strong odor that permeated throughout the interior of the glue factory thereby distorting natural senses. Site conditions and available equipment prevented the extension of more than two borings within the building. Provided below is a description of each boring location. See the Field Work Map on Page 18 of this Report for the location of the two borings.

Boring B-2 was extended in the northern end of the former glue factory approximately 9 feet south of the northern wall (roll-up garage door) and approximately 7.5 feet west of the drum storage area (B-2 was extended approximately 60 feet north of B-1). B-1 was extended to a depth of approximately 14 feet below grade; site conditions prevented the extension of the boring to further depths. Shallow groundwater was not encountered during the extension of this boring. The initial recovery (0-2 feet below grade) consisted of fill material with brick fragments; a strong glue odor was noted within this recovery. Recovery between 5 and 7 feet below grade consisted of a combination of fill material and a red/brown silt and clay; an odor was also noted within this recovery. Recovery between 10 and 12 feet below grade consisted of a uniform light brown/reddish brown fine grained sand and silt; no odor was noted within this recovery. Recovery between 12 and 14 feet below grade consisted of a brown fine grained sand and silt; no odor was noted in this recovery.

Material exhibiting a chemical odor resembling glue was noted in soils recovered between 0-2 feet below grade and 5-7 feet below grade; however, the soils did not appear to be stained or discolored. Instrument indications of contamination using the PID were encountered from 0 to 7 feet below grade with the maximum reading encountered from the recovery between 0 and 2 feet below grade (35 ppm-ge). These readings decreased to 16 ppm-ge in soils from 5-7 feet below grade, 3.7 ppm-ge in soils from 3.7 ppm-ge and to 1.6 ppm-ge in soils from 12-14 feet below grade.

**It is recommended that a second series of borings be extended within the former glue factory to document the horizontal extent of contamination and to document any variations in the previously identified vertical extent of contaminated soil. Based on data generated to date, these borings should be extended to depths of no greater than 10 feet below grade. Split spoon sampling should be conducted at two foot intervals within each boring to document the extent of subsurface contaminated soil.**
