July 14, 2017

Re: End of Phase 1B Fieldwork: Proposed Pre-K at 168 8th Street, Brooklyn, NY (16PR03021)

Project Location
Figure 1

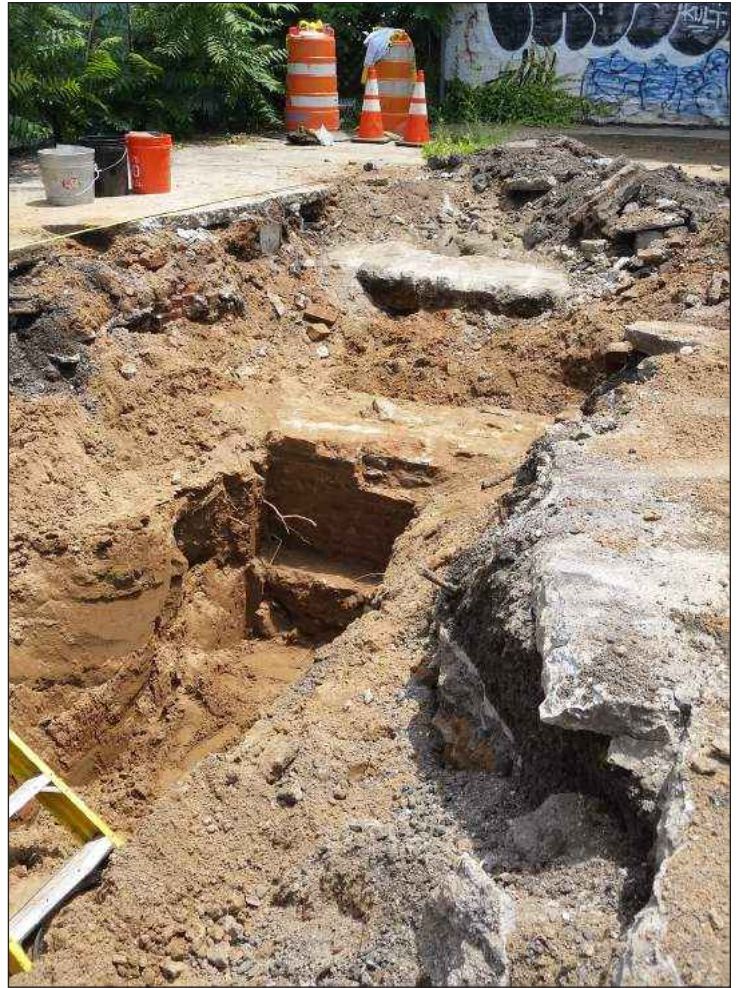
1

The east half of Trench 1, showing a brick foundation wall believed to be associated with a 19th century ink factory (center) and a concrete wall (background) associated with a later building.

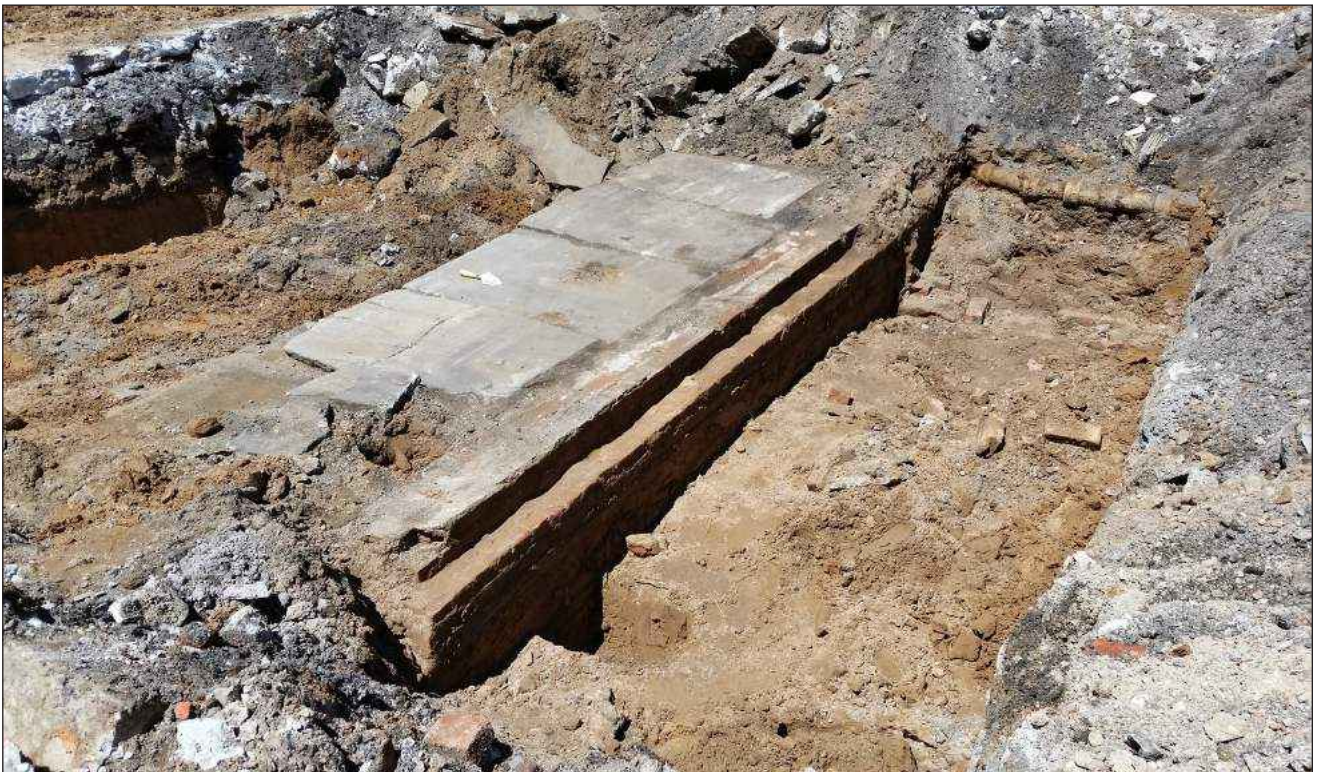
2

Looking southwest at an intact brick foundation wall, blue stone paved floor surface (with floor drain), and utilities within Trench 2.

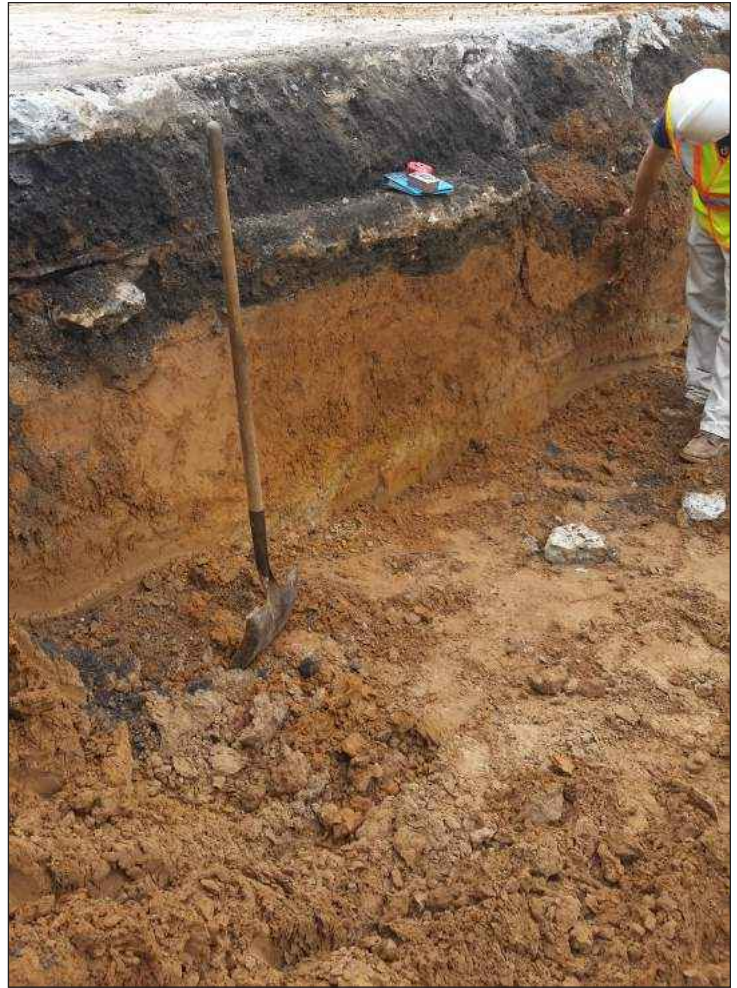
Clean soil layers within the northern wall of the west half of Trench 3. **3**

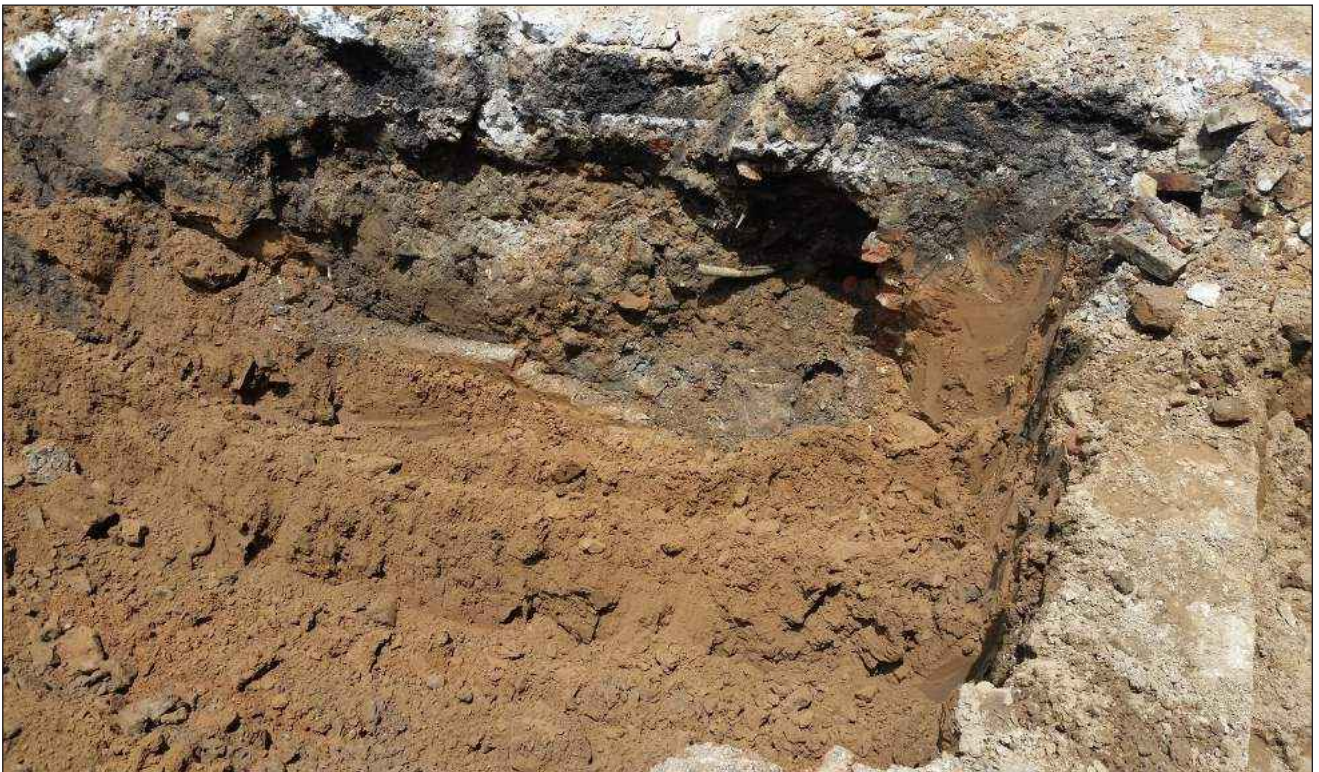
Evidence of utility-related disturbance and brick walls in the northern wall of the east half of Trench 3. **4**

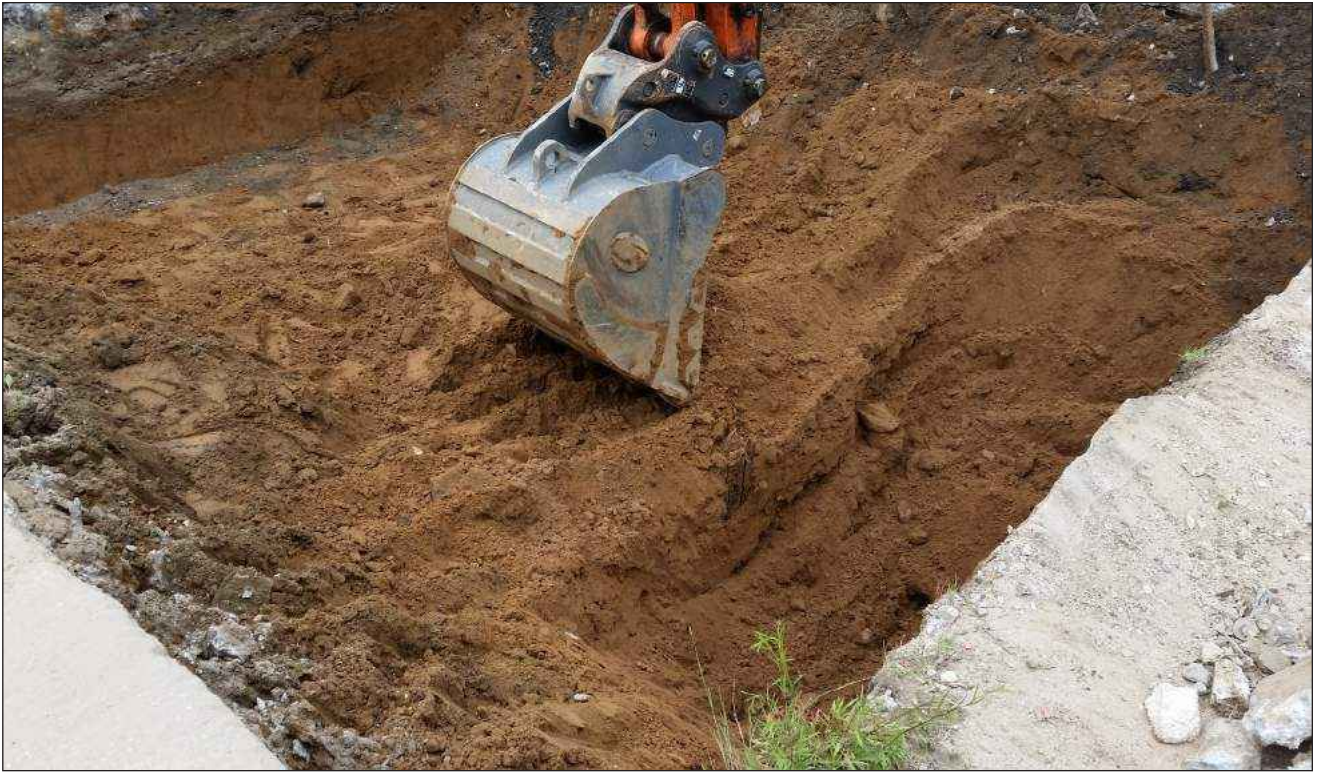
Looking northwest at clean soils at a shallow depth (2 to 3 feet) **5**
beneath the two concrete slabs in Trench 4.

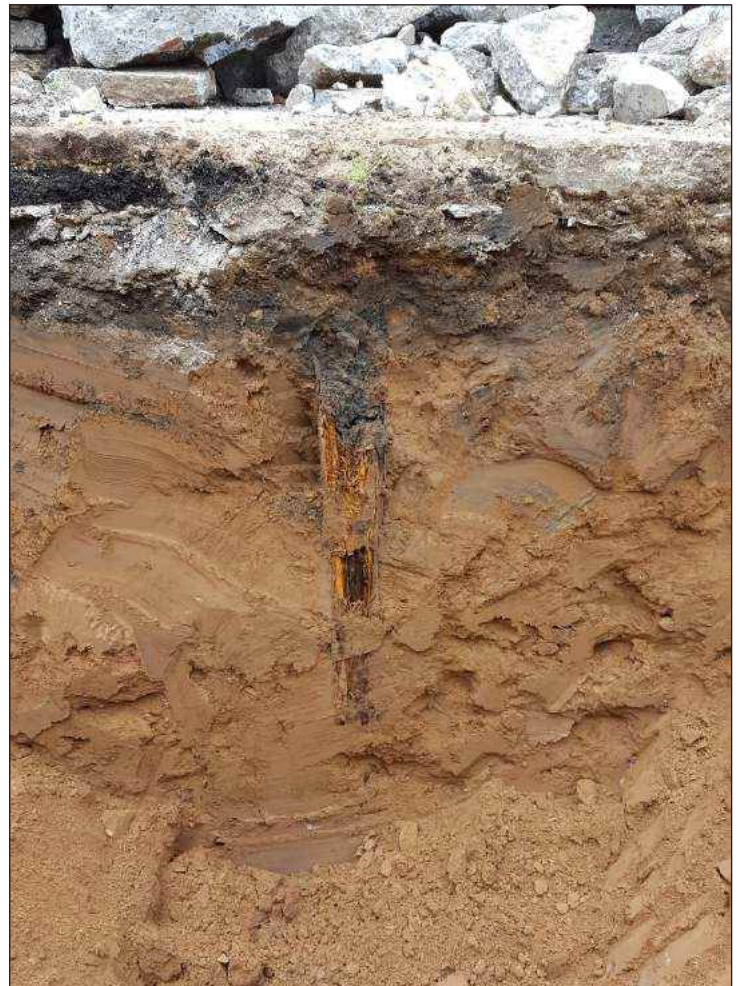
A 6-inch-square wood post found in the clean subsoil in the east wall of Trench 4, one of several similar posts found in the immediate area. **6**

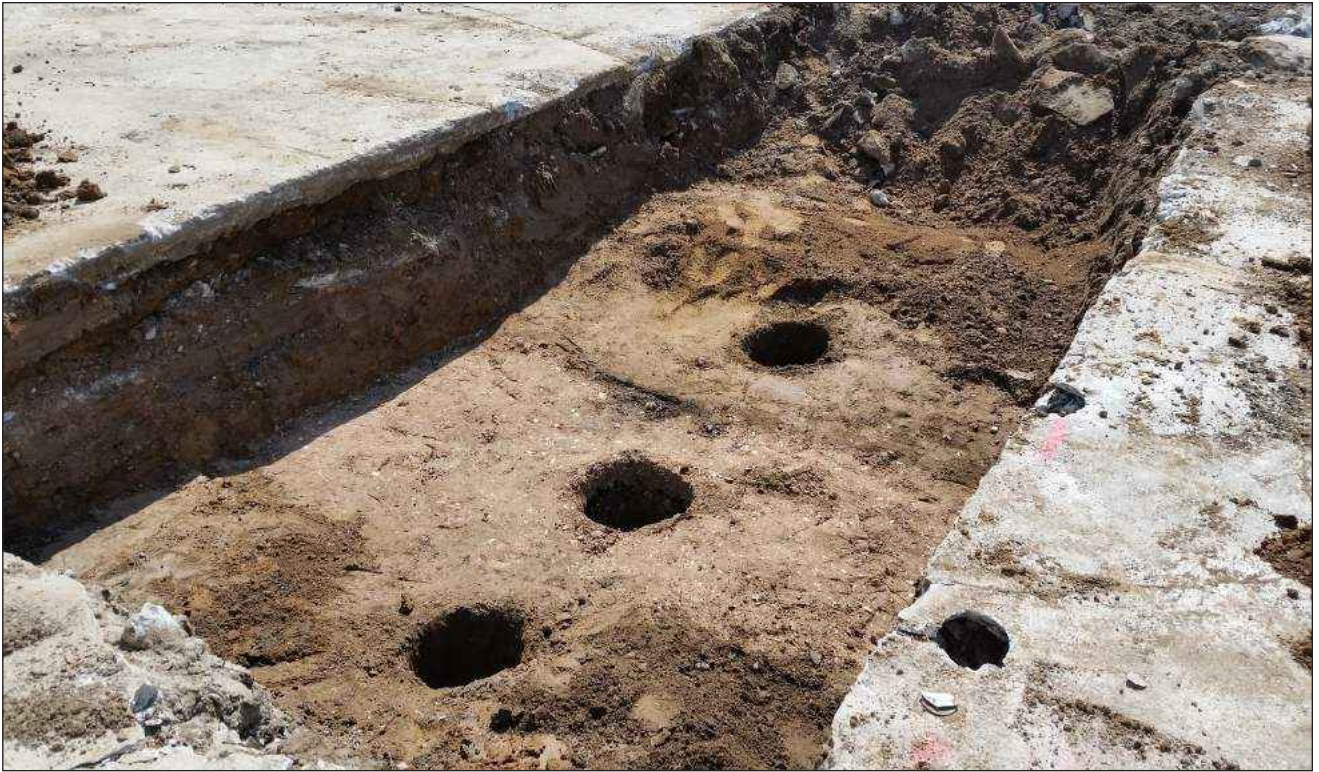
7

Trench	Length (in feet)	Width (in feet)	Maximum Depth (in feet)	Observations
5	57	10	12.5	The western end of Trench 5 appeared to contain an intact buried ground surface that was disrupted by a shallow, rectangular excavation (approximately 4 feet in width) that had been re-filled with an ashy fill (see Photograph 7). Three STPs were excavated in this area, one west of the ashy fill (STP 5-2), one within the fill layer (STP 5-1), and one to the east (STP 5-3). The ash layer appeared to be less than one foot in thickness and was immediately over a possible buried ground surface. Clean, undisturbed subsoil was observed in all three STPs at a depth of 8 to 26 inches below the top of the STP (which were opened 3 feet below the ground surface). Evidence of a deep (12-foot) refilled trench was observed in the northern wall of the eastern half of Trench 5. The previous excavation was backfilled with mixed soils and very large boulders and appears to be associated with the construction of a concrete support column that was observed within the northern wall of the trench. At the eastern end of the trench, a large brick cistern and a stone well consistent with 19th century shaft features were encountered (see Photograph 8). The features appeared to be filled with ashy material and were reburied pending a Phase 2 archaeological evaluation.

Looking northeast at the western end of Trench 5, showing three Shovel Test Pits (STPs) excavated into buried ground surfaces; the middle STP was excavated into a rectangular area of ashy fill.

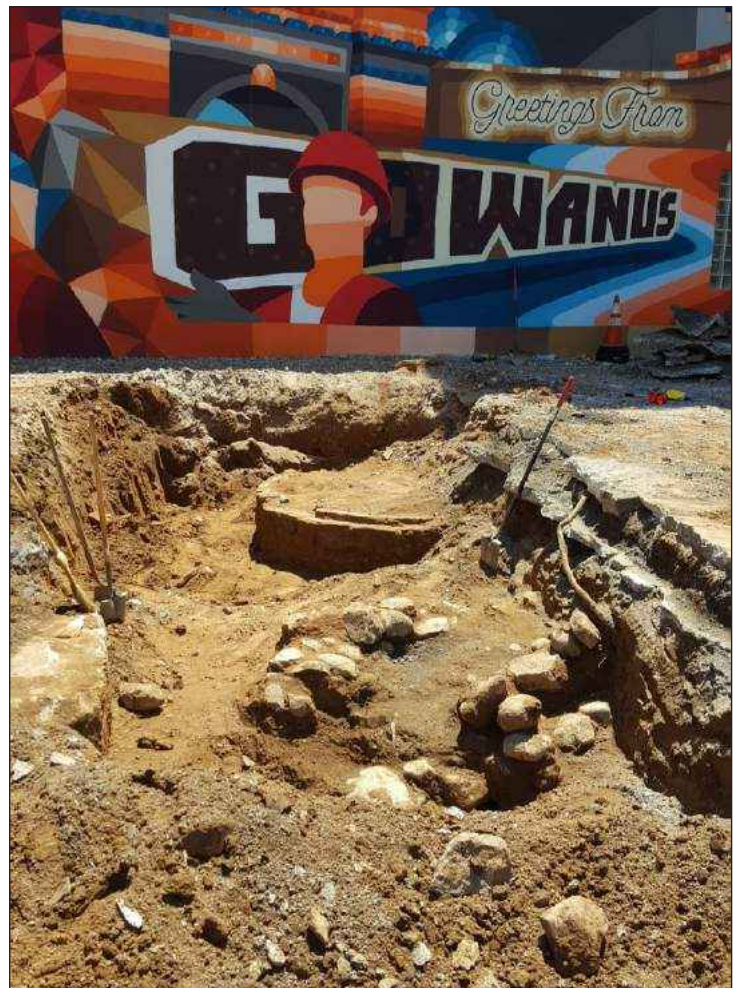
8

The brick foundation walls and blue stone paved floor appear to be associated with the ink factory buildings that were present on the site in the late-19th century as seen on historic maps. Maps indicate that the eastern portion of the northern half of the project site was redeveloped with a brick building between 1908 and 1916 and the additional concrete slabs and foundation walls observed in the eastern portions of Trenches 1 and 3 appear to be associated with that building. The wooden piles may be associated with a small iron-framed wood building located to the southwest of the ink factory as seen only on the 1898 Hyde map of Brooklyn; all other maps depict that portion of the project site as undeveloped. The brick cistern and stone well observed in the eastern portion of Trench 5 confirm the presence of an intact 19th century backyard area and the western end of Trench 5 and the brick foundation walls in Trench 7 confirm that the 19th century ground surface is still partially intact and that it is situated immediately above clean subsoil. A Phase 2 Archaeological Evaluation of the brick cistern and stone well is recommended as described below.

Shaft features encountered at the east end of Trench 5, including a stone well (at bottom) and a brick cistern (at top).

As mentioned previously, a Phase 2 evaluation of the area surrounding the brick cistern and stone well observed at the eastern end of Trench 5 is recommended. It is expected that the Phase 2 evaluation of the features observed at the eastern end of Trench 5 will effectively serve as a data recovery to mitigate the unavoidable adverse effects of the proposed action. The Phase 2 evaluation/data recovery will result in the collection of a large sample of the data associated with the features. In addition, the Phase 2 evaluation will require the opening of a large area around the features, exposing a greater portion of the seemingly intact ground surface, which could expose additional features. Laboratory processing of recovered artifacts will be initiated following the completion of the Phase 2 survey and a detailed Phase 1B/Phase 2 technical report will be prepared (a stand-alone Phase 1B report is not proposed at this time). The final report will document all methodologies used during the course of the Phase 1B and Phase 2 archaeological investigations and will discuss all findings that emerged from the recovered data, as well as maps, plans, drawings, photographs, and/or other relevant images as needed to illustrate project

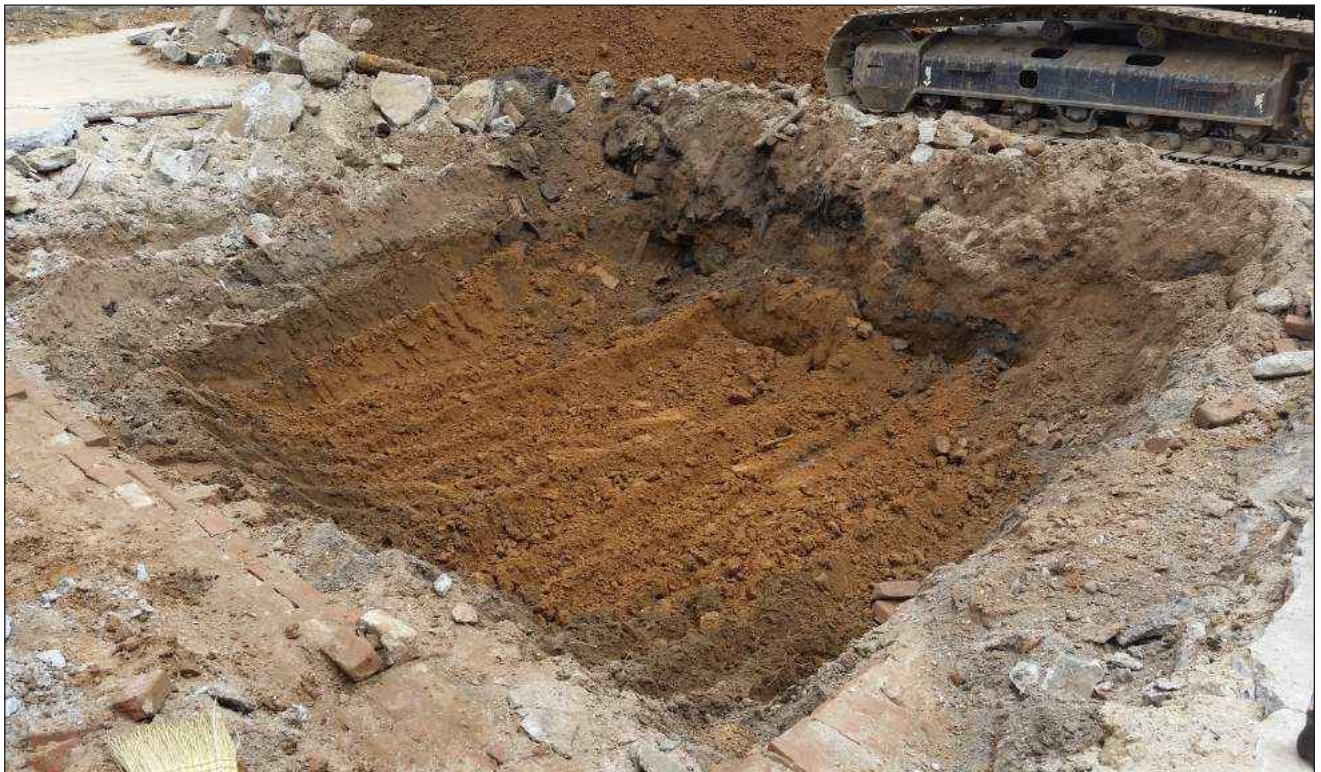
10

Looking northeast at Trench 7, showing brick foundation walls from a 19th century house (at left and right) and clean subsoil that was exposed beneath a thin layer of ashy fill containing artifacts.

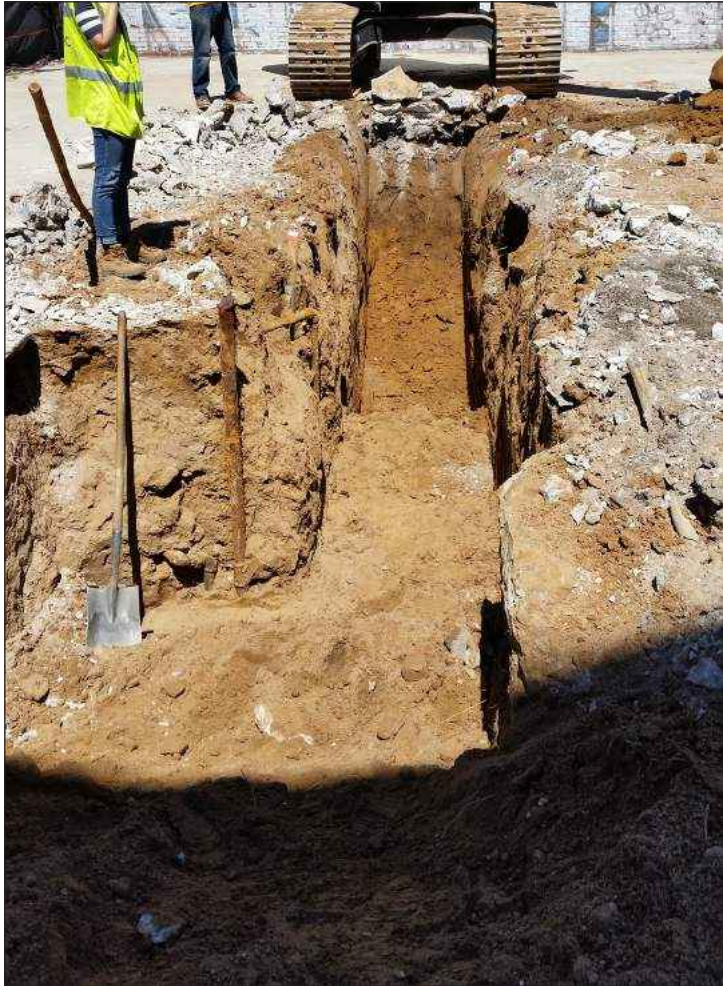
8	40	10	10.5	The western two-thirds of Trench 8 appeared to have been extensively disturbed by the installation of utility lines and gasoline tanks (see Photograph 11). Disturbed portions of brick walls likely representing the front wall of the 19th century home were observed in the southern portion of the trench (see Photograph 12).
Note: Each trench was stepped to ensure worker safety and to prevent the collapse of trench walls. As such, a smaller area within each trench was selected for very deep excavation and the maximum depth was not reached across the entire trench. However, a sufficient portion of each trench was excavated to the maximum depth to observe and document soil stratigraphy and to identify features or evidence of past excavations. In addition, the slab across the northern half of the site was approximately 16 inches lower than the slab in the southern half of the site.

Looking west at Trench 8; the pipes at left lead to at least two buried gasoline tanks and the lighter soil in the background appears to be clean subsoil. 11

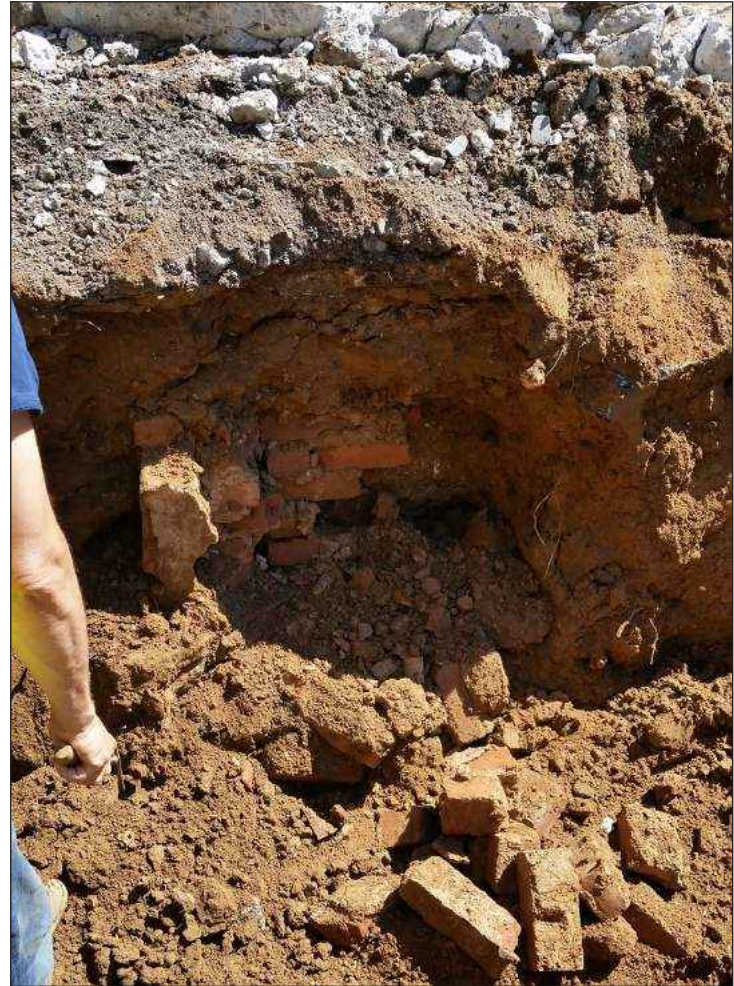
Partial remnant of a brick wall in the northern wall of Trench 8 that appears to have been disturbed during the installation of the gasoline tanks; soils to the west of the disturbed area appear to be clean. 12
