## SITE OBSERVATION REPORT

<b>PROJECT No.:</b> 170552901  <b>PROJECT:</b> 159 Boerum Street  <b>LOCATION:</b> Brooklyn, NY	<b>CLIENT:</b> SPG Boerum LLC	<b>DATE:</b> Monday, November 21, 2022  <b>WEATHER:</b> Partly Cloudy, 29-42 °F Wind: WSW @ 1.8-6.0 mph  <b>TIME:</b> 6:45 am to 3:30 pm
<b>CONTRACTOR:</b> SD Builders		<b>LANGAN REP. :</b> Lauren Roper
<b>CONTRACTOR'S EQUIPMENT:</b> Hitachi ZX 160LC Excavator Deere 300G Excavator Casagrande C9 Drill Rig Kubota SVL65-2 Skid Steer	<b>PRESENT AT SITE:</b> Lauren Roper – Langan James Hsu – SD Builders - General Contractor Lucas Alvarez - Rise Concrete (Rise) – Foundation Contractor Able Siquij – Anel Queens Construction Inc. (Anel) – Drilling Contractor	
<b>OBSERVATIONS, DISCUSSIONS, TEST RESULTS, ETC.:</b>  Langan was present to observe environmental protocols in accordance with the New York State Department of Environmental Conservation (NYSDEC)-approved Remedial Action Work Plan (RAWP) for Brownfield Cleanup Program (BCP) site C224291 at 159 Boerum Street (Block 3071, Lot 40). Observed activities were as follows:  <b>Site Activities</b> <ul style="list-style-type: none"> <li>• Rise graded an about 40-foot long by 20-foot wide area

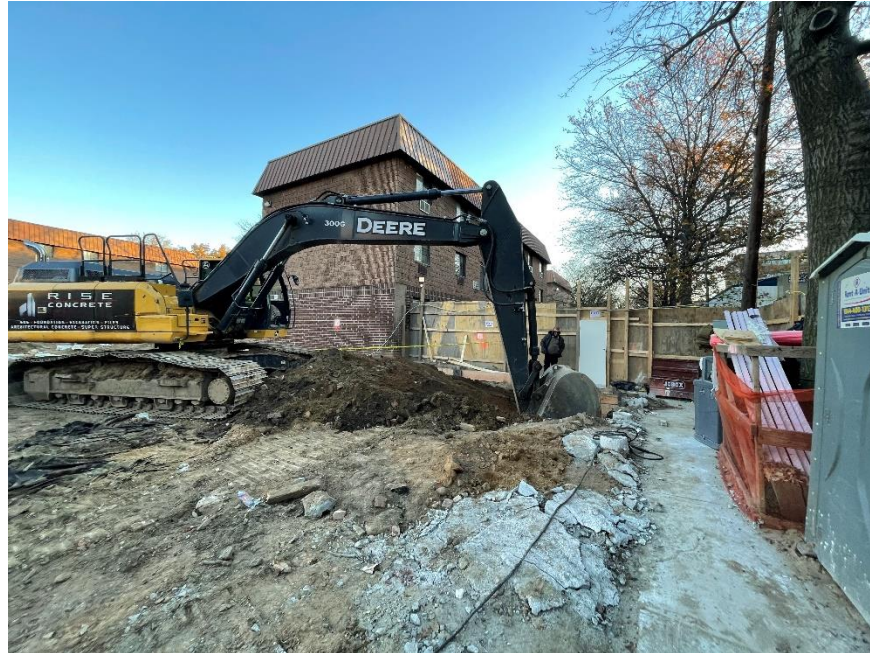
**Photo 1:** View of Rise excavating non-hazardous fill in the southeastern part of the site (facing northeast).

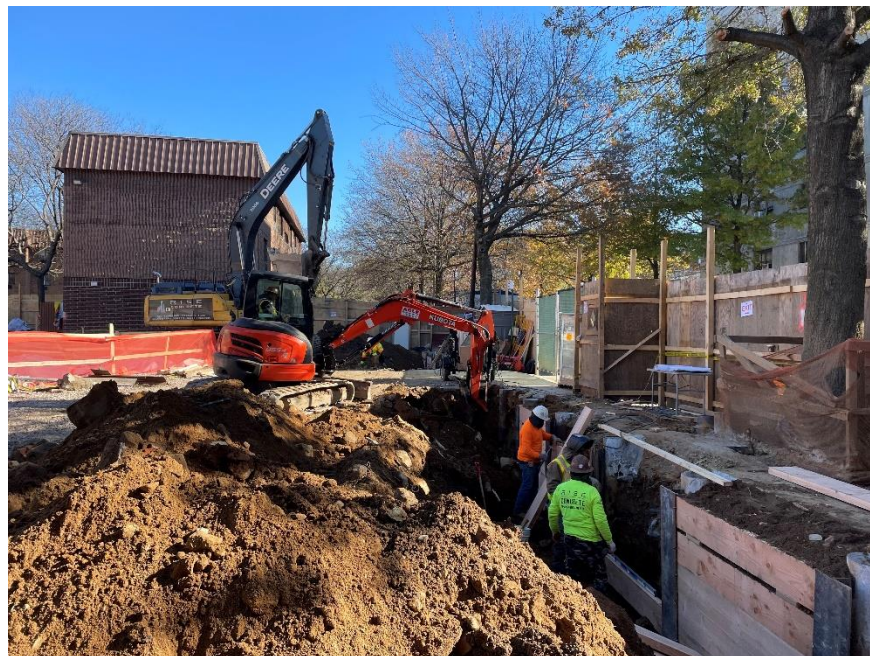
**Photo 2:** View of Rise installing lagging along the southern site boundary (facing east).
