LANGAN SITE OBSERVATION REPORT – Week of September 20, 2021

CLIENT: 473 President LLC	DATES: Monday, September 20, 2021 to Friday, September 24, 2021
PROJECT No.: 170361303	BCP SITE ID: C224080
PROJECT: President Street Properties	
LOCATION: 469 President Street and 532 Union Street, Brooklyn, New York	
EQUIPMENT: DK-50 Track-Mounted Drilling Rig MiniRAE 3000 Photoionization Detector TSI DustTrak II	PRESENT AT SITE: Langan: Tyler Goodnough, Tyler Zorn Pillori Associates, P.A.: Sebastian Leon Warren George, Inc. (WGI)

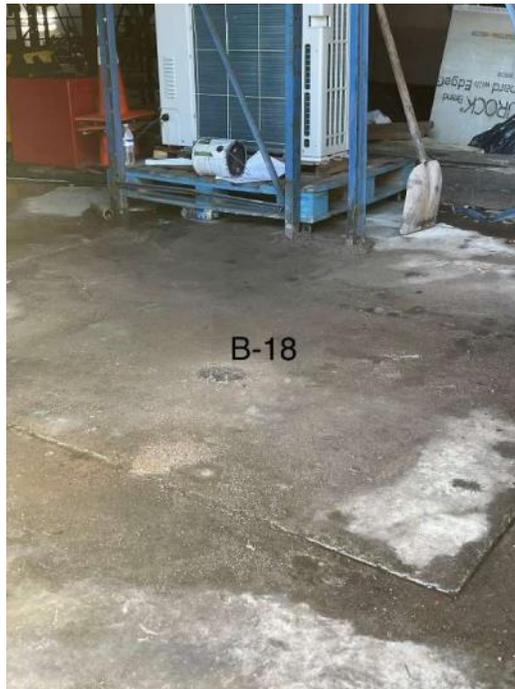
- WGI continued advancing geotechnical borings as part of a geotechnical subsurface investigation. WGI advanced two borings, B-16 and B-18, inside the vacant 469 President Street building using a track-mounted drilling rig to 102 and 82 feet below grade, respectively. WGI demobilized following completion of the investigation.

Photo 1: Boring B-18 (facing south)

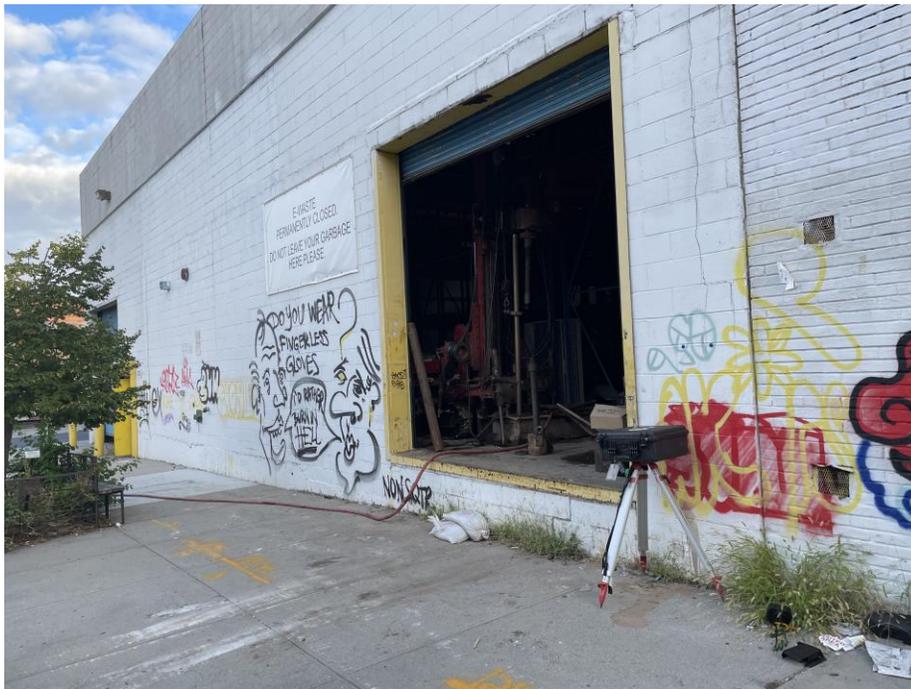
- Langan performed continuous air monitoring on the site perimeter for volatile organic compounds (VOCs) and particulate matter smaller than 10 microns in diameter (PM10). The air monitoring station was located outside of the garage door at the southern side of the building.

- VOC concentrations were not recorded on September 23, 2021 due to an equipment malfunction.
- Elevated PM10 concentrations on September 22, 23, and 24, 2021 are attributed to the drilling rig exhaust fumes during advancement of borings B-16 and B-18. The borings were advanced using mud rotary drilling, a drilling method that saturates recovered soil samples with drilling fluid (i.e., water and bentonite mixture). No visible dust was observed.

Photo 2: Air monitoring station (facing north)
