CLIENT: 473 President LLC PROJECT No.: 170361303 PROJECT: 473 President Street/President Street Portfolio LOCATION: Brooklyn, New York	DATE: Tuesday, May 3, 2022 WEATHER: Mostly Cloudy, 52-60 °F, Wind: 3-9 mph N TIME: 07:00 – 15:15 BCP SITE Nos.: C224220/C224309
EQUIPMENT: Komatsu PC490LC excavator MiniRAE 3000 photoionization detector (3) TSI DustTrak II (2)	PRESENT AT SITE: Langan: Jack Millman Urban Atelier Group (UAG): Matthew Barile Kingdom Associates, Inc. (Kingdom): Brian Keane New York City (NYC) Land Surveyors PC: Kevin Chisvette

Langan was on-site to document implementation of the New York State Department of Environmental Conservation (NYSDEC)-approved Remedial Action Work Plans (RAWP) for Brownfield Cleanup Program (BCP) Site Nos. C224220 (473 President Street) and C224309 (President Street Portfolio).

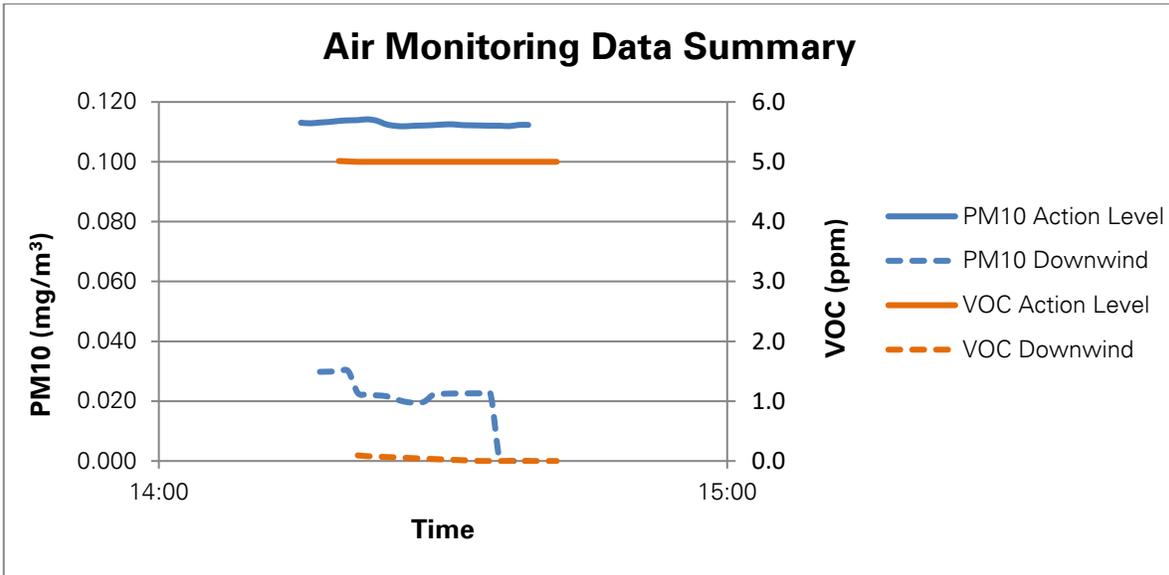
- Langan conducted real-time air monitoring for volatile organic compounds (VOC) and particulate matter smaller than 10 microns in diameter (PM10) at the upwind and downwind perimeters of the

work area during ground-intrusive activities. VOC and PM10 action levels were not exceeded during the monitoring period. Recorded air monitoring data is presented on the following graph:

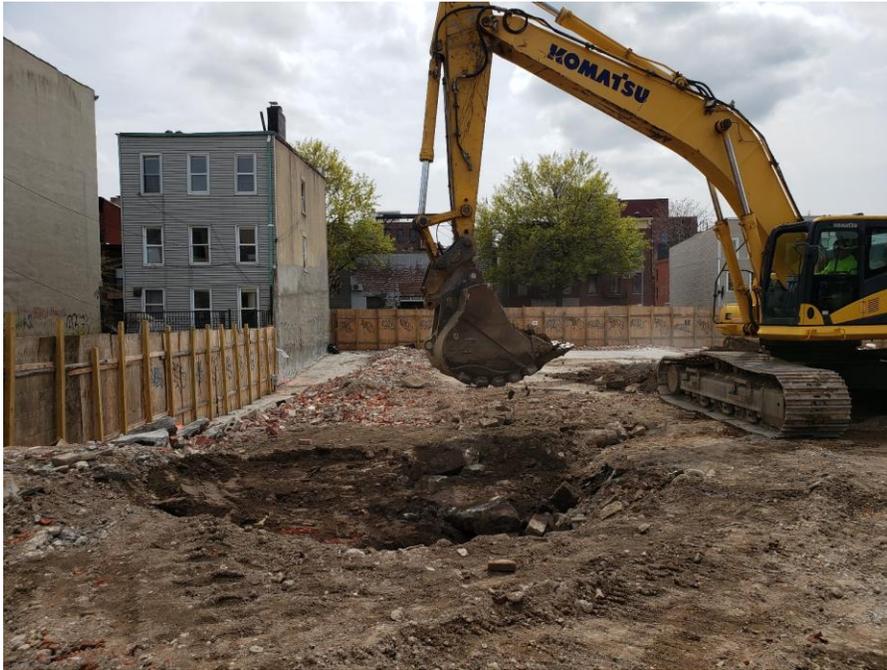
- Kingdom backfilled an about 10-foot-long by 10-foot-wide area around the pile cap with previously excavated fill (originating from the same excavation) in the eastern part of the site to grade surface. Visual, olfactory, and photoionization detector (PID) evidence of contamination was not observed.
- NYC Land Surveyors PC located and surveyed previously installed groundwater monitoring wells. Seven previously installed monitoring wells were not found and are likely buried under construction and demolition debris (C&D) at the site or were destroyed during building demolition.

Photo 1: Kingdom backfilling an area around a pile cap in the eastern part of the site (facing south).

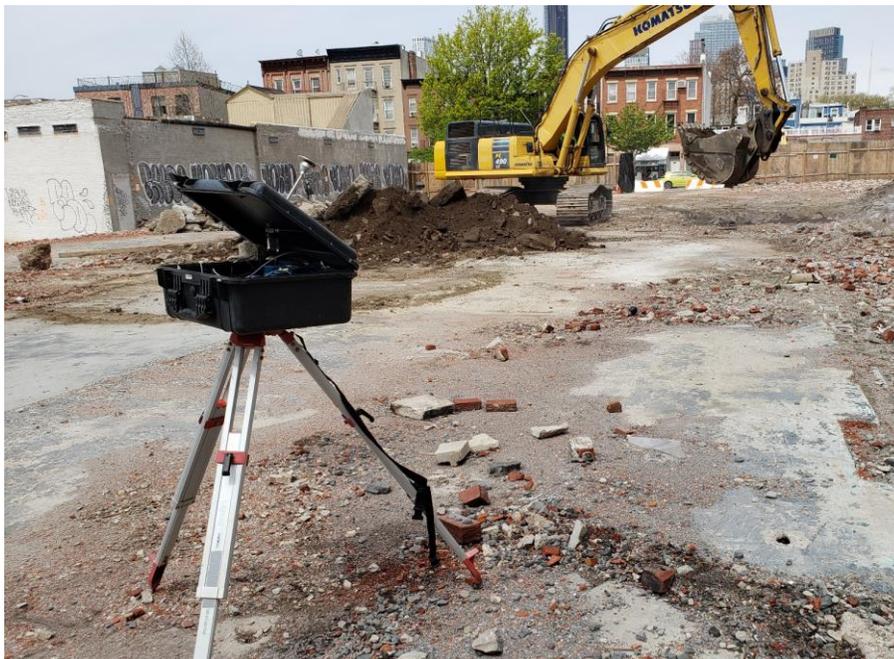
Photo 2: Downwind air monitoring station in the southern part of the site (facing north).
