PROJECT No.: 170361303 PROJECT: 473 President Street, President Street Portfolio, and 514 Union Street LOCATION: Brooklyn, New York BCP SITE ID: C224220, C224309, and C224318		CLIENT: 473 President LLC	DATE: Fri., December 23, 2022 WEATHER: Rain, 37-45°F, Wind: ENE 13-18 mph TIME: 06:45 – 14:30 MONITOR: Audrey Seery
EQUIPMENT: Geoprobe 8140LS RAE Systems MiniRAE 3000 TSI DustTrak II MiniRAE 3000 Photoionization Detector (PID)		PRESENT AT SITE: Langan: Audrey Seery Eastern Environmental Solutions, Inc. (Eastern Environmental): Nick Turro, Chris Orne GZA GeoEnvironmental, Inc. (GZA): Geder Mena	
OBSERVATIONS, DISCUSSIONS, TEST RESULTS, ETC.: <p>Langan was on-site to document implementation of the New York State Department of Environmental Conservation (NYSDEC)-approved 6 December 2022 Grossly Contaminated Material Investigation Work Plan (GCMIWP).</p> <p>Site Activities</p> <ul style="list-style-type: none"> • Eastern Environmental used a Geoprobe 8140 sonic drill rig to advance soil boring SB03_CT to about 105 feet below grade surface (bgs). No soil recovery was documented for the 95 to 100 and the 100 to 105 feet bgs intervals. <ul style="list-style-type: none"> ○ Recovered soil wa

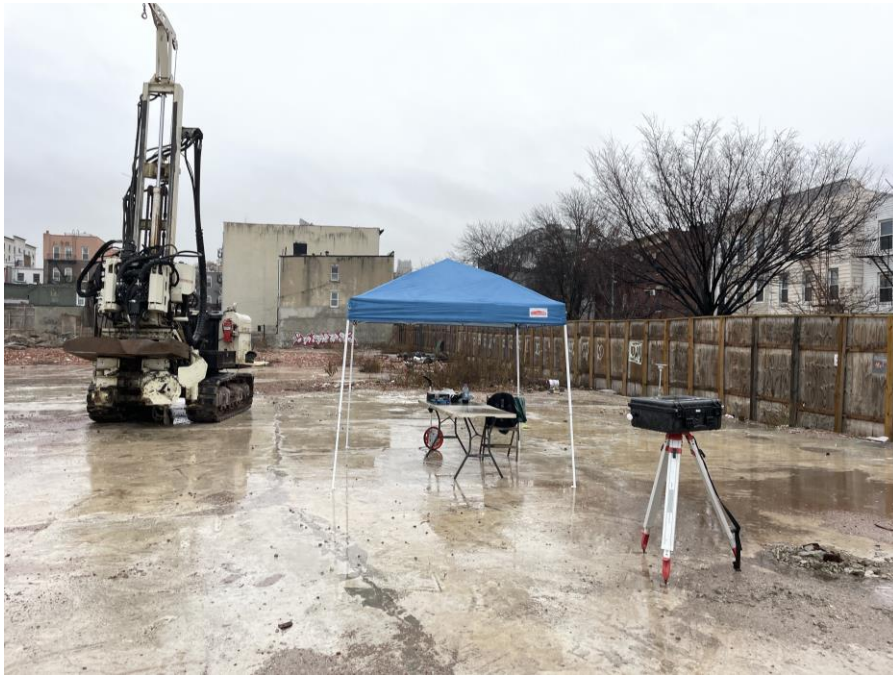
Photo 1: Eastern Environmental advancing soil boring SB03_CT in the central part of 473 President Street (facing southeast)

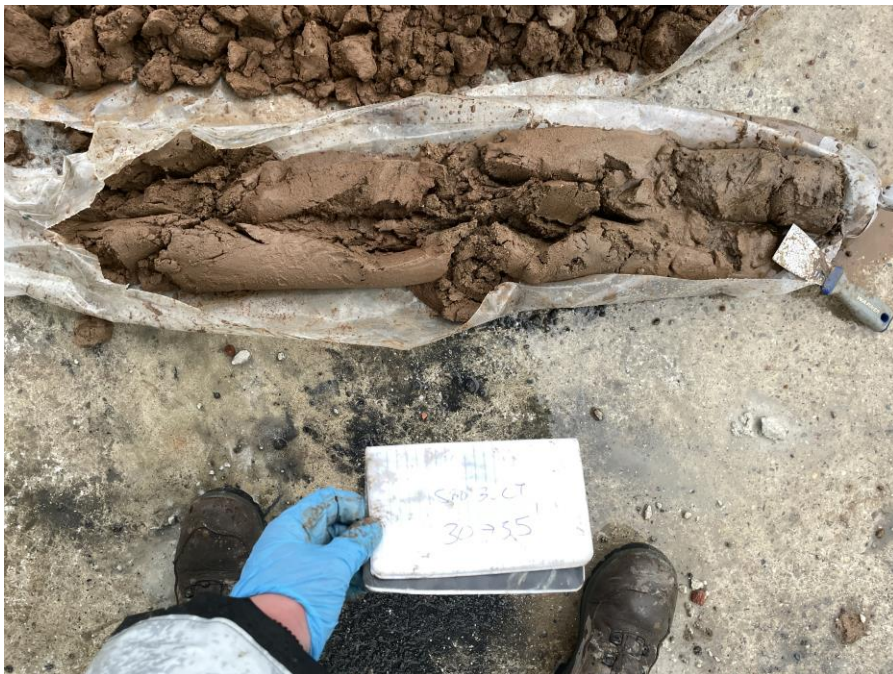
Photo 2: Soil screening at soil boring SB03_CT (facing down)
