## DAILY STATUS REPORT

Langan Project No:	100805202	Project:	210 Douglass Street Site	Date:	02/07/2023
NYSDEC BCP Site No:	C224316			Time:	6:45 – 14:45

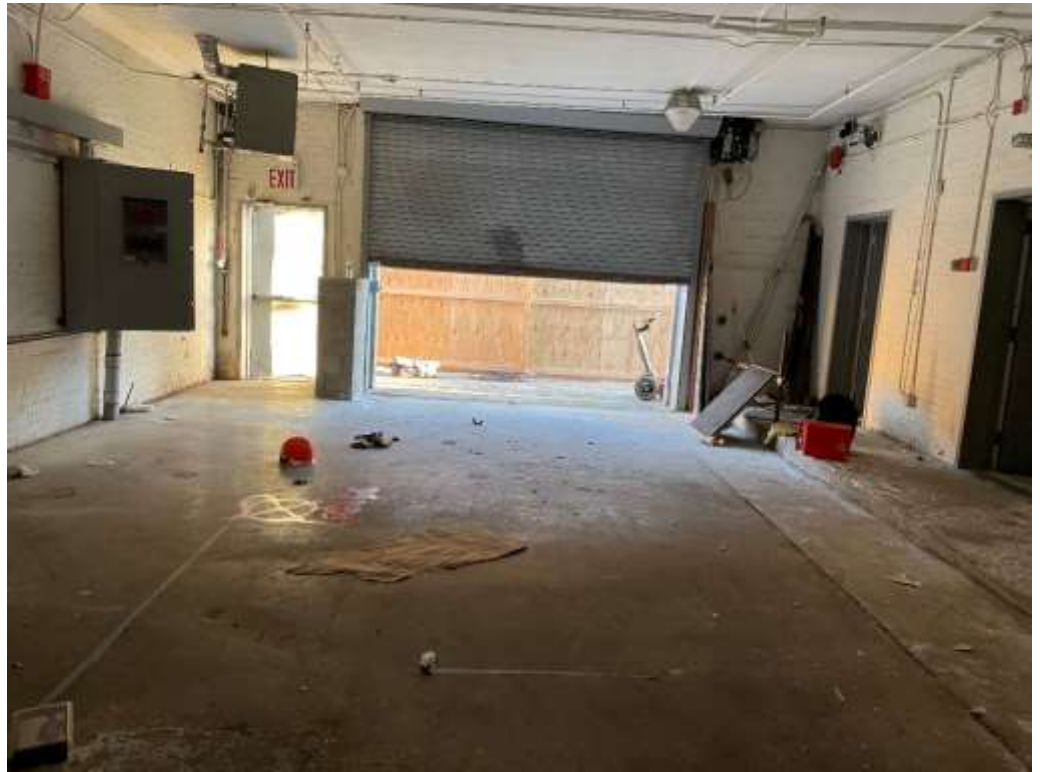
Photo 1 – General Site conditions on Lot 14, facing north.

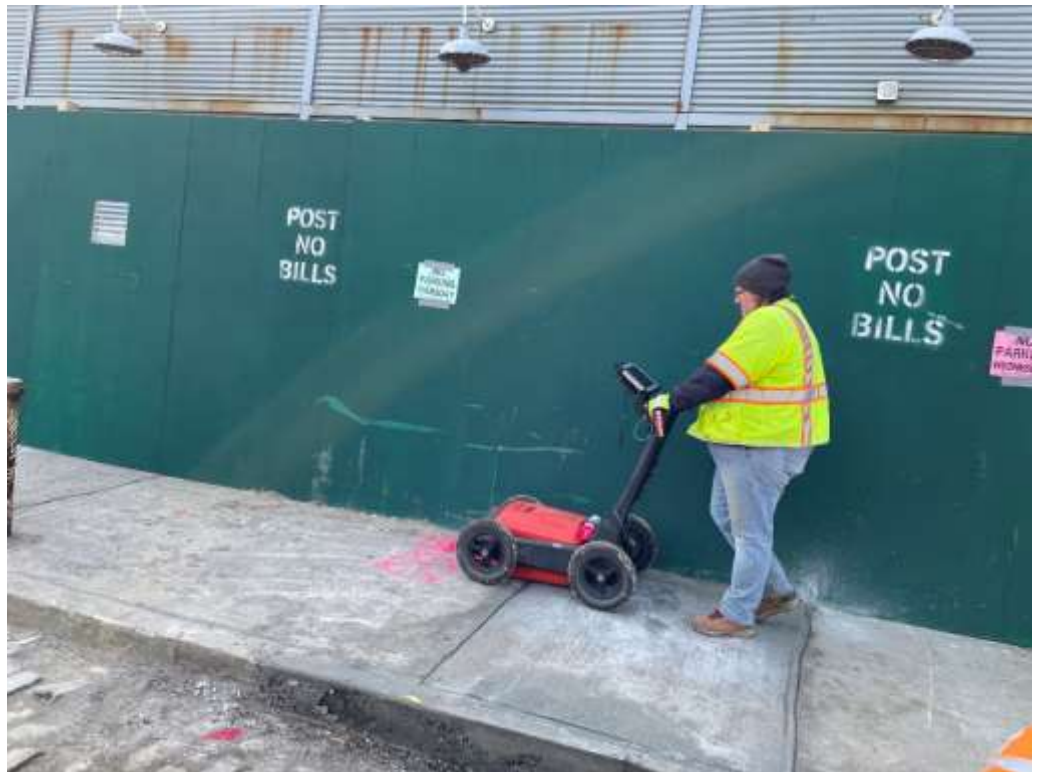
Photo 2 – Hager-Richter clearing sidewalk soil boring location LSB-26, facing south.

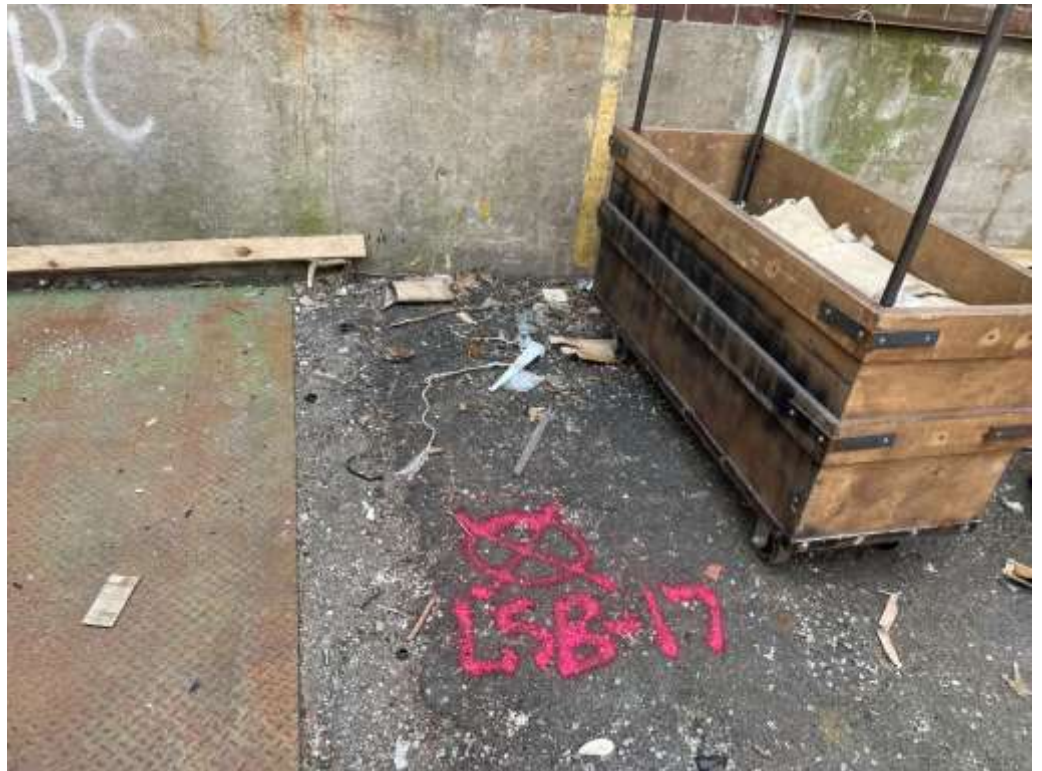
Photo 3 – Soil boring location LSB-17 on Lot 10, facing south.

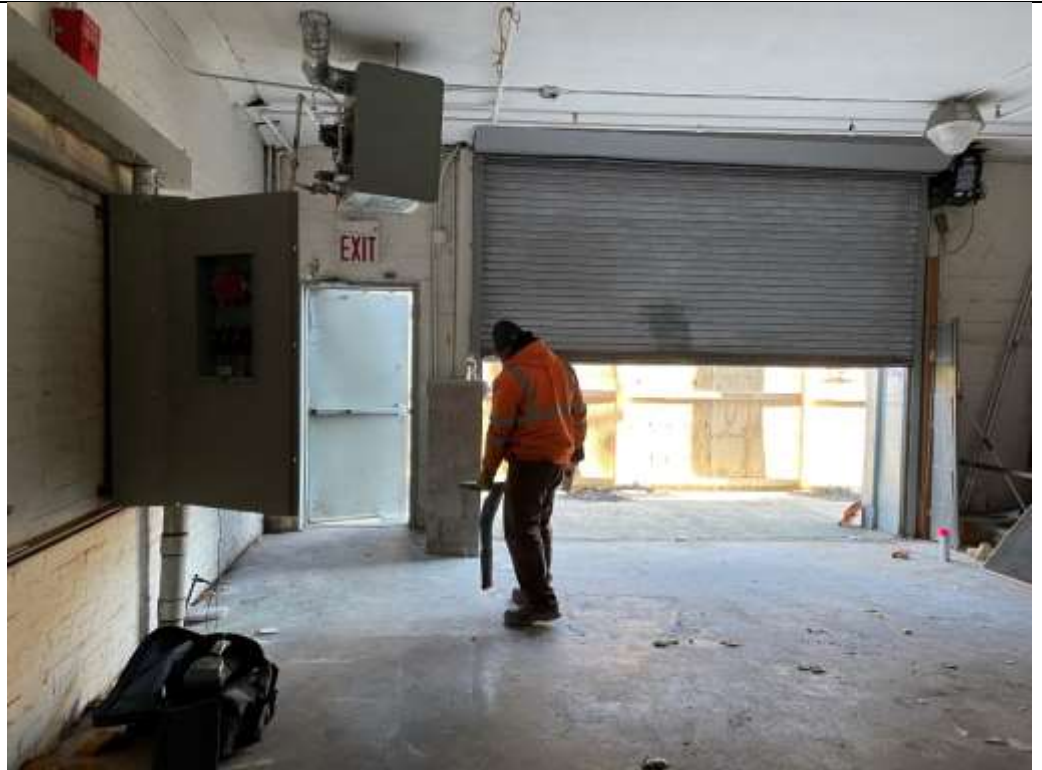
Photo 4 – Hager-Richter clearing soil boring location LSB-18 on Lot 14, facing north.
