PROJECT No.: 170361306	CLIENT: Gowanus President Owner LLC	DATE: Wed., February 22 nd , 2023
PROJECT: 514 Union Street		WEATHER: Overcast/Rain, 39 – 44 °F Wind: NW @ 3 – 10 mph
LOCATION: Brooklyn, New York		TIME: 6:45 am – 3:45 pm
BCP SITE ID: C224318		MONITOR: Audrey Seery
EQUIPMENT: Geoprobe 6620DT MiniRAE 3000 Photoionization Detector (PID) Air monitoring station (DustTrak II, MiniRAE 3000 PID) Solinst Water Level Meter YSI 600XL Water Quality Meter JCB 507 Forklift	PRESENT AT SITE: Langan: Audrey Seery Regenesis: Julian Serrano, Neal Wang Coastal Environmental Solutions, Inc.: John Slavin	
OBSERVATIONS, DISCUSSIONS, TEST RESULTS, ETC.: Langan was on-site to document implementation of the New York State Department of Environmental Conservation (NYSDEC)-approved February 2 nd , 2023 Interim Remedial Measures Work Plan (IRMWP) No. 2.		
Site Activities <ul style="list-style-type: none">Regenesis completed four low-dose PlumeStop® injections points (IP22, IP27, IP28, and IP29) across the target treatment interval (TTZ) of 10 to 30 feet below grade surface (bgs). Remedial products applied included PlumeStop®, S-MicroZVI®, and BDI PLUS®.

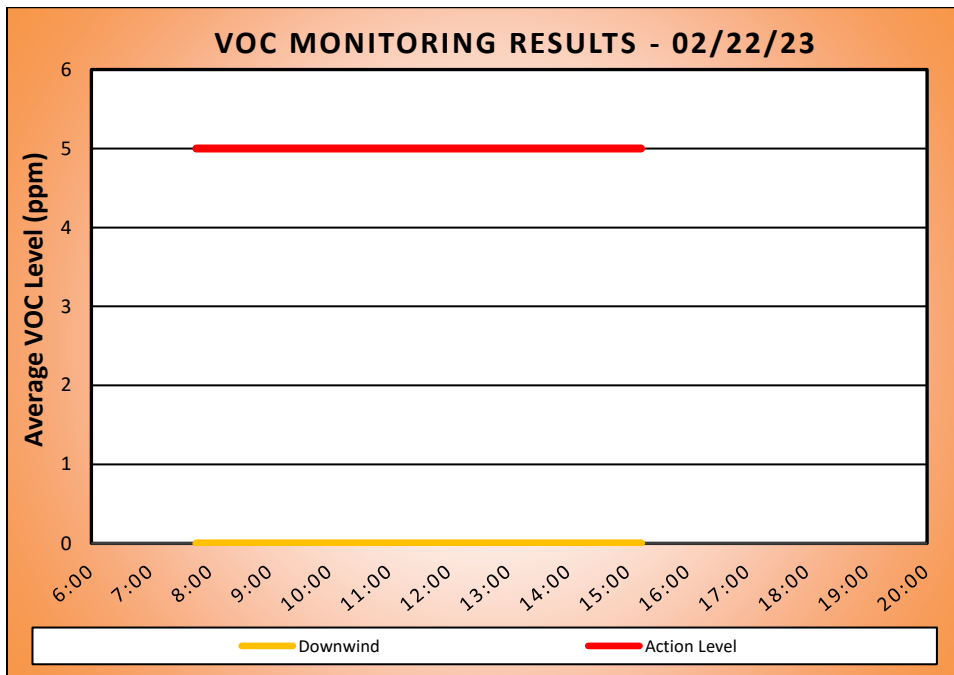
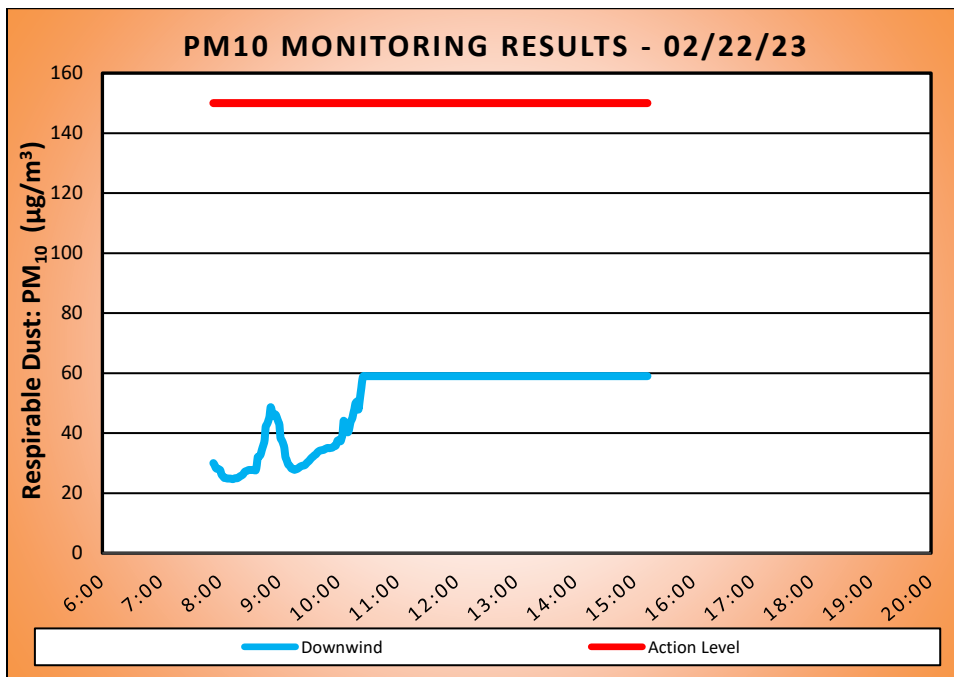
- Langan performed continuous air monitoring at downwind perimeter of the work zone for volatile organic compounds (VOCs) and particulate matter smaller than 10 microns in diameter (PM10) during ground-intrusive activity. VOC and PM10 action levels were not exceeded during the monitoring period. Recorded air monitoring data is summarized in the following graphs:

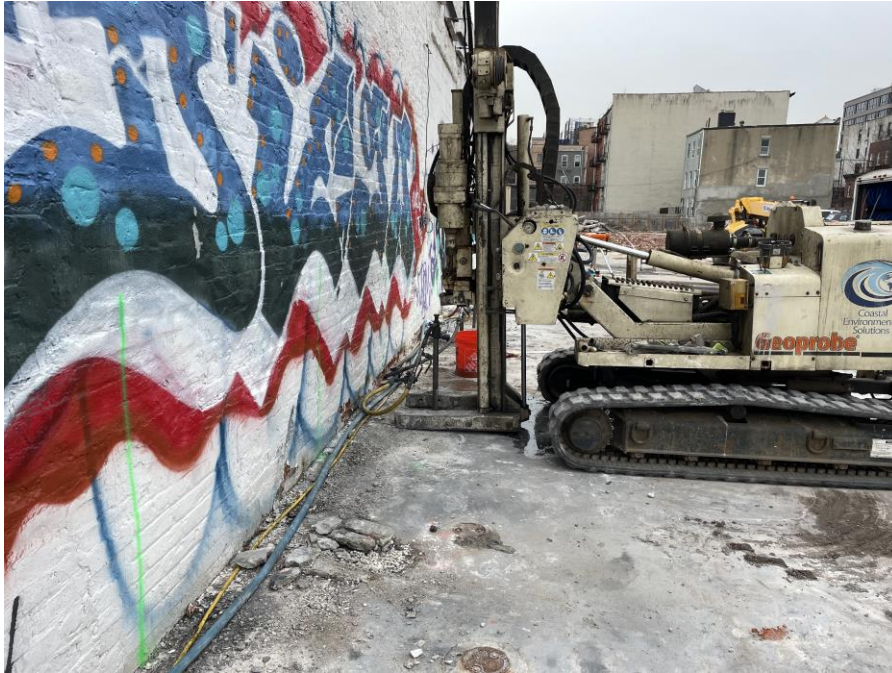
Photo 1: Regensis applying remedial products at injection point IP27 (facing east).

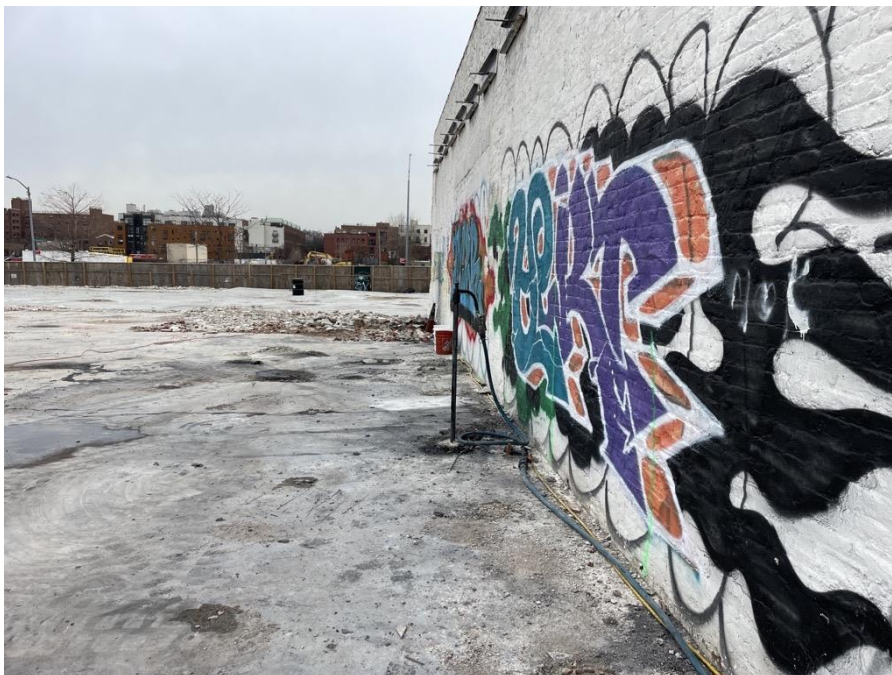
Photo 2: Regensis applying remedial products at injection points IP22(facing west).
