| <b>PROJECT No.:</b> 170361306<br><br><b>PROJECT:</b> 514 Union Street<br><b>LOCATION:</b> Brooklyn, New York<br><b>BCP SITE ID:</b> C224318 | <b>CLIENT:</b><br>Gowanus President Owner LLC | <b>DATE:</b> Fri., February 24 <sup>th</sup> , 2023<br><br><b>WEATHER:</b> Partly Cloudy, 43 – 46 °F<br>Wind: NW @ 5 – 10 mph<br><b>TIME:</b> 6:45 am – 2:30 pm<br><b>MONITOR:</b> Audrey Seery |
| <p><b>OBSERVATIONS, DISCUSSIONS, TEST RESULTS, ETC.:</b> Langan was on-site to document implementation of the New York State Department of Environmental Conservation (NYSDEC)-approved February 2<sup>nd</sup>, 2023 Interim Remedial Measures Work Plan (IRMWP) No. 2.</p> <p><b>Site Activities</b></p> <ul style="list-style-type: none"> <li>Regenesis completed three low-dose PlumeStop® injections points (IP39A, IP39B, and IP40) across the target treatment interval (TTZ) of 10 to 30 feet below grade surface (bgs). Remedial products applied included PlumeStop®, S-MicroZVI®, and BDI PLUS®.</li> <li>Coastal advanced three soil borings to maximum depth of about 10 feet bgs for the collection of supplemental waste characterization soil samples to facilitate disposal facility approval of future soil disposal. <ul

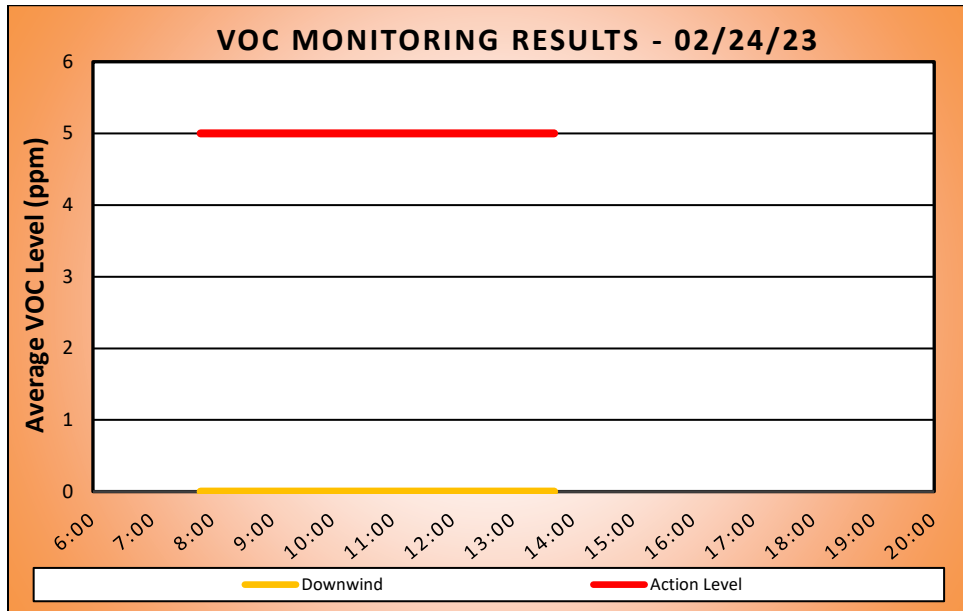
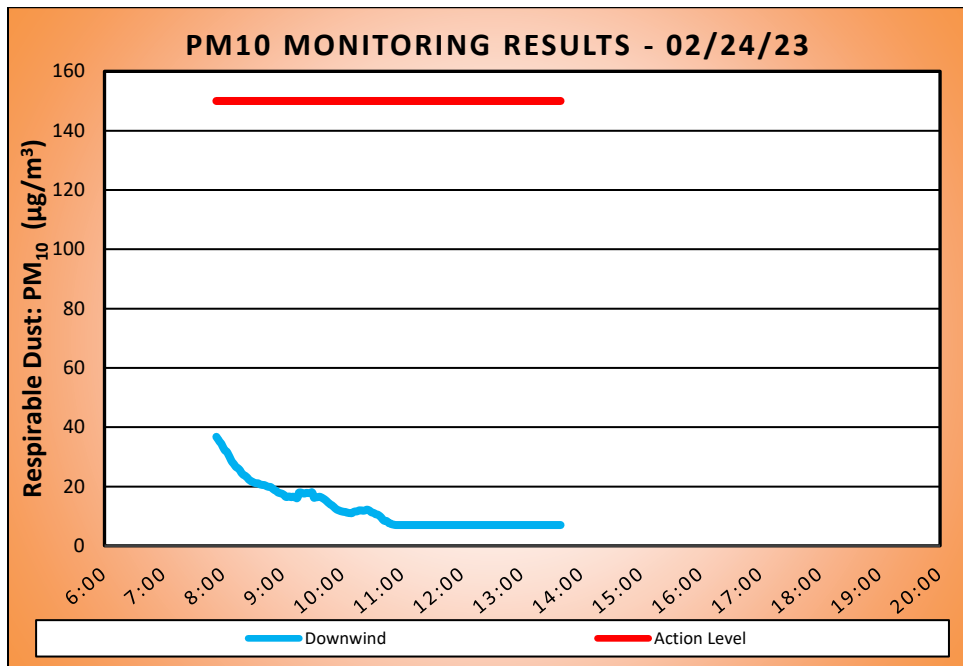
- Langan performed continuous air monitoring at downwind perimeter of the work zone for volatile organic compounds (VOCs) and particulate matter smaller than 10 microns in diameter (PM10) during ground-intrusive activity. VOC and PM10 action levels were not exceeded during the monitoring period. Recorded air monitoring data is summarized in the following graphs:

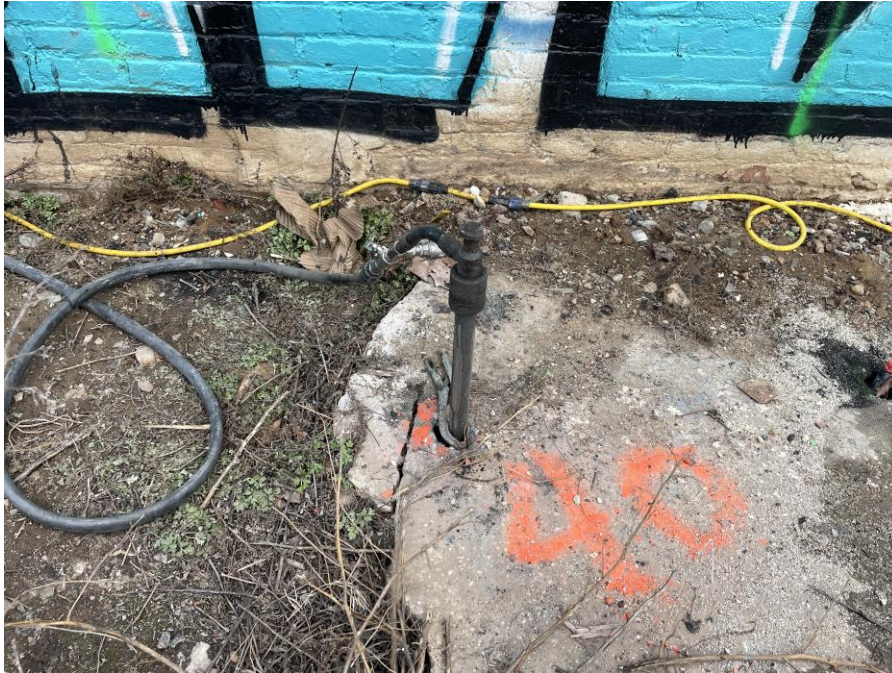
**Photo 1:** Regensis applying remedial products at injection point IP40 (facing north).

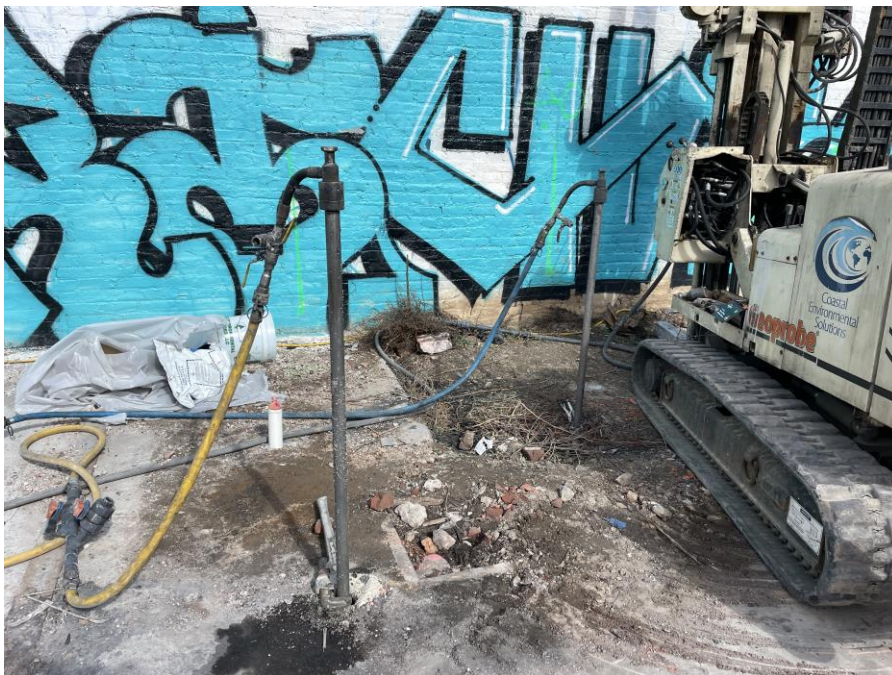
**Photo 2:** Regensis applying remedial products at injection points IP39B and IP39A (facing north).

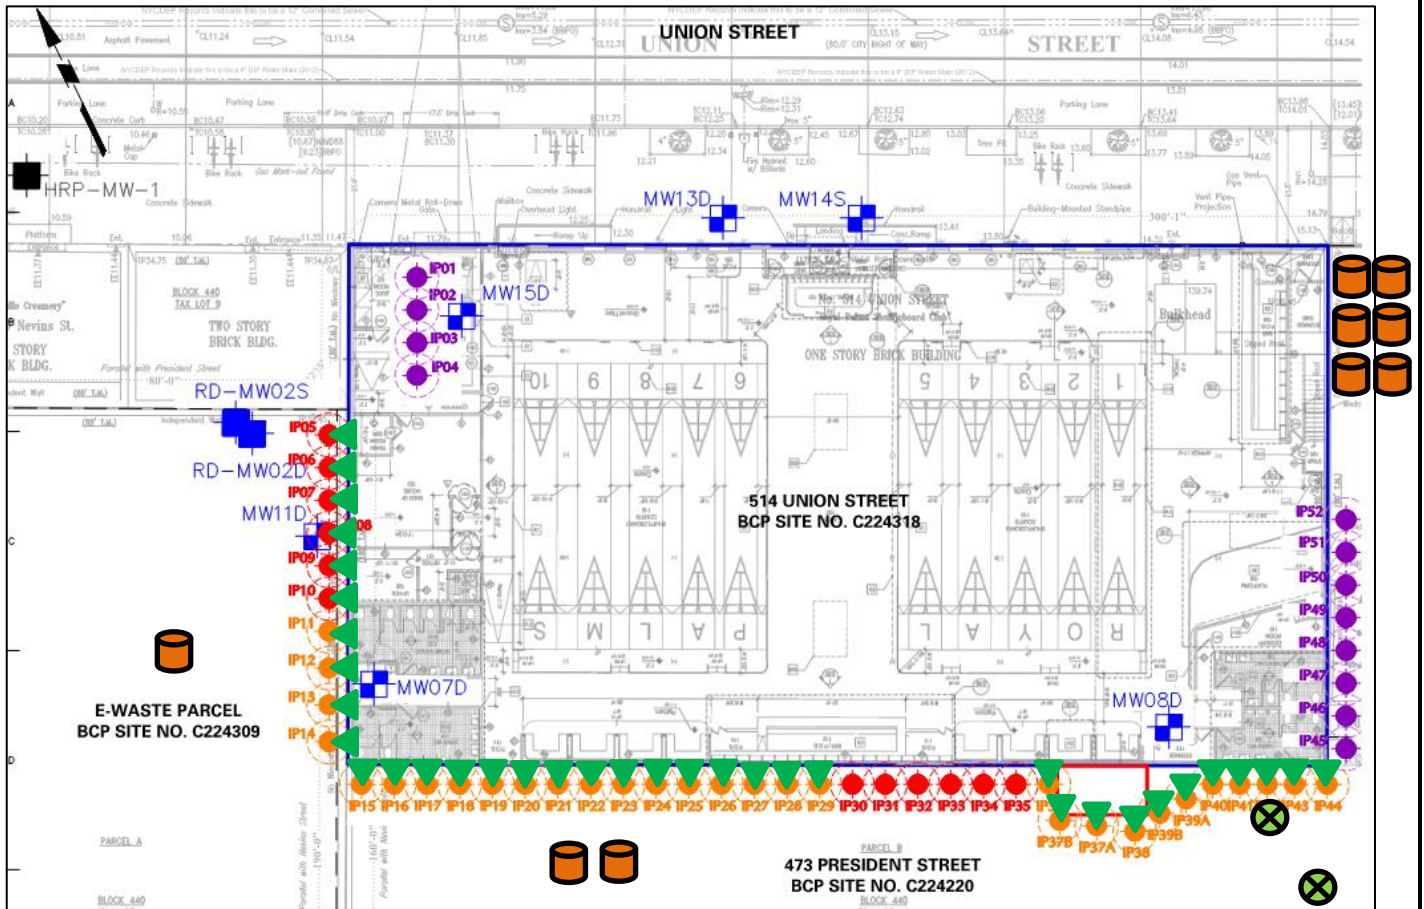
**Site Map**

1. Five 55-gallon drums containing soil cuttings
2. Four 55-gallon drums containing purged groundwater/drilling fluid
