PROJECT No.: 170361306	CLIENT: Gowanus President Owner LLC	DATE: Mon., February 27 th , 2023
PROJECT: 514 Union Street		WEATHER: Cloudy, 35 – 43 °F Wind: NE @ 8 – 14 mph
LOCATION: Brooklyn, New York		TIME: 6:45 am – 4:30 pm
BCP SITE ID: C224318		MONITOR: Audrey Seery
EQUIPMENT: Geoprobe 6620DT MiniRAE 3000 Photoionization Detector (PID) Air monitoring station (DustTrak II, MiniRAE 3000 PID) Solinst Water Level Meter YSI 600XL Water Quality Meter JCB 507 Forklift	PRESENT AT SITE: Langan: Audrey Seery Regenesis: Julian Serrano, Neal Wang Coastal Environmental Solutions, Inc.: Brandon Sullivan	
OBSERVATIONS, DISCUSSIONS, TEST RESULTS, ETC.: Langan was on-site to document implementation of the New York State Department of Environmental Conservation (NYSDEC)-approved February 2 nd , 2023 Interim Remedial Measures Work Plan (IRMWP) No. 2.		
Site Activities <ul style="list-style-type: none">Regenesis partially completed two high-dose PlumeStop® injections points (IP30 and IP35) across the target treatment interval (TTZ) of 10 to 30 feet below grade surface (bgs). Remedial products applied included PlumeStop®, S-MicroZVI®, and BDI PLUS®.Drilling refusal was encountered at injection points

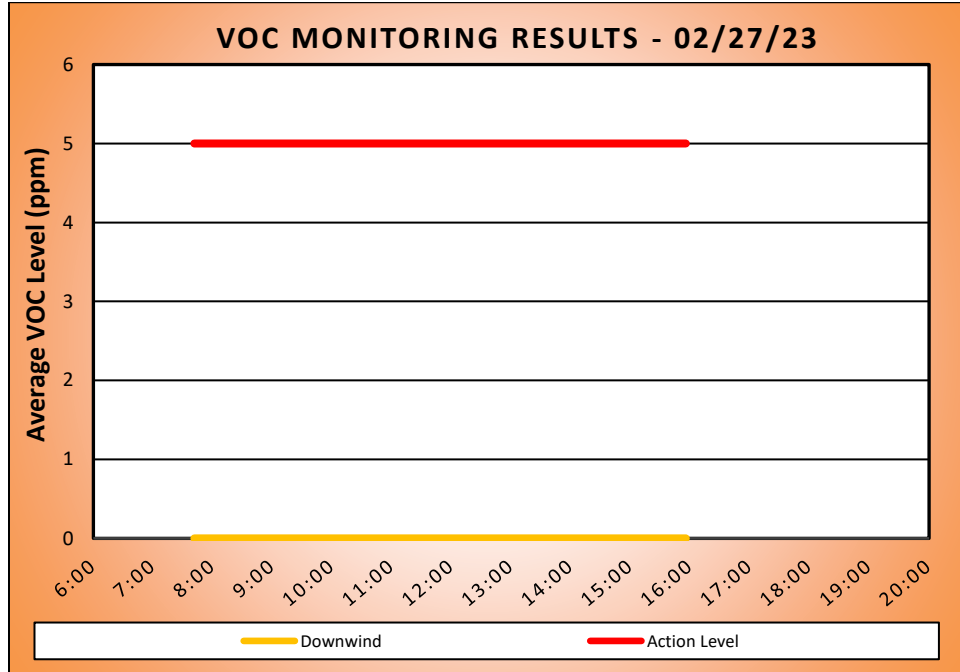
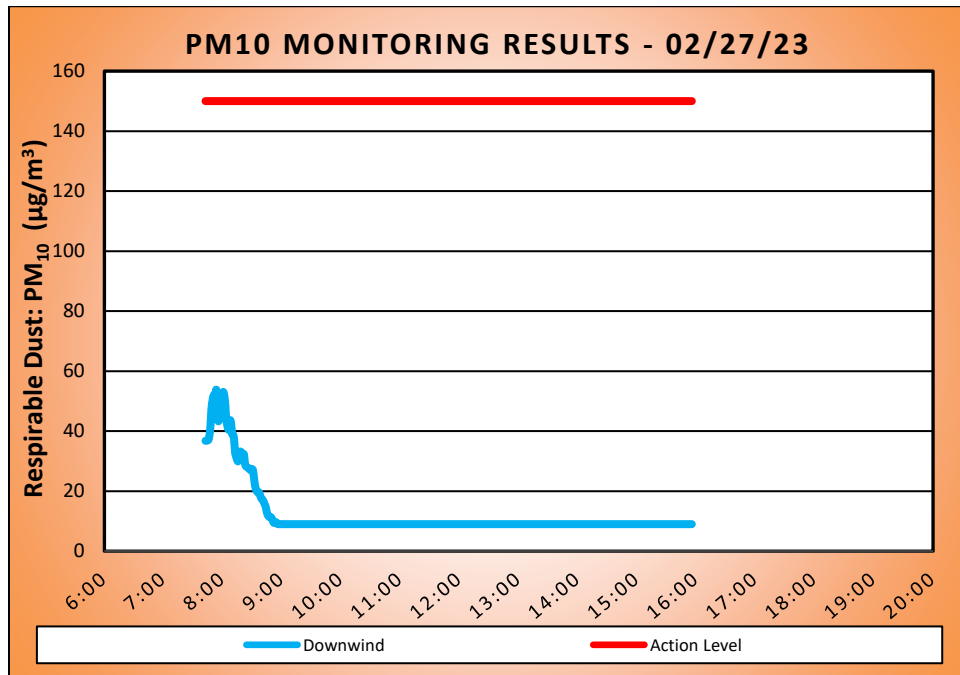
- Langan performed continuous air monitoring at downwind perimeter of the work zone for volatile organic compounds (VOCs) and particulate matter smaller than 10 microns in diameter (PM10) during ground-intrusive activity. VOC and PM10 action levels were not exceeded during the monitoring period. Recorded air monitoring data is summarized in the following graphs:

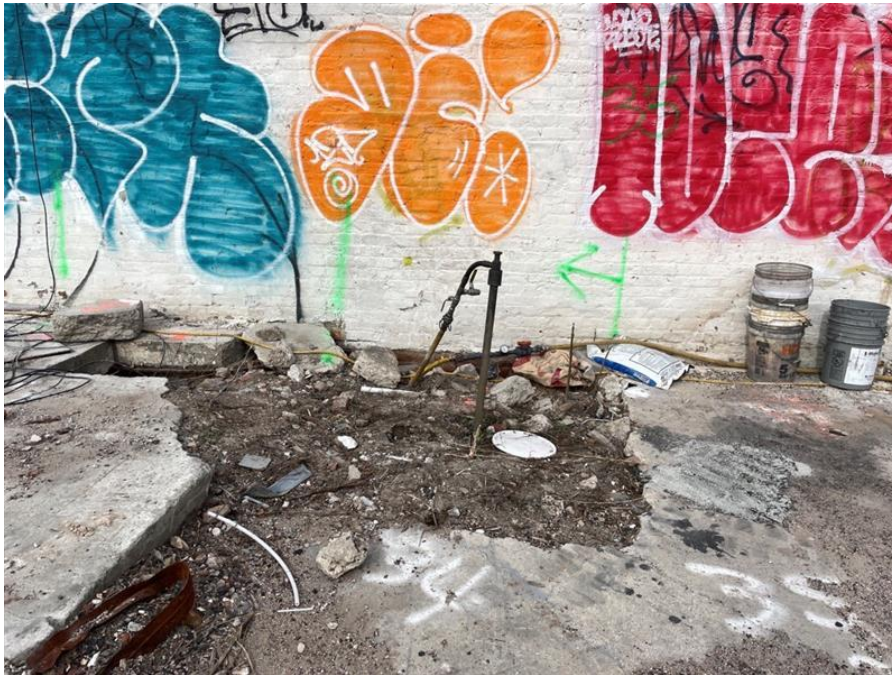
Photo 1: Regensis applying remedial products at injection point IP35 (facing north).

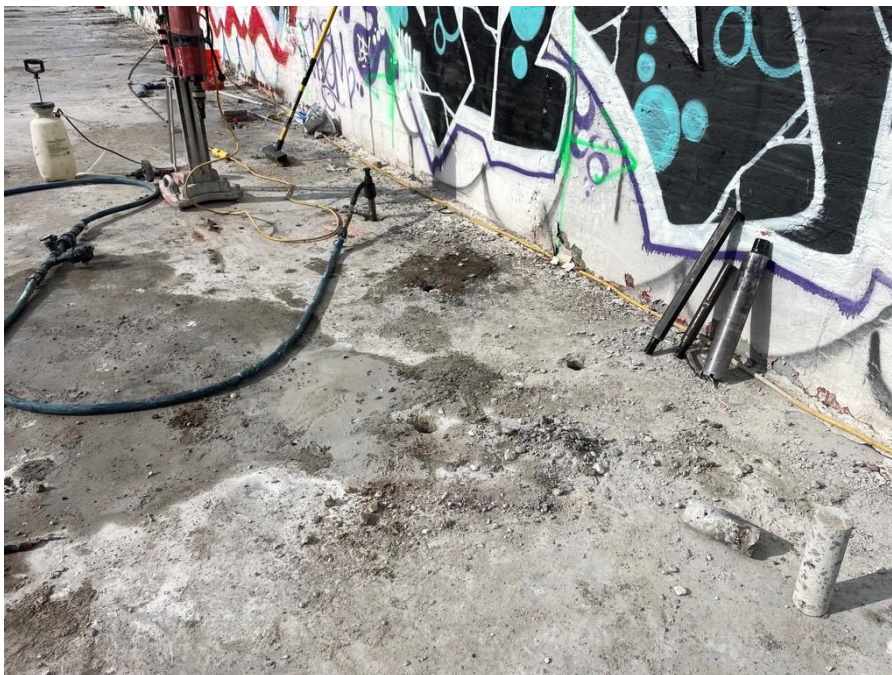
Photo 2: Regensis applying remedial products at injection point IP30 (facing northwest).
