PROJECT No.: 170361306 PROJECT: 514 Union Street LOCATION: Brooklyn, New York BCP SITE ID: C224318	CLIENT: Gowanus President Owner LLC	DATE: Wed., March 1 st , 2023 WEATHER: Cloudy, 36 – 44 °F Wind: NE @ 5 – 10 mph TIME: 7:00 am – 4:45 pm MONITOR: Audrey Seery
EQUIPMENT: Geoprobe 6610DT MiniRAE 3000 Photoionization Detector (PID) Air monitoring station (DustTrak II, MiniRAE 3000 PID) Solinst Water Level Meter YSI 600XL Water Quality Meter JCB 507 Forklift	PRESENT AT SITE: Langan: Audrey Seery, Vinicius De Paula Regenesis: Julian Serrano, Neal Wang, James Cobb Coastal Environmental Solutions, Inc.: Brandon Sullivan NYSDEC: Aaron Fischer	
<p>OBSERVATIONS, DISCUSSIONS, TEST RESULTS, ETC.: Langan was on-site to document implementation of the New York State Department of Environmental Conservation (NYSDEC)-approved February 2nd, 2023 Interim Remedial Measures Work Plan (IRMWP) No. 2.</p> <p>Site Activities</p> <ul style="list-style-type: none"> • Regenesis completed three 3-D Microemulsion (3DME®) injection points (IP45, IP46 and IP47) across the target treatment interval (TTZ) of 10 to 30 feet below grade surface (bgs). Remedial products applied included 3DME®, S-MicroZVI®, and BDI PLU

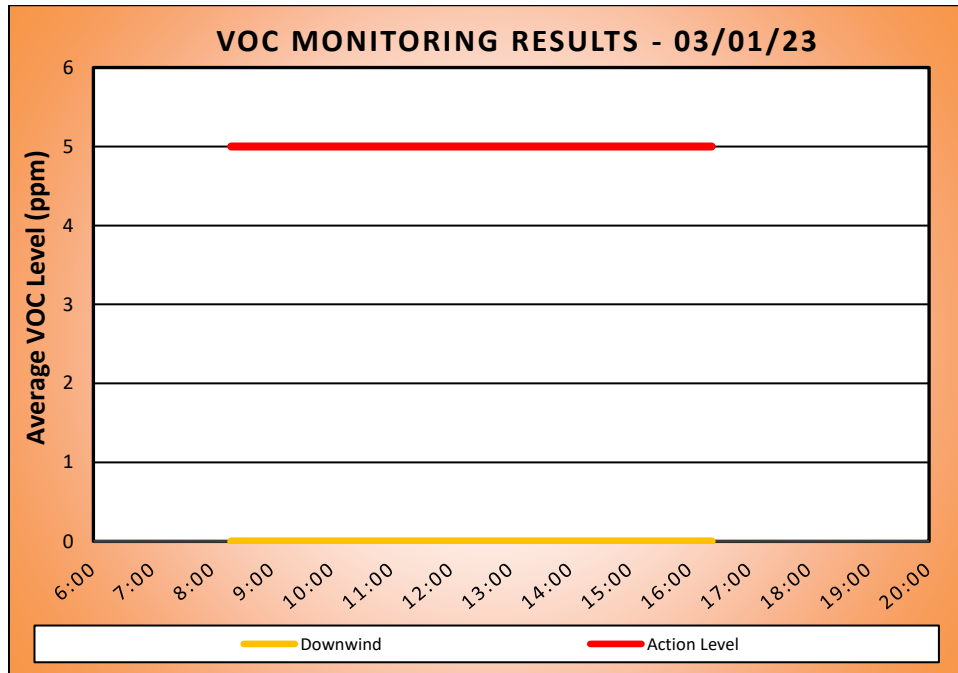
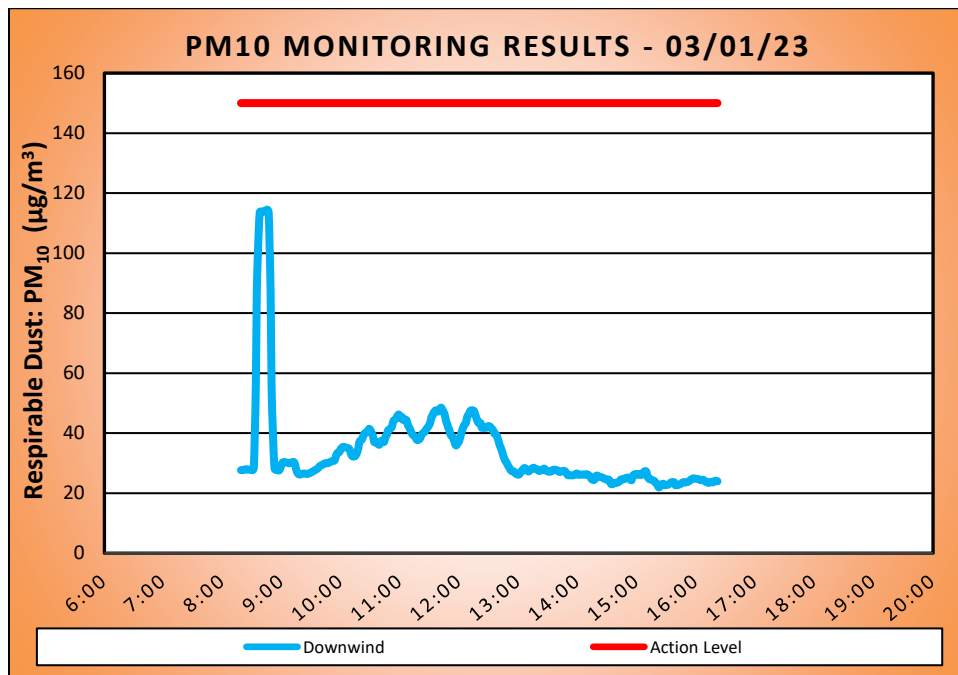
- Langan performed continuous air monitoring at downwind perimeter of the work zone for volatile organic compounds (VOCs) and particulate matter smaller than 10 microns in diameter (PM10) during ground-intrusive activity. VOC and PM10 action levels were not exceeded during the monitoring period. Recorded air monitoring data is summarized in the following graphs:

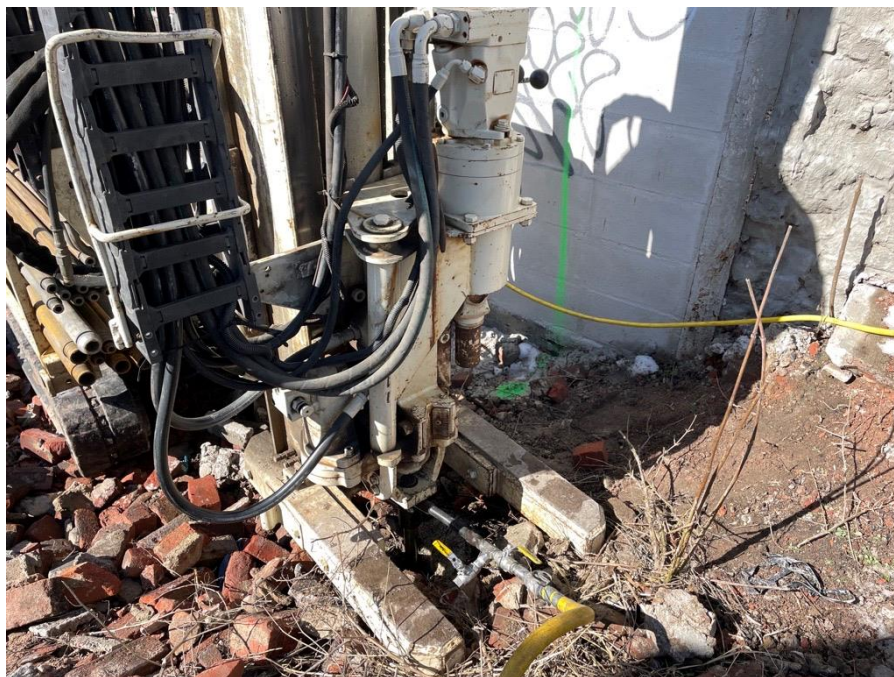
Photo 1: Regensis applying remedial products at injection point IP45 (facing southwest).

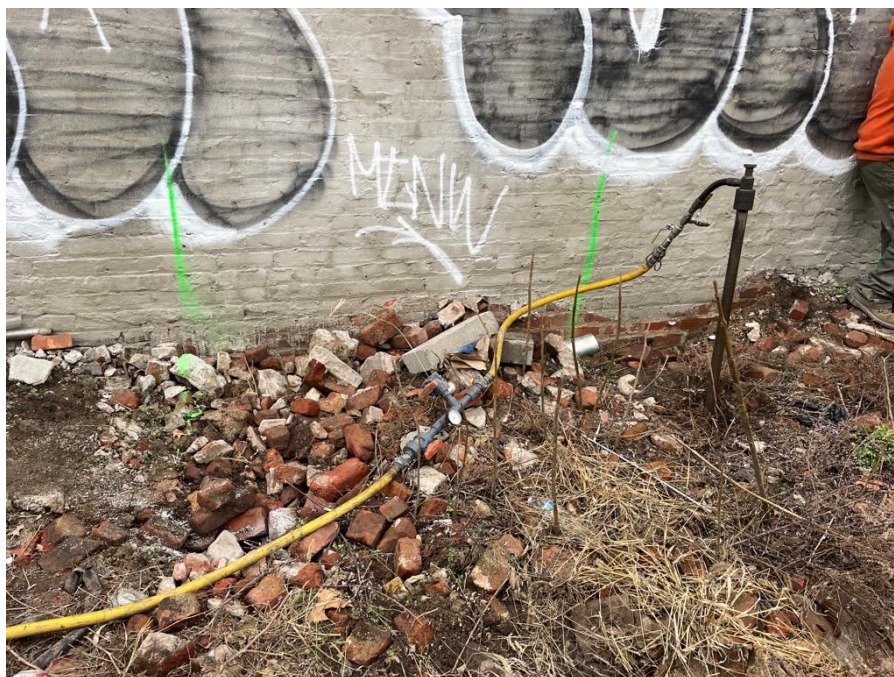
Photo 2: Regensis applying remedial products at injection point IP48 (facing northwest).
