<b>PROJECT No.:</b> 170361306  <b>PROJECT:</b> 514 Union Street <b>LOCATION:</b> Brooklyn, New York <b>BCP SITE ID:</b> C224318	<b>CLIENT:</b> Gowanus President Owner LLC	<b>DATE:</b> Mon., March 6 <sup>th</sup> , 2023  <b>WEATHER:</b> Partly Cloudy, 40– 50 °F Wind: NW @ 2 – 6 mph <b>TIME:</b> 6:45 am – 5:15 pm <b>MONITOR:</b> Audrey Seery
<b>EQUIPMENT:</b> Geoprobe 6611DT MiniRAE 3000 Photoionization Detector (PID) Air monitoring station (DustTrak II, MiniRAE 3000 PID) Solinst Water Level Meter YSI 600XL Water Quality Meter JCB 507 Forklift	<b>PRESENT AT SITE:</b> <b>Langan:</b> Audrey Seery <b>Regenesis:</b> Julian Serrano, Neal Wang <b>Coastal Environmental Solutions, Inc.:</b> Brandon Sullivan	
<p><b>OBSERVATIONS, DISCUSSIONS, TEST RESULTS, ETC.:</b> Langan was on-site to document implementation of the New York State Department of Environmental Conservation (NYSDEC)-approved February 2<sup>nd</sup>, 2023 Interim Remedial Measures Work Plan (IRMWP) No. 2.</p> <p><b>Site Activities</b></p> <ul style="list-style-type: none"> <li>• Regenesis completed four high-dose PlumeStop® injections points (IP31, IP32, IP33, and IP34) across the target treatment interval (TTZ) of 12 to 30 feet

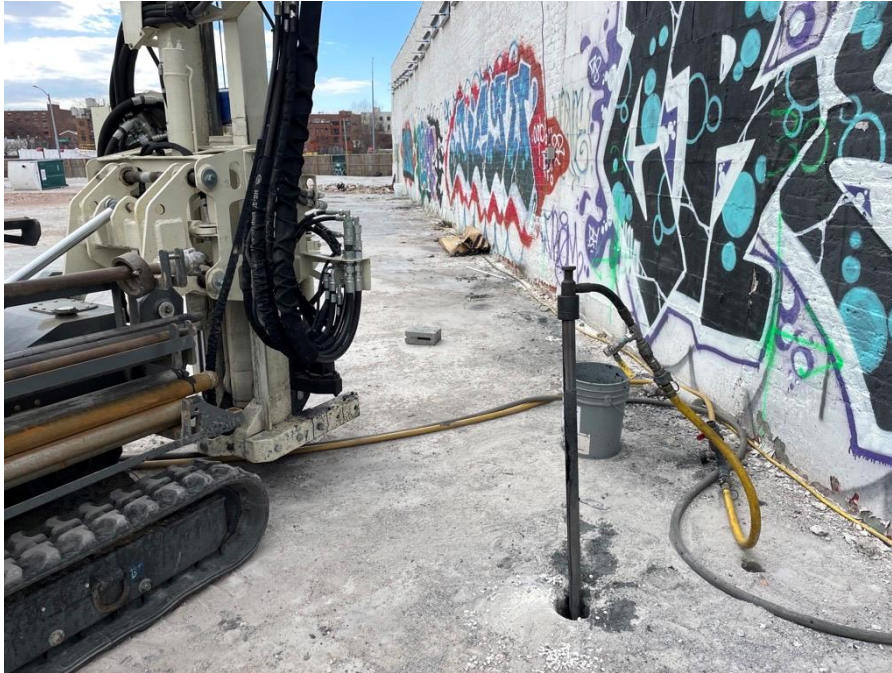
**Photo 1:** Regenesis applying remedial products at injection point IP31 (facing northwest).

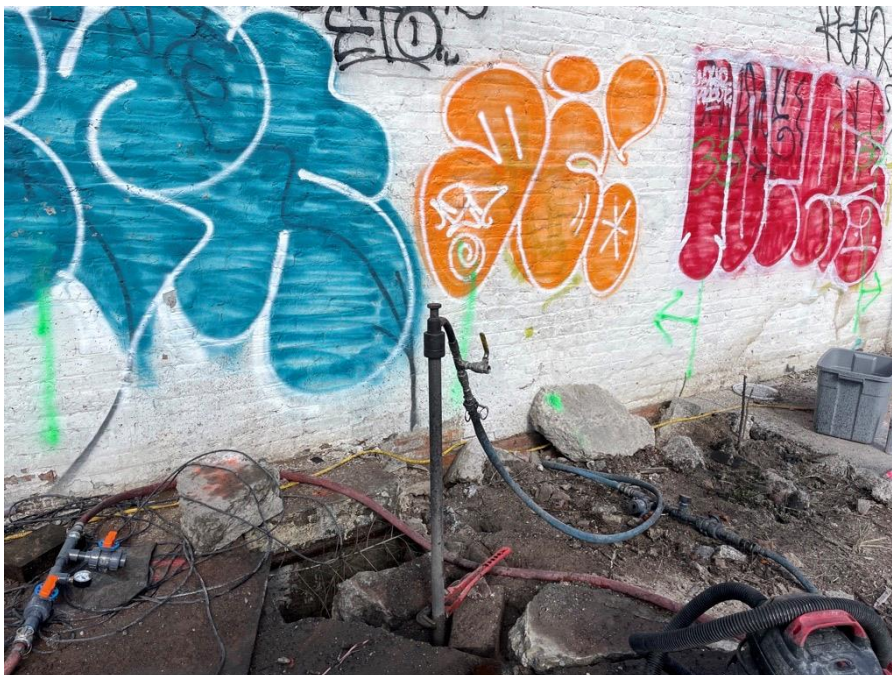
**Photo 2:** Regenesis applying remedial products at injection point IP34 (facing northeast).
