SITE OBSERVATION REPORT

PROJECT No.: 170610401

PROJECT: C224328 – 326-350 Rockaway Avenue

DATE: Mon, May 2, 2022

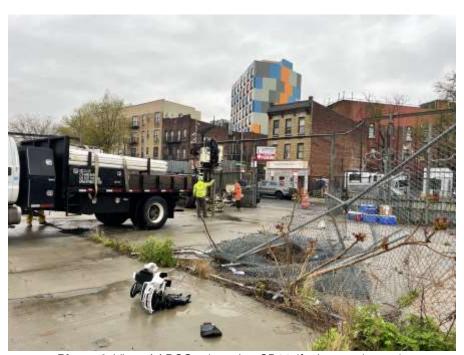
- o **SB11** was advanced to about 50 feet below grade surface (bgs). Historic fill was observed to a depth of 7 feet bgs underlain by native sand. Fill/soil was screened was screened for odors, staining and organic vapors using a photoionization detector (PID); evidence of impacts were not observed. Upon reaching termination depth of the boring, **MW01** was installed using 15 feet of 0.02-inch slot well screen connected to 35 feet of 2-inch diameter, threaded, flush-joint, polyvinyl chloride (PVC) casing. No. 2 clean sand was used to fill the annulus around the screen to 33 feet bgs. A bentonite seal was installed above the sand up to grade surface. Groundwater was observed at about 38 feet below top of casing.

Photo 1: View AARCO advancing SB11 (facing northwest).

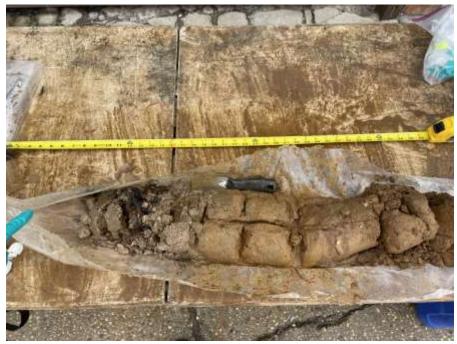
- o **SB15** were advanced to a depth of about 50 feet bgs. Historic fill was observed to a depth of 6.5 feet bgs underlain by native sand. Fill/soil was screened was screened for odors, staining and organic vapors using a photoionization detector (PID); evidence of impacts were not observed. Upon reaching termination depth of the boring, **MW03** was installed using 20 feet of 0.02-inch slot well screen connected to 30 feet of 2-inch diameter, threaded, flush-joint, PVC casing. No. 2 clean sand was used to fill the annulus around the screen to 28 feet bgs. A bentonite seal was installed above the sand up to grade surface. Groundwater was observed about 36.5 feet below top of casing.

Photo 2: View of SB15_5-10 (facing west).
