SITE OBSERVATION REPORT

Hazardous 170610401 PROJECT: C224328 – 326-350 Rockaway Avenue LOCATION: 326-350 Rockaway Avenue, Brooklyn, NY	CLIENT: 326 Rockaway Managing Member LLC	DATE: Thurs, May 5, 2022 WEATHER: Sunny, 50-74°F Wind: N at 0-5 mph TIME: 6:30am to 4:15pm
CONTRACTOR: AARCO Environmental Services Corp. (AARCO)		LANGAN REP. : Ali Reach, Caleb Bogin
CONTRACTOR'S EQUIPMENT: Geoprobe® 8140LC Sonic Drill Rig	PRESENT AT SITE: RI Day 4 Ali Reach, Caleb Bogin – Langan Daybi Pacheco – AARCO

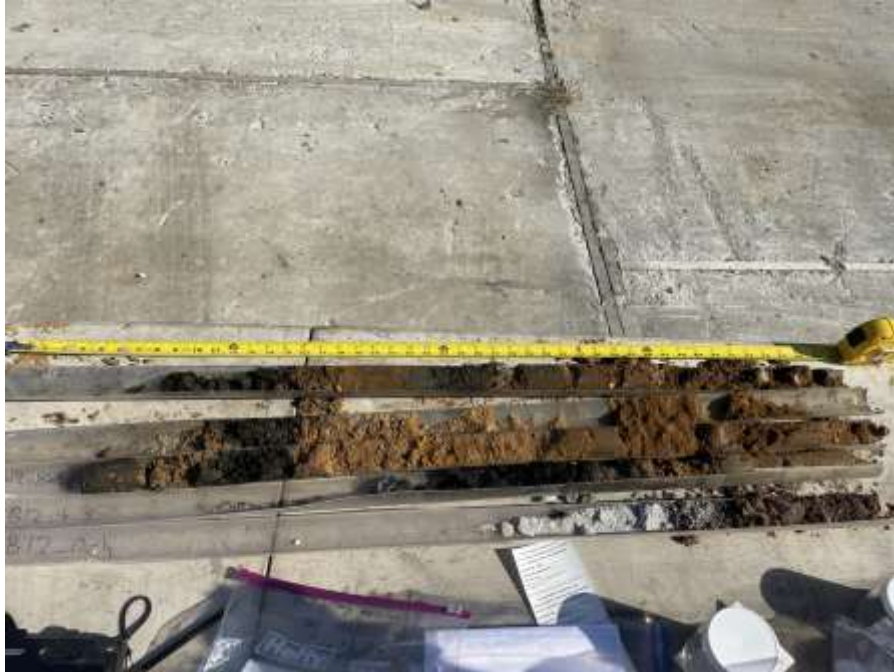
Photo 1: Soil Boring SB12 (facing west).

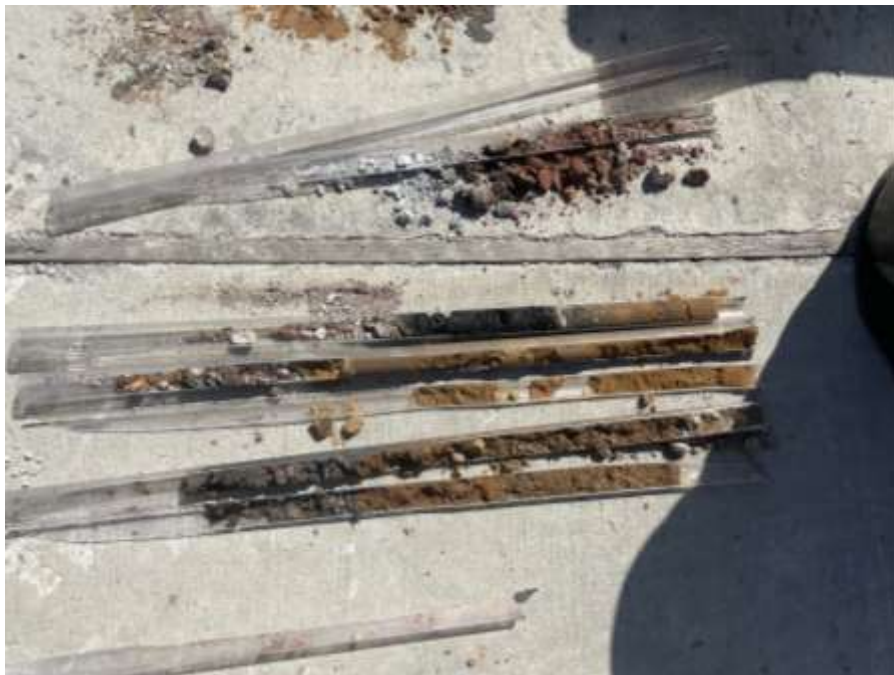
Photo 2: Soil Boring SB13 (facing west).
