## **WEEKLY INSPECTION REPORT**

IEC Project No:	14729	NYSDEC BCP Site No:	C224329	Date:	12/13/23
Project:	585 Union Street, Brooklyn, NY

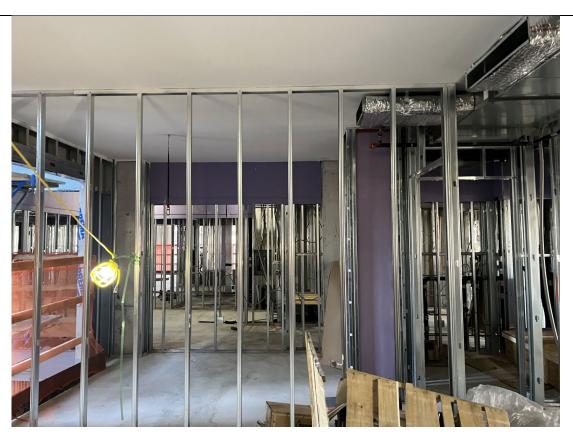
Photo 1 –
Representative
photo of
sheetrock on
the second
floor.

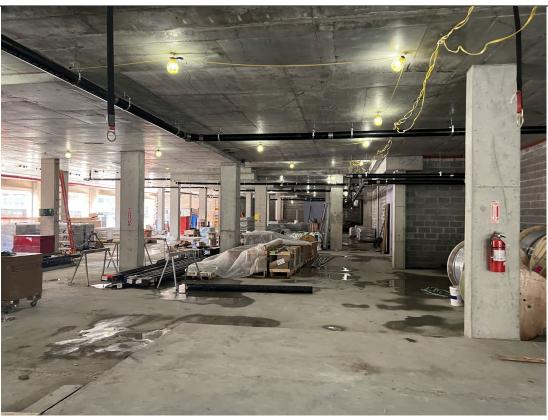
Photo 2 – Representative view of the first floor.

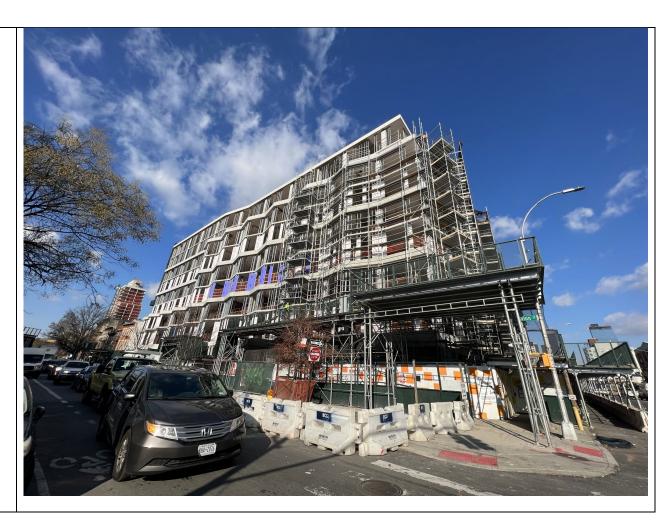
Photo 3 –
Representative photo of the exterior of the building.
