RE: Remedial Action Work Plan – Addendum #2
737 4th Avenue, Brooklyn, New York
BCP #C224332

Client:	737 4TH AVENUE LLC	Inspection Date:	08/29/2023
Project Site Address:	737 4TH AVENUE, BROOKLYN NY.	Time In/Out:	8:00AM - 11:00AM
Project ID:	CVPAR17462	Report N°:	SSS20230829
Inspector(s):	DAVID F YANKEY CWI MSI EIT	Site Weather (°F):	CLEAR (70)

STRUCTURAL STABILITY - CONSTRUCTION OPERATIONS **INFLUENCING ADJACENT STRUCTURES** **INSPECTION REPORT**

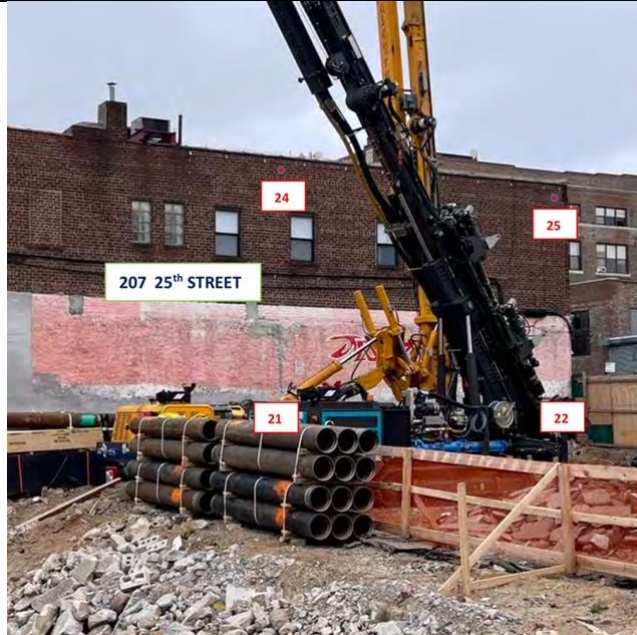
Photo 2: PROPERTIES VERIFIED

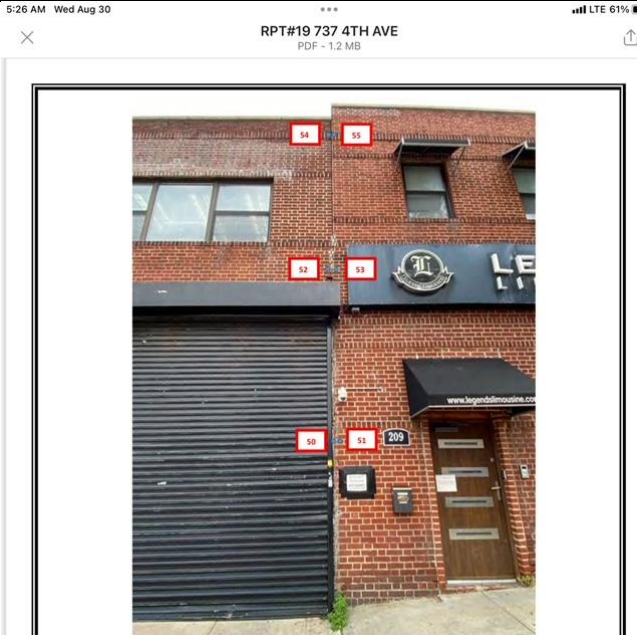
Photo 3: OPTICAL POINTS AT EAST

Photo 4: SOUTH FAÇADE CRACK AT 207 & 209 BOUNDARY

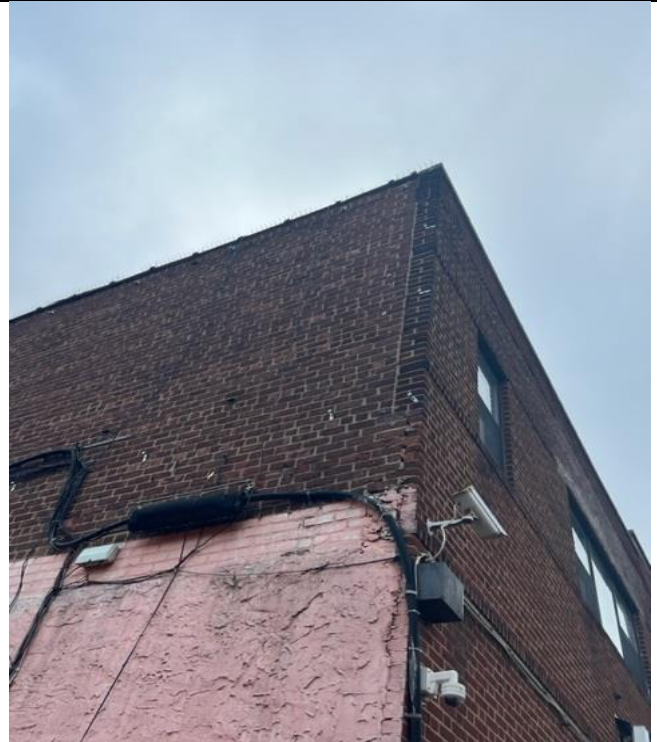
Photo 5: REPORT USED

Photo 6: SOUTHEAST CORNER OF BUILDING 207

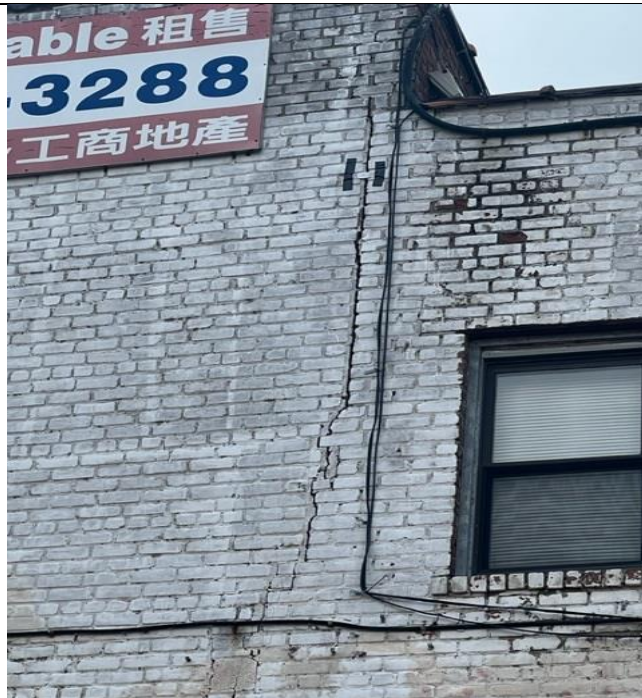
IT IS EVIDENT THAT BUILDING IS PREDOMINANTLY MOVING IN THE EAST DIRECTION TOWARDS 4TH AVENUE. CRACK PROPAGATION WILL INCREASE AS LONG AS PILE DRILLING IS ONGOING CLOSE TO THE BUILDINGS. ALL CRACK LOCATIONS NEED TO BE RECTIFIED. EOR NEEDS TO ADVISE ON CRACK STITCHING METHOD AND EVALUATE CONDITION AT SOUTHEAST CORNER OF BUILDING 207. THIS NEEDS TO BE PROVIDED AND CRACK MONITORS ERECTED WITH SATISFACTORY READINGS BEFORE SECANT AND STRUCTURAL PILE DRILLING CAN PROCEED.

Photo 7: CRACK PROPAGATION AT EAST ELEVATION
BETWEEN 262 AND 207

MEANS OF STABILIZING FAÇADE WALLS OF ADJACENT PROPERTIES NEED TO BE PROVIDED.

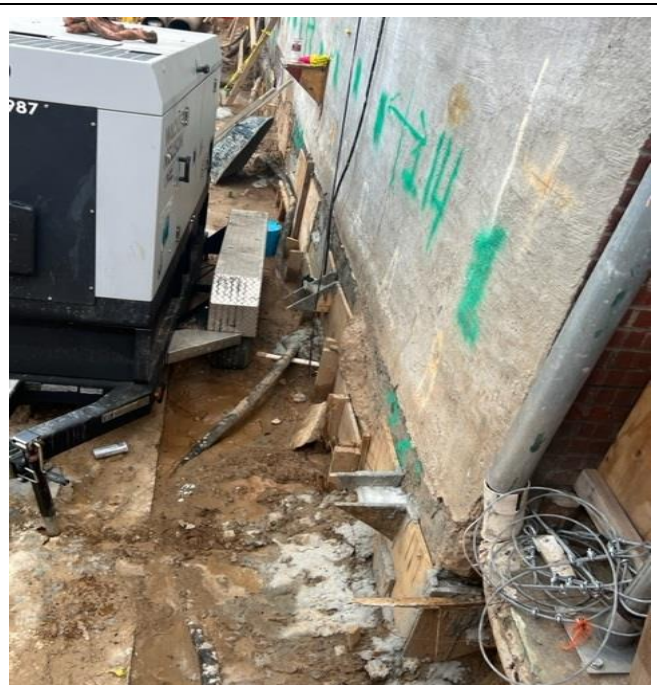
Photo 8: PROPOSED SECANT AND STRUCTURAL PILE
LOCATIONS

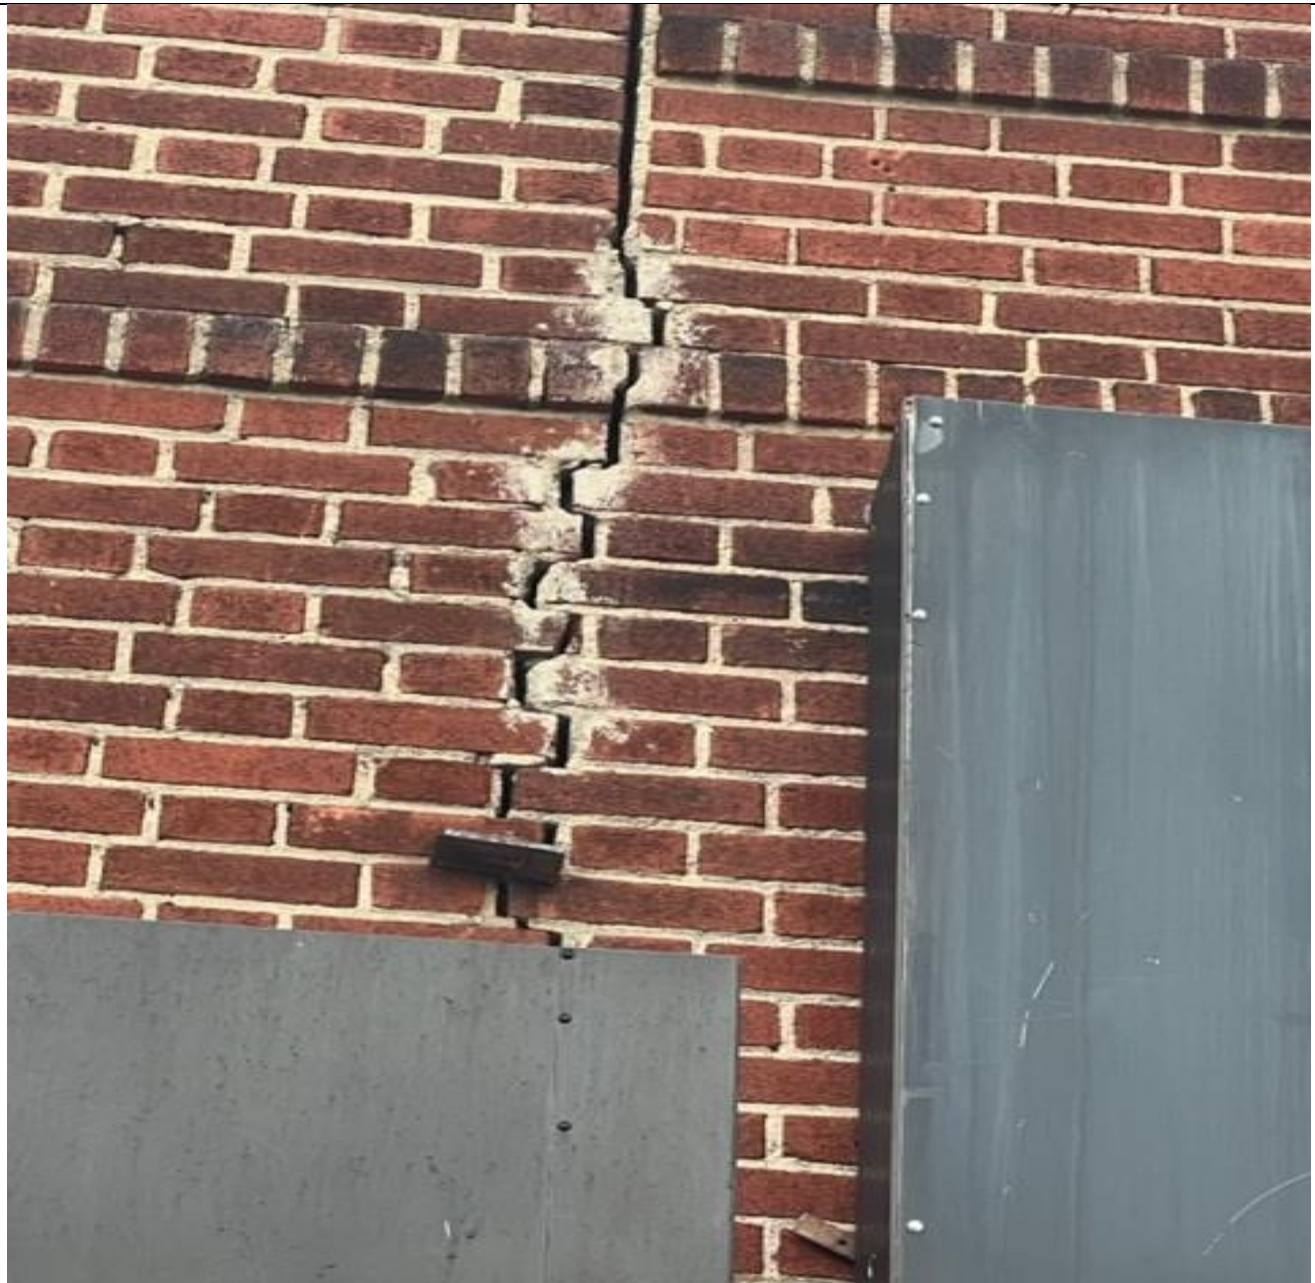
Photo 9: EXTENT OF CRACK AT SOUTH FAÇADE OF 207/209 BUILDING
