DAILY FIELD REPORT

Project	340 Myrtle Ave Site	Report No.	1
BCP Site	BCP Site No. C224340	Date	5/20/2024
Location	340 Myrtle Avenue, Brooklyn, NY	File No.	0210873
Client	340 Myrtle Development LLC	Temperature	L: 54 H:73
Contractor	Haley & Aldrich, Brooklyn Builders, Blanco Drilling	Wind Direction	NE to SW, 4mph
Weather	Sunny	Personnel on Site	Z. Richards
Humidity	84%	Time on Site	7:00 am to 4:20 pm

H & A of New York Engineering and Geology, LLP (Haley & Aldrich) was present to document the implementation of the April 2024 NYSDEC-approved Remedial Action Work Plan (RAWP) prepared by Tenen Environmental, LLC (Tenen) for the 340 Myrtle Ave BCP Site (C224340), located at 340 Myrtle Avenue, Brooklyn, NY. Site Observations are summarized below.

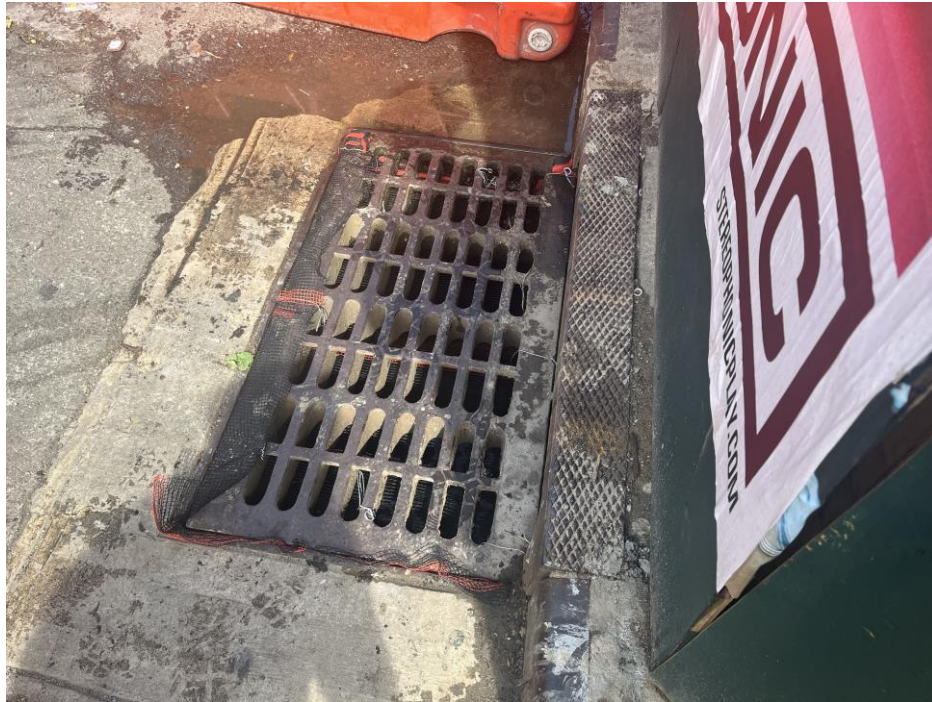
Photo 1: View of filter fabric installed in catch basin along Myrtle Avenue, facing east.

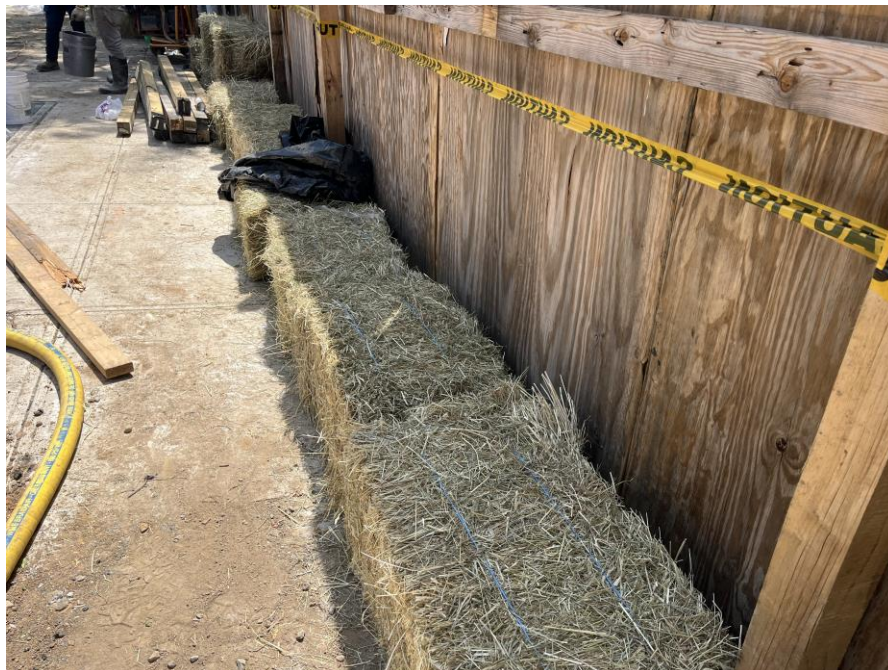
Photo 2: View of hay bales installed for erosion and sediment control along perimeter of the Site, facing south.

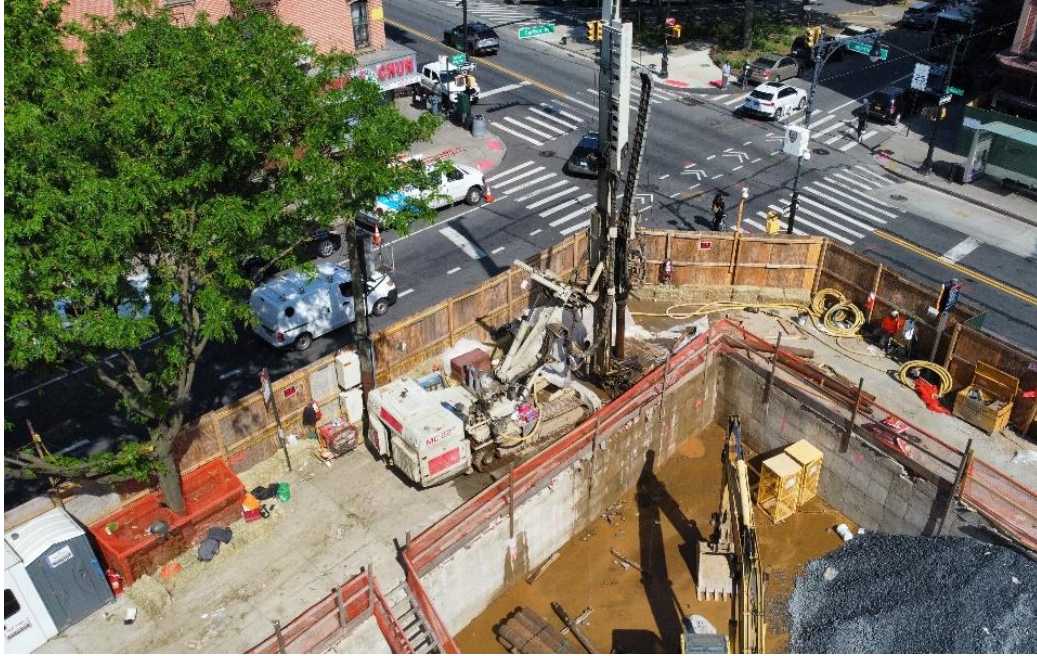
Photo 1: View of soldier pile installation, facing northwest.

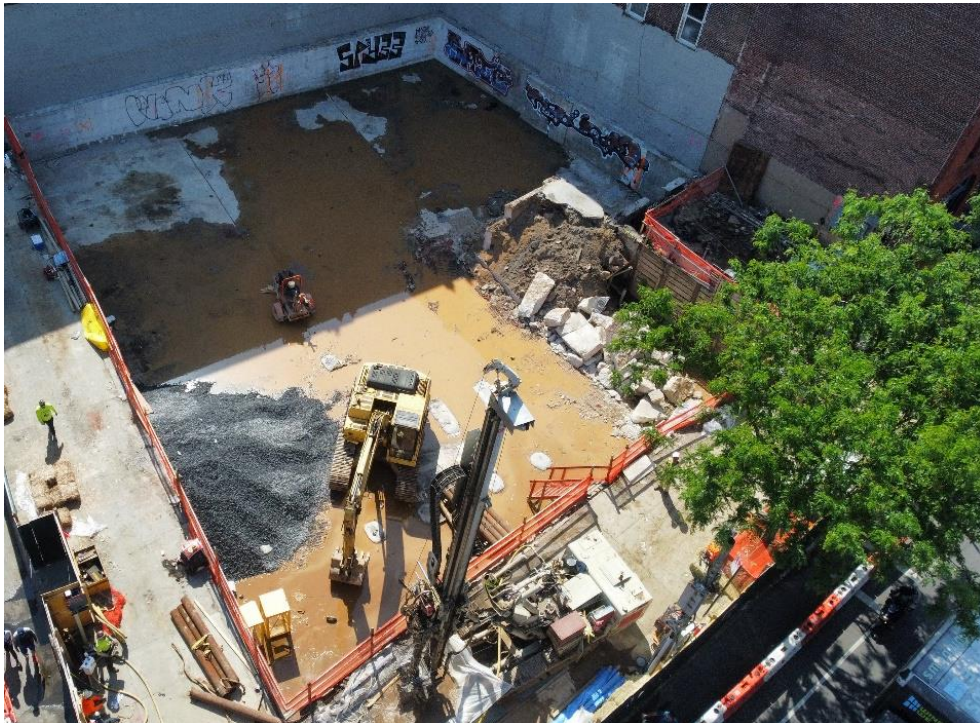
Photo 2: View of Site conditions, facing southeast.

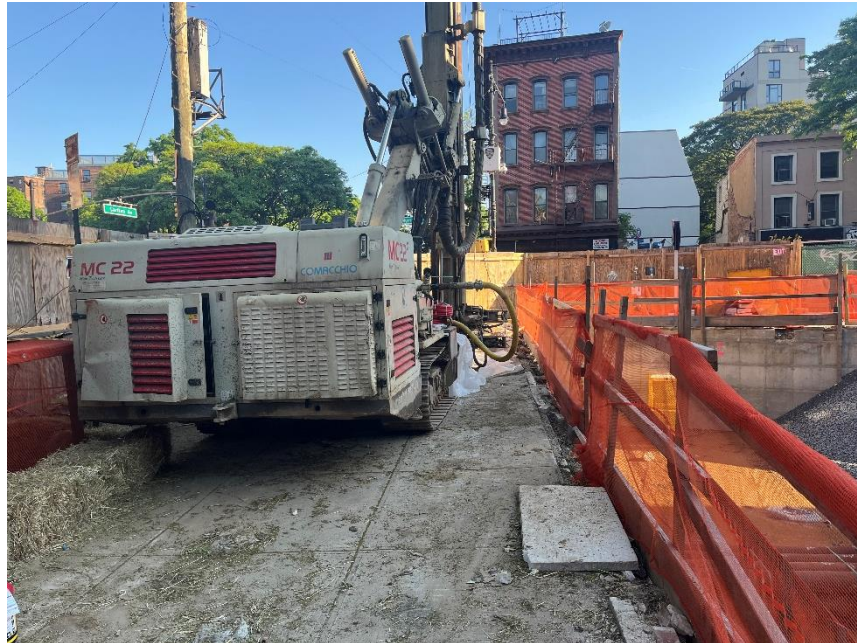
Photo 1: View of installation of soldier piles, facing north.

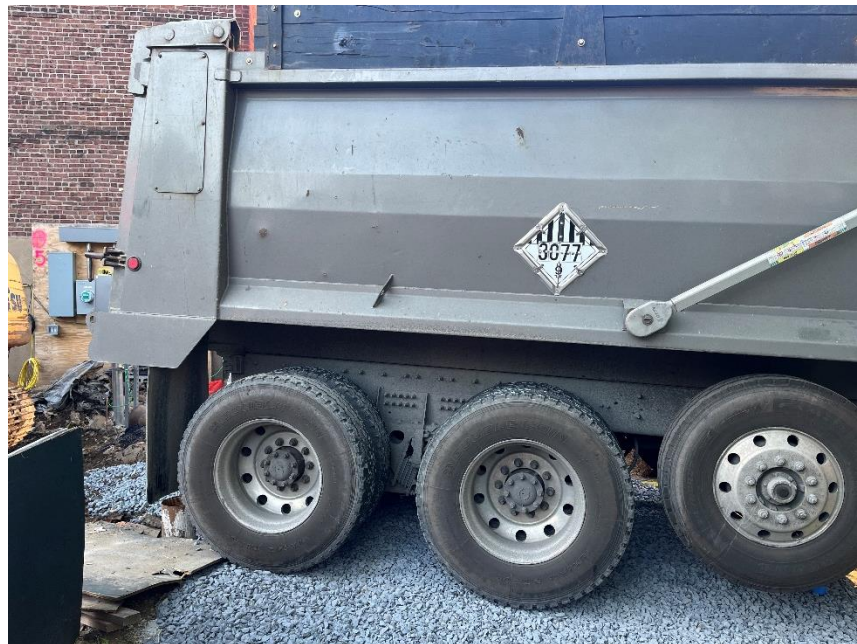
Photo 2: View of tri-axle truck backing onto site on stabilized construction entrance, facing south.

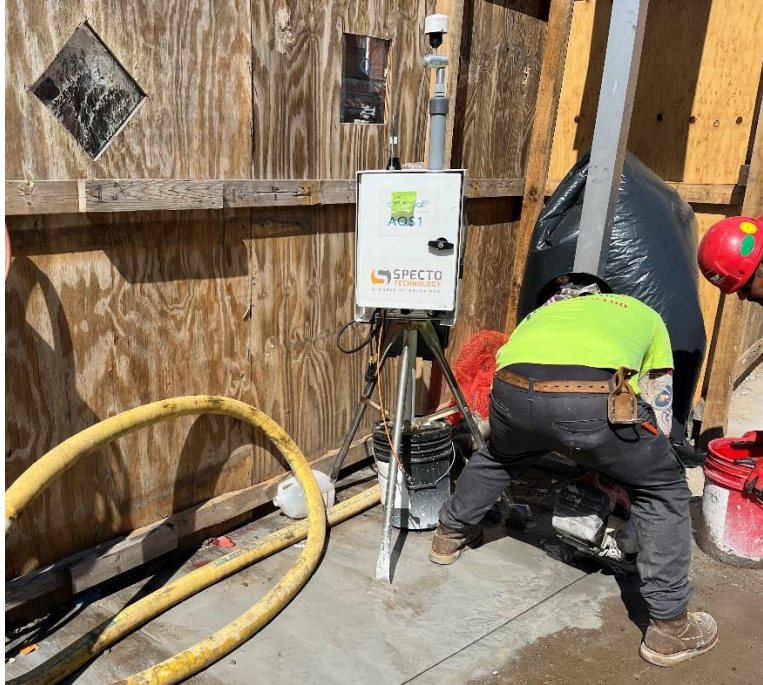
- The particulate 15-minute average concentration of matter smaller than 10 microns in diameter (PM10) exceeded the action level at Station 3 at 3:15 pm and 3:30 pm due to the saw cutting of concrete immediately within the vicinity of Station 3. Additional water was used as a dust suppression technique and concentrations returned to background levels during the next 15-minute average.

- The particulate 15-minute average concentration of PM10 exceeded the action level at Station 1 at 3:30 pm and 3:45 pm due to the saw cutting of concrete immediately within the vicinity of Station 1. Additional water was used as a dust suppression technique and concentrations returned to background levels during the next 15-minute average.

Photo 3: View of contractors saw cutting concrete and using water for dust suppression near CAMP Station 3, facing northeast.

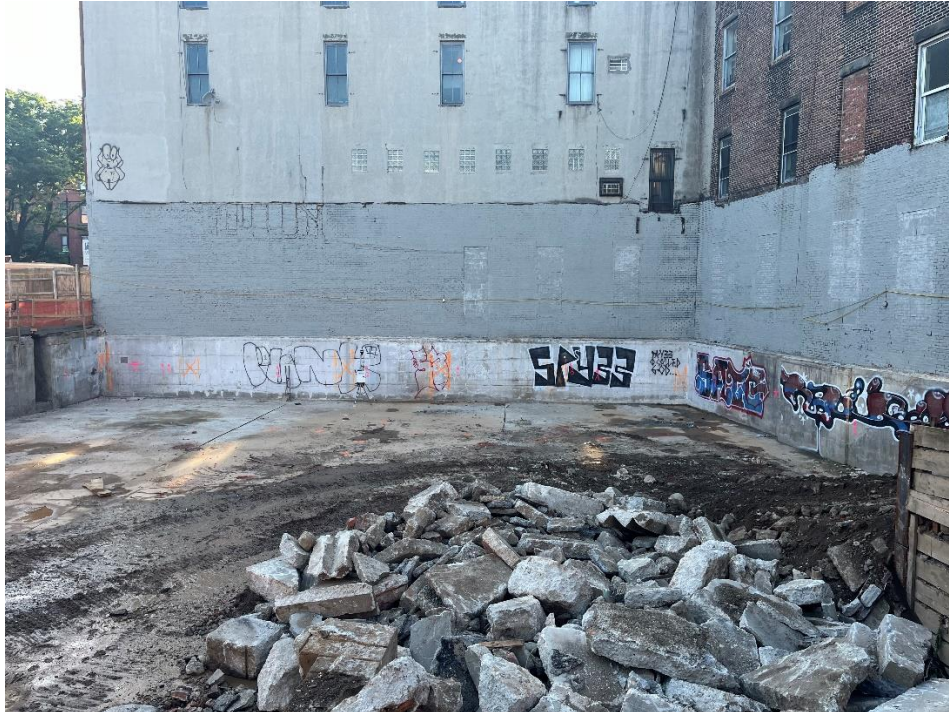
Photo 4: View of general site conditions and CAMP Station 2, facing east.

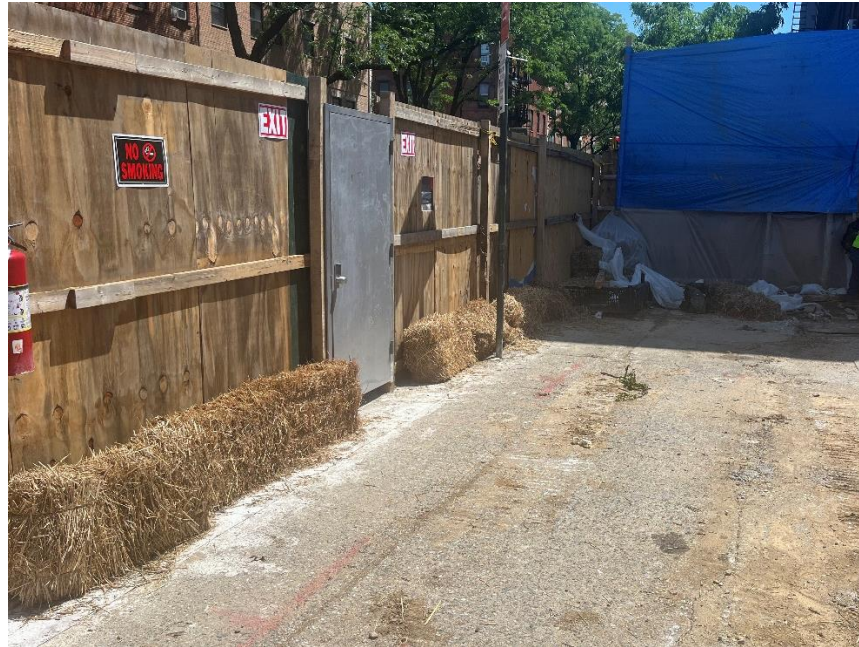
Photo 1: View of Site conditions and hay bales installed for erosion and sediment control along perimeter of the Site, facing northeast.

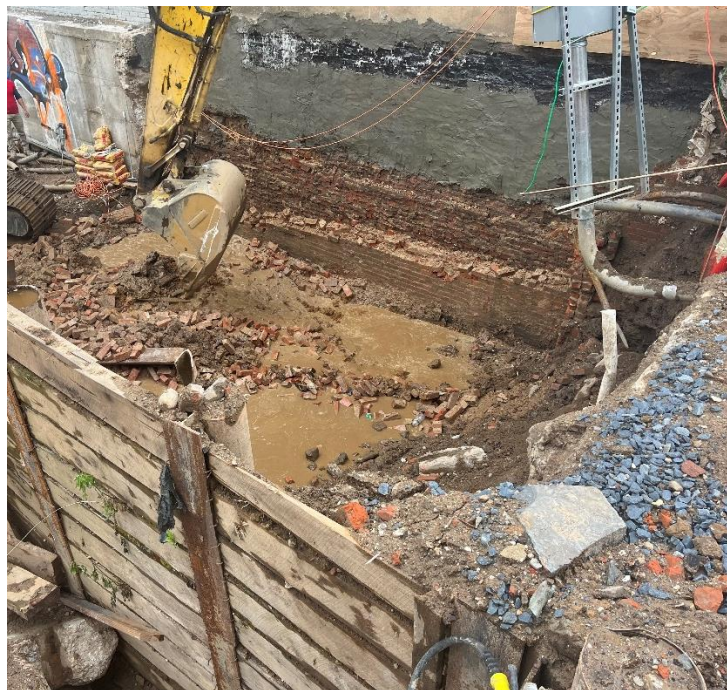
Photo 2: View of contractors preparing south-adjacent building foundation for parking, facing south.

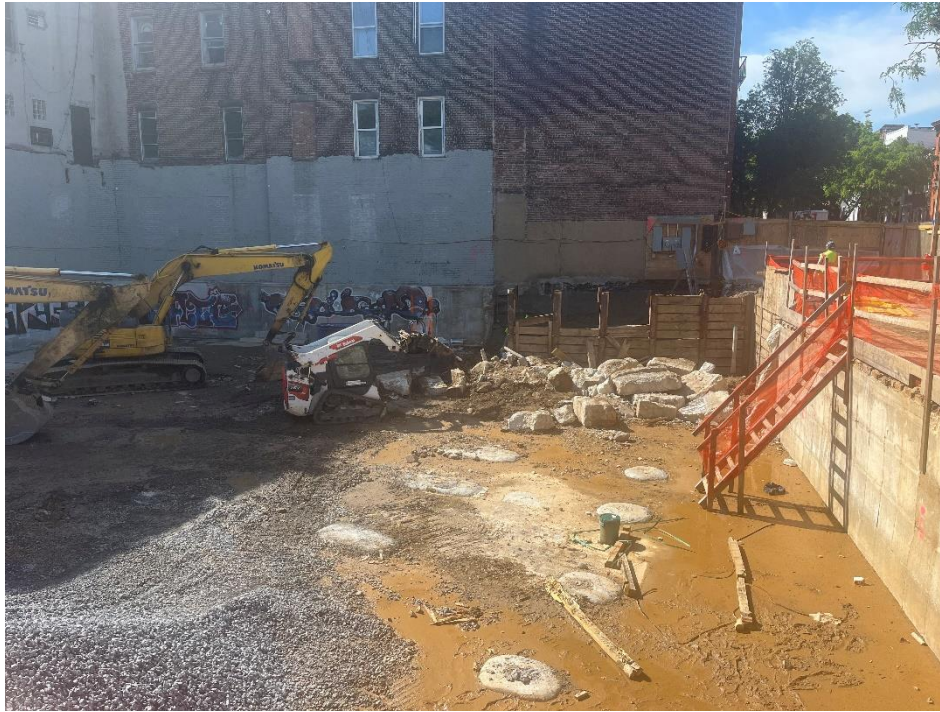
Photo 1: View of Site conditions, facing south.

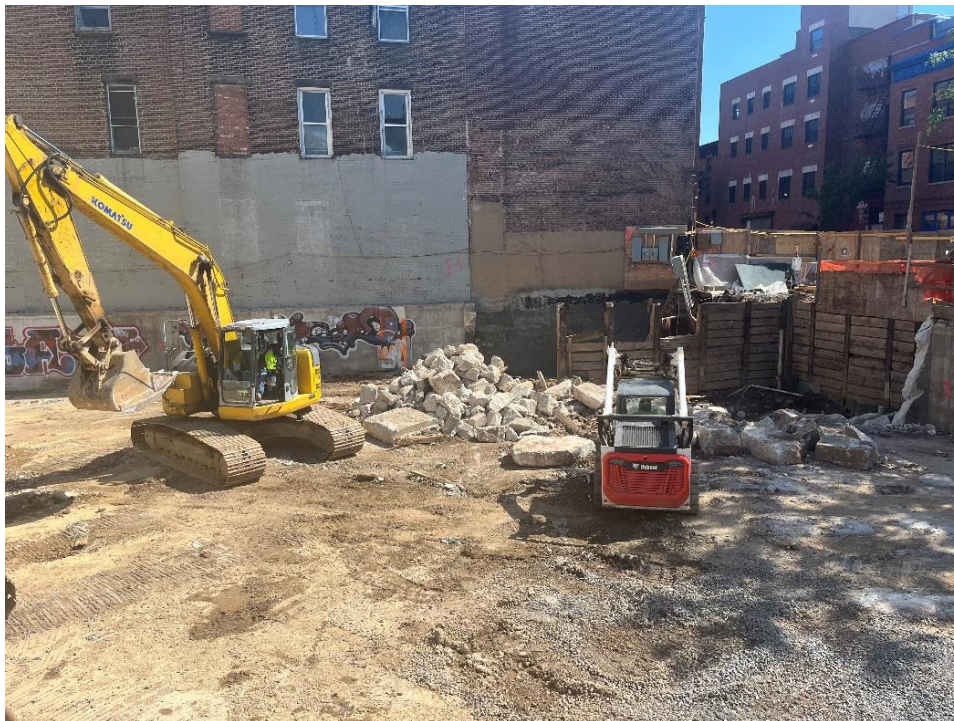
Photo 2: View of contractors stockpiling C&D, facing south.

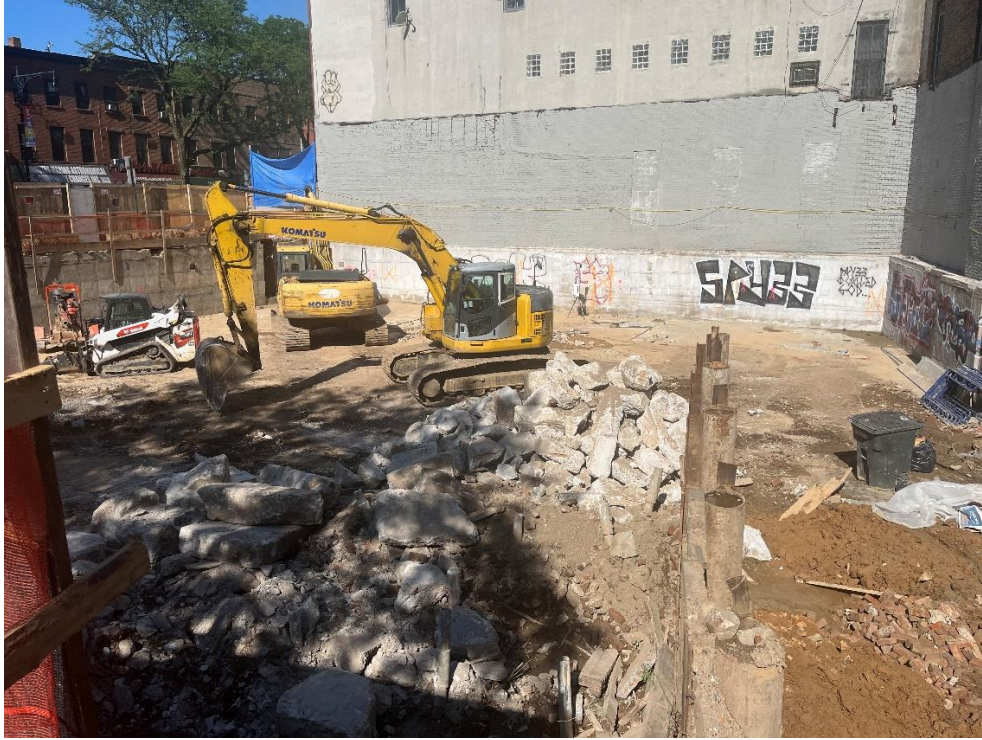
Photo 3: View of Site conditions and CAMP Station 2, facing east.

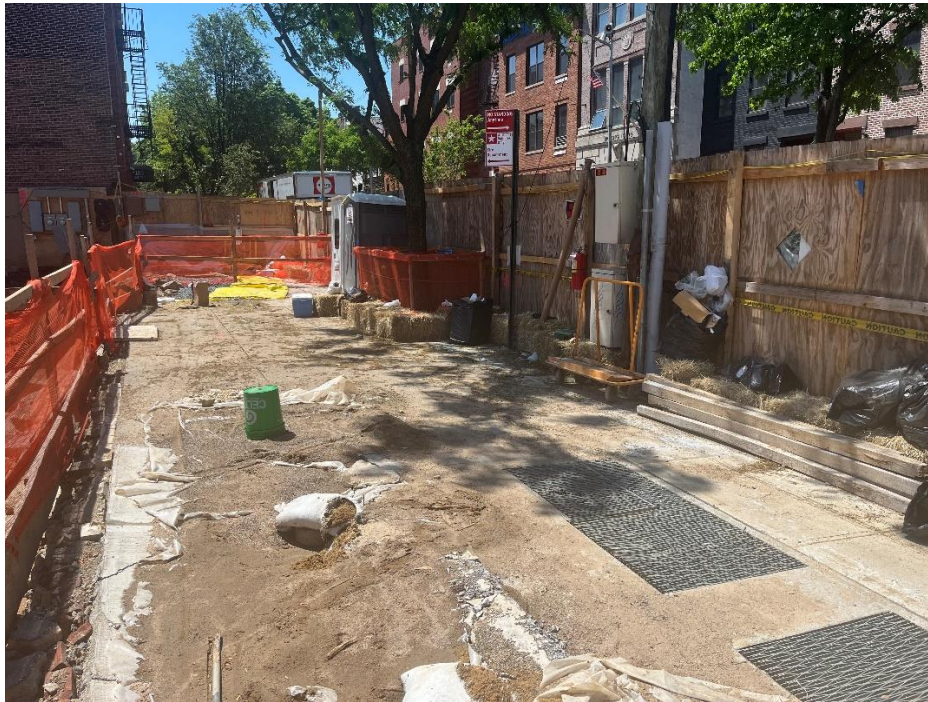
Photo 4: View of Site conditions and hay bales installed for erosion and sediment control along perimeter of the Site, facing south.

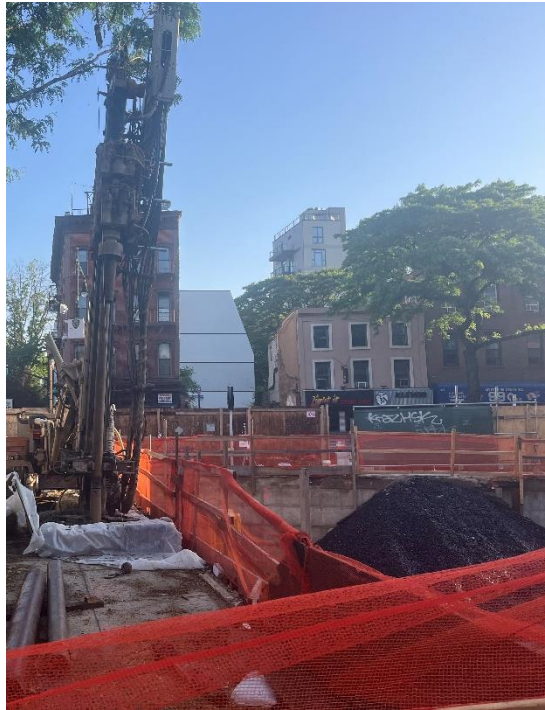
Photo 1: View of contractor installing soldier piles on the western portion of site, facing north.

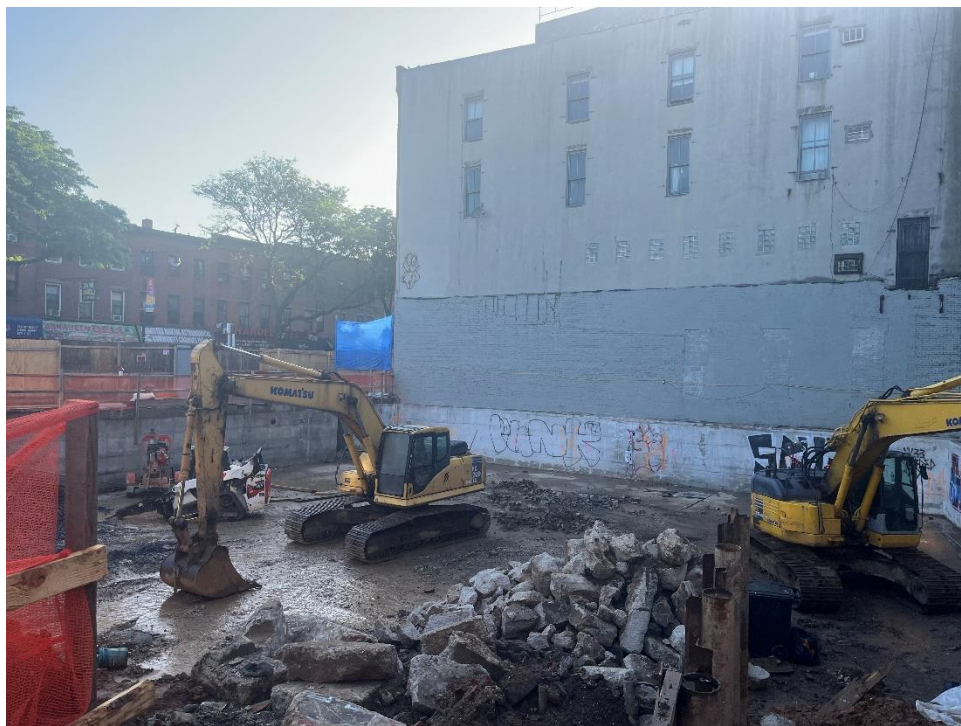
Photo 2: View of site conditions, facing northeast.

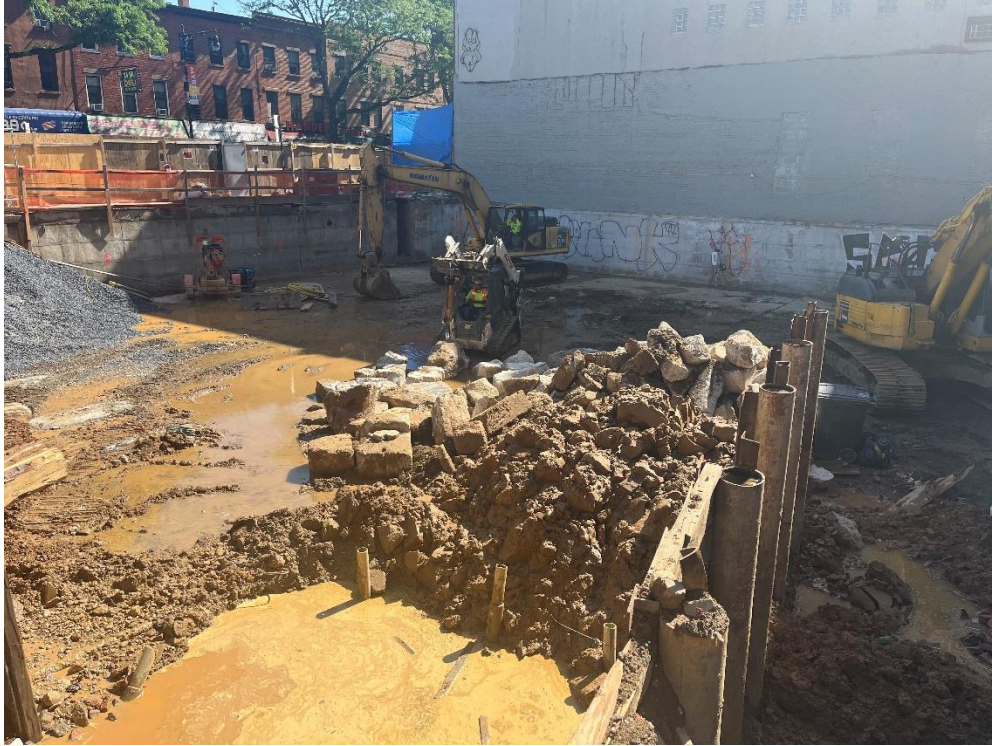
Photo 3: View of CAMP Station 2 and contractor breaking down concrete, facing northeast.

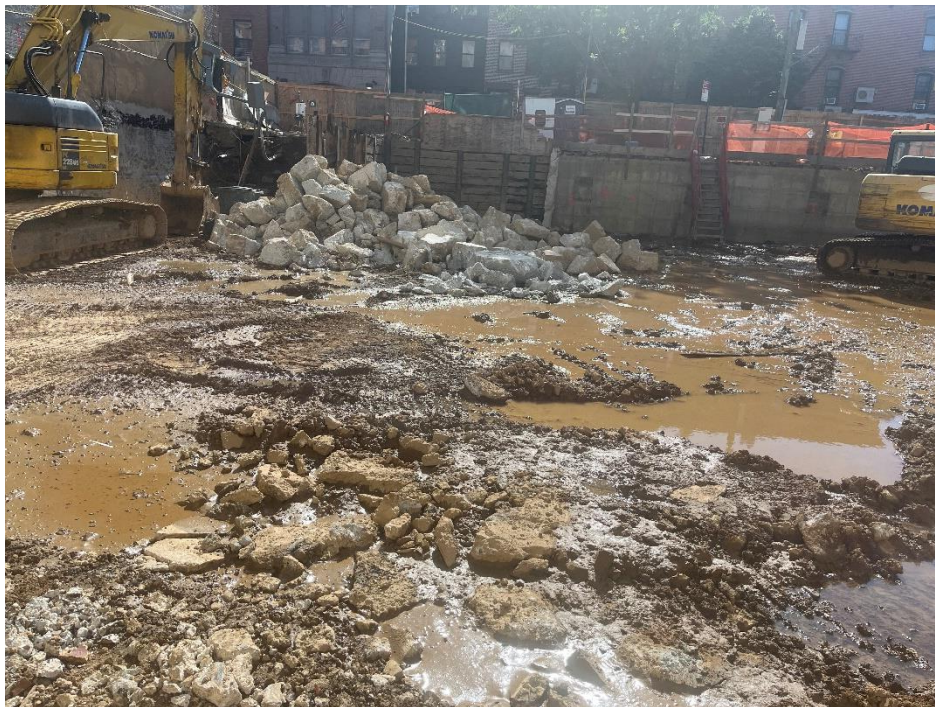
Photo 4: View of Site conditions and stockpiled C&D, facing west.

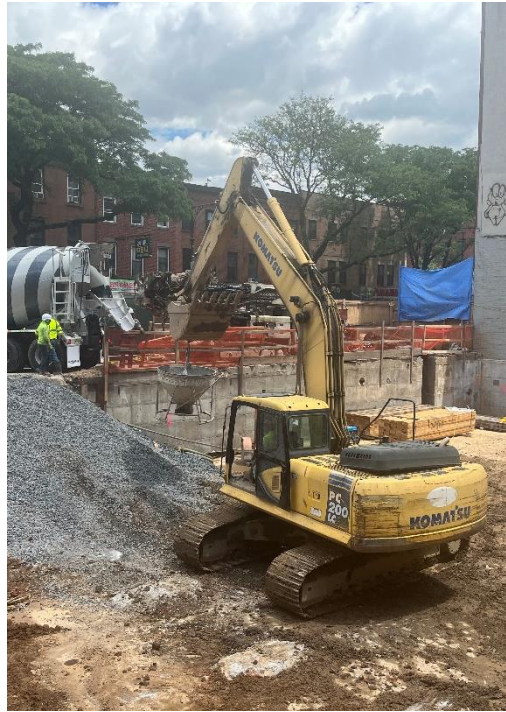
Photo 1: View of contractor delivering concrete for SOE installation, facing northwest.

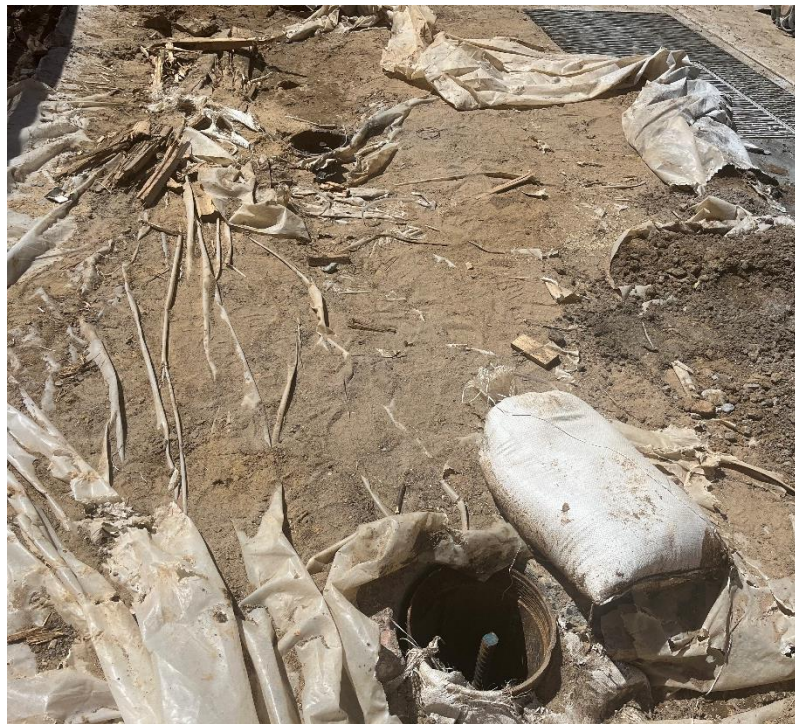
Photo 2: View of installed SOE piles prior to concrete pour, facing east.

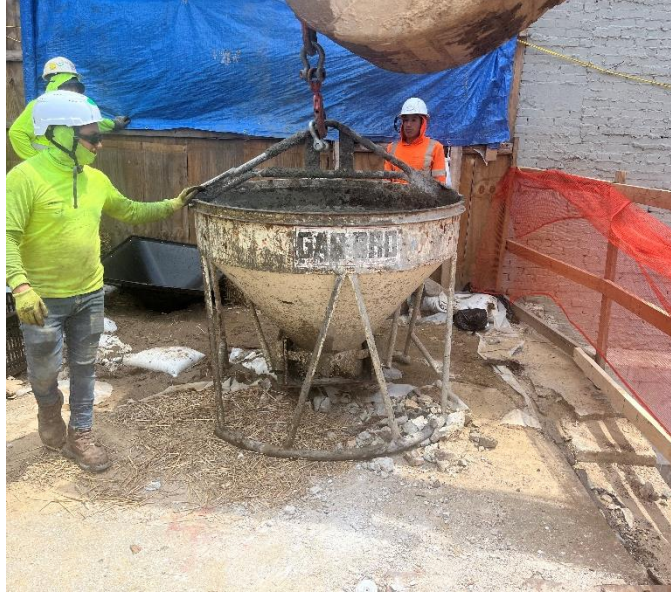
Photo 3: View of the contractor pouring concrete into SOE piles, facing southwest.

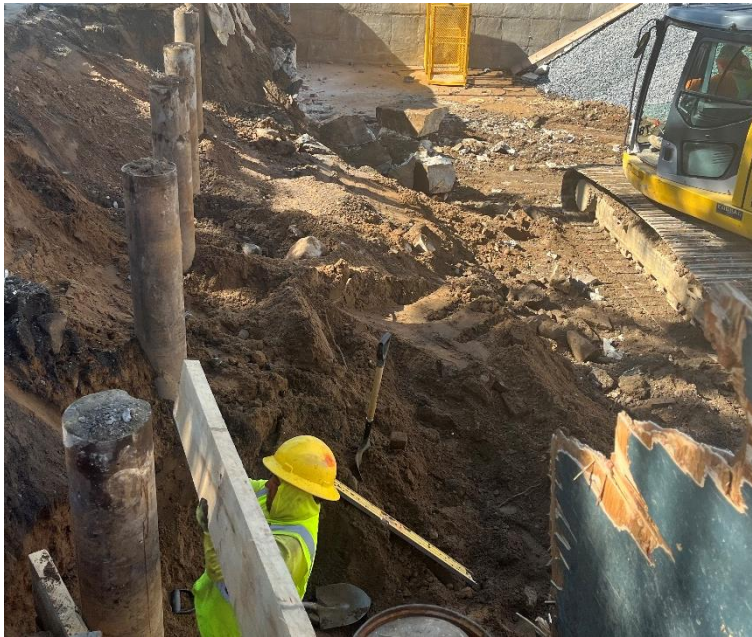
Photo 4: View of contractor installing SOE, facing north.

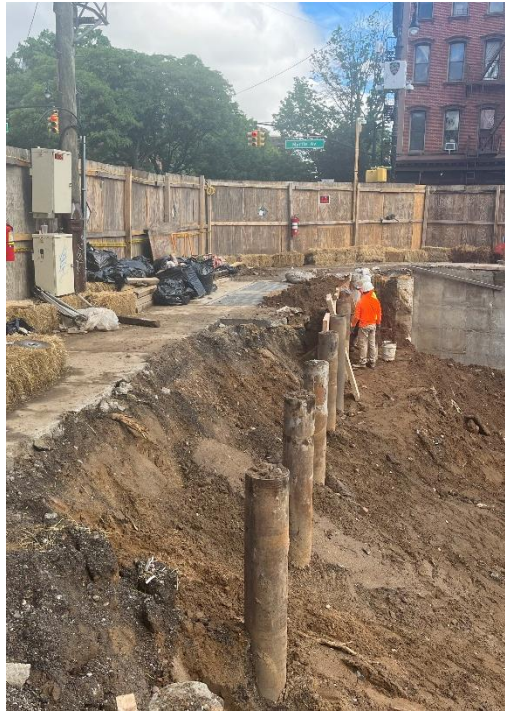
Photo 1: View of SOE, lagging activities along the western portion of site, facing north.

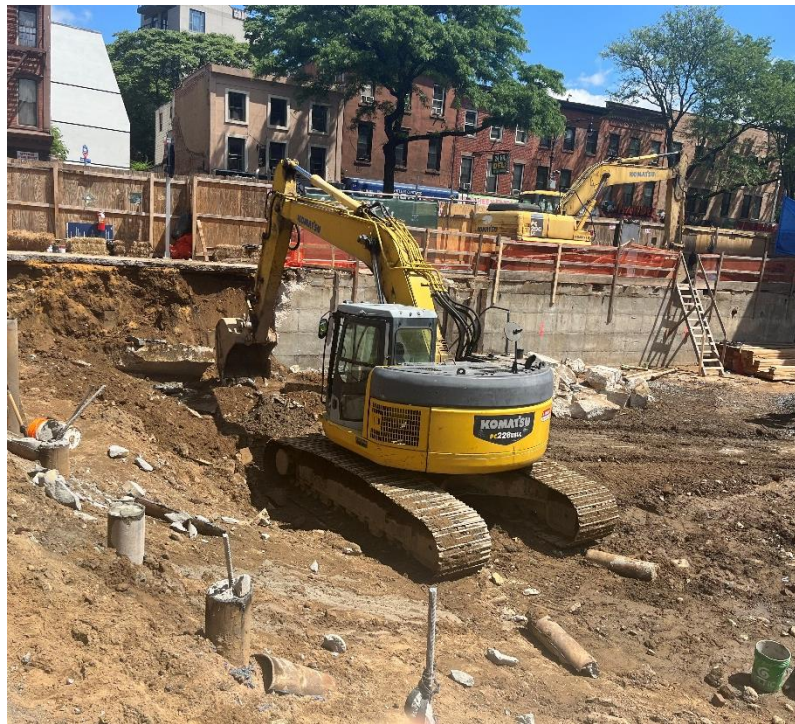
Photo 2: View of removal of northwest foundation wall, facing northeast.

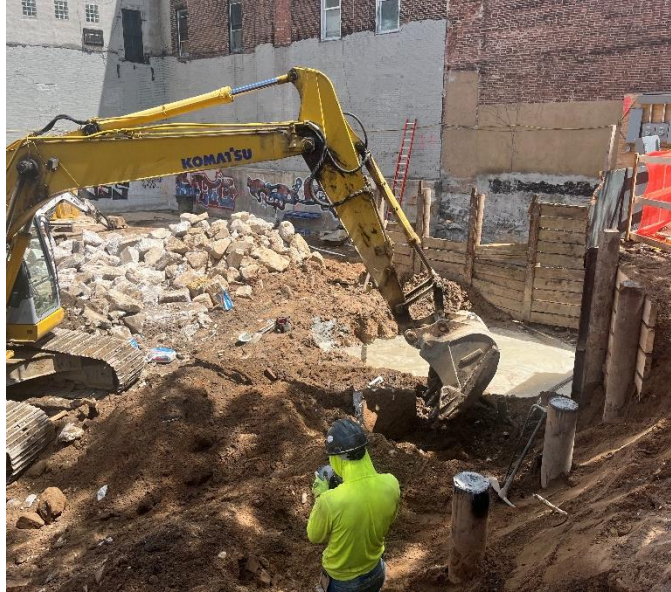
Photo 3: View of the contractor excavating for lagging activities, facing southeast.

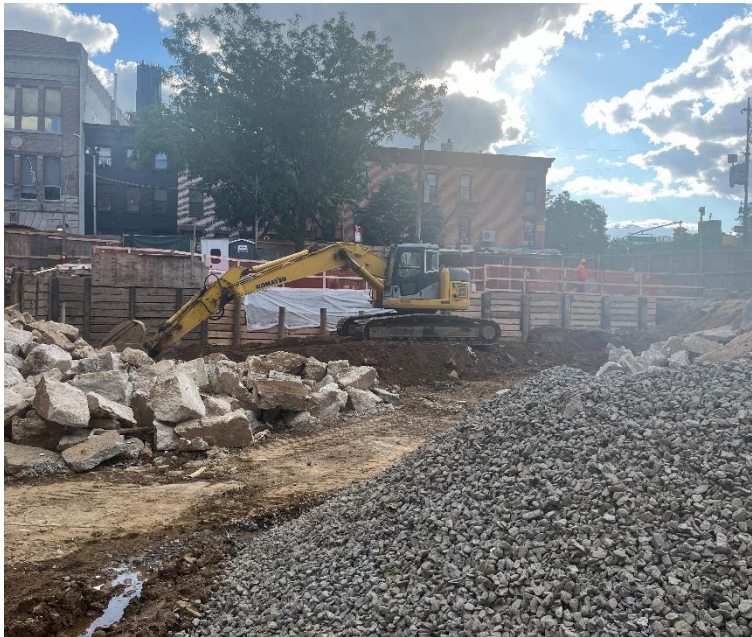
Photo 4: View of site conditions, facing west.

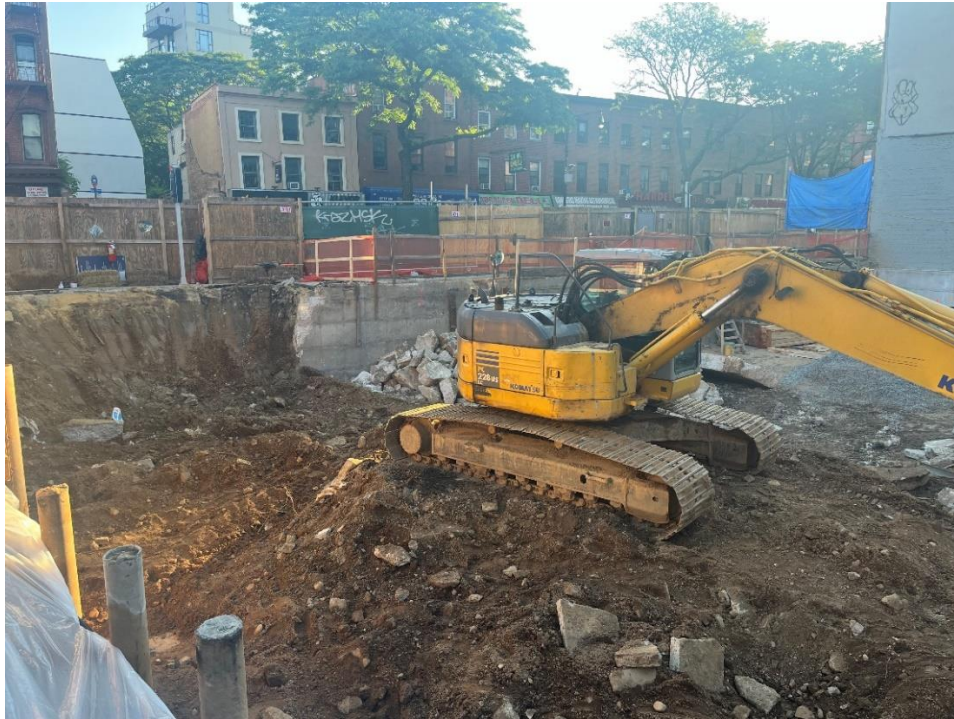
Photo 1: View of site conditions, facing northeast.

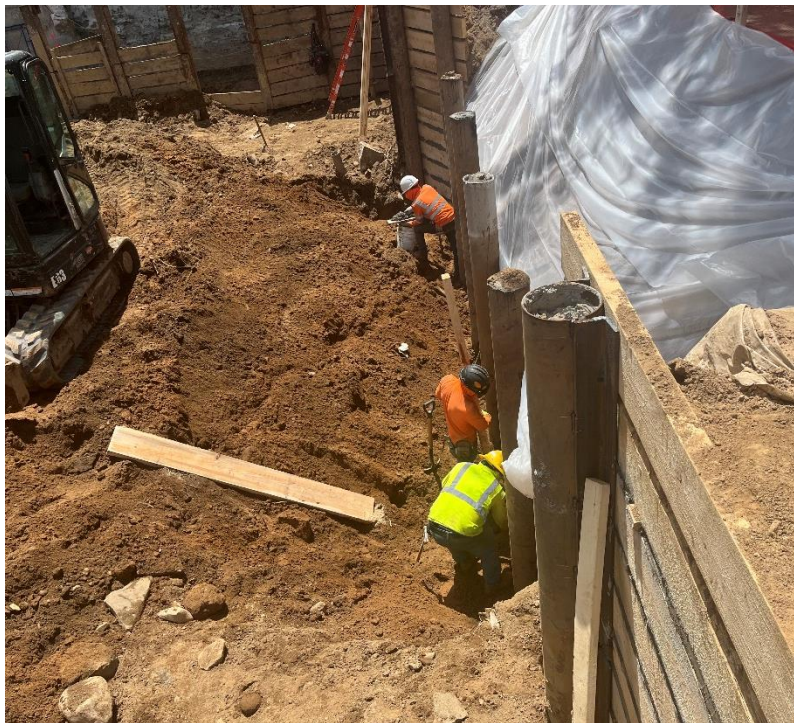
Photo 2: View of lagging along the western portion of site, facing south.

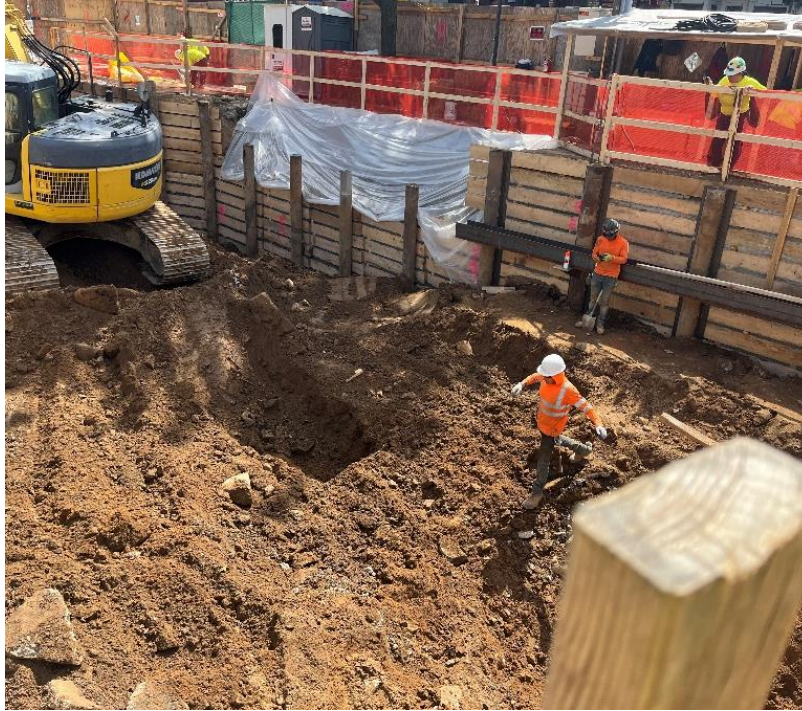
Photo 3: View of the contractor excavating for heel block, facing southwest.

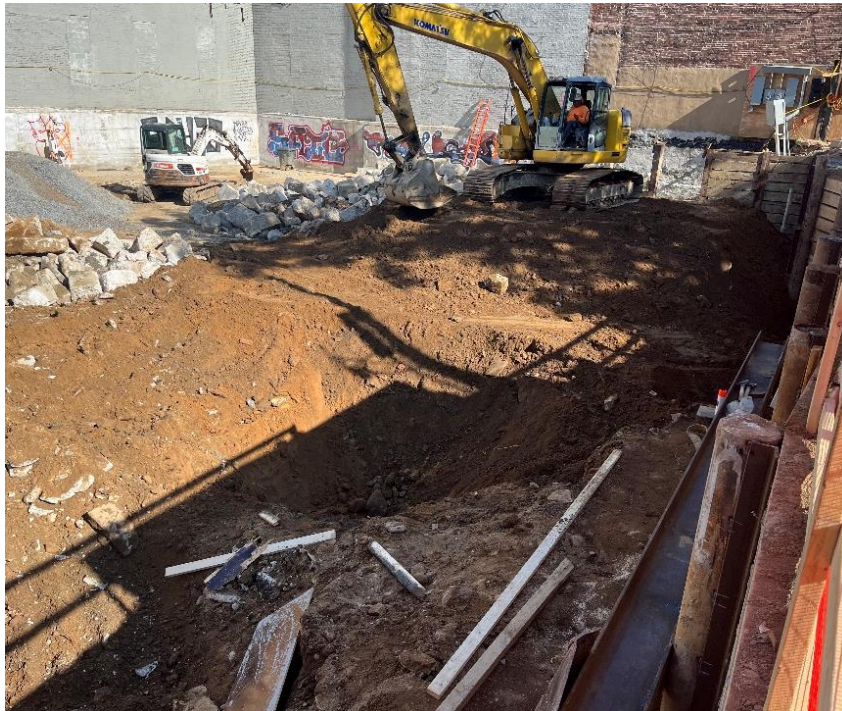
Photo 4: View of site conditions, facing southwest.
