Project	340 Myrtle Ave Site	Report No.	10
BCP Site	BCP Site No. C224340	Date	6/3/2024
Location	340 Myrtle Avenue, Brooklyn, NY	File No.	0210873
Client	340 Myrtle Development LLC	Temperature	L: 65 H:84
Contractor	Haley & Aldrich, Bruklyn Builders,	Wind Direction	WSW to ENE, 4 mph
	Blanco Drilling (Blanco), Raptor		
	Construction (Raptor)		
Weather	Mostly Cloudy	Personnel on Site	Z. Richards
Humidity	80%	Time on Site	6:50 am to 4:30 pm

H & A of New York Engineering and Geology, LLP (Haley & Aldrich) was present to document the implementation of the April 2024 NYSDEC-approved Remedial Action Work Plan (RAWP) prepared by Tenen Environmental, LLC (Tenen) for the 340 Myrtle Ave BCP Site (C224340), located at 340 Myrtle Avenue, Brooklyn, NY. Site Observations are summarized below.

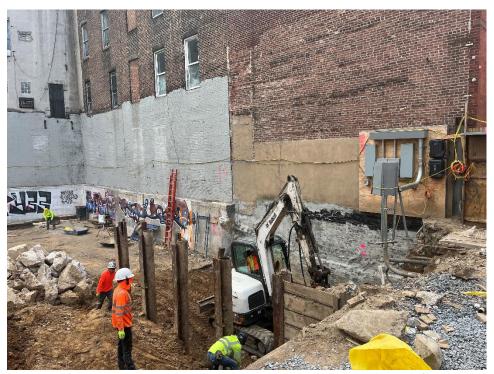
Photo 1: View of CAMP Station 1 and contractor removing existing lagging, facing southeast.

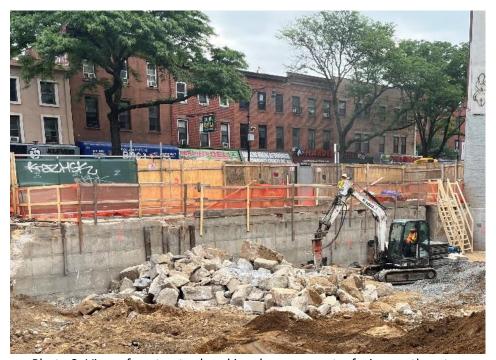
Photo 2: View of contractor breaking down concrete, facing northeast.

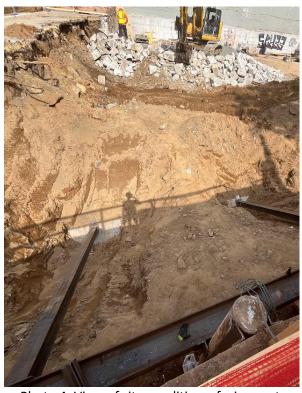
Photo 4: View of site conditions, facing east.

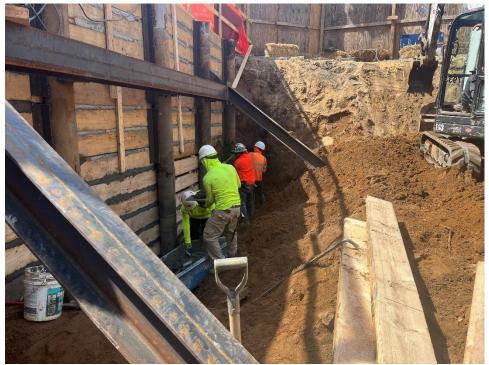
Photo 1: View of contractor installing lagging in western portion of site, facing north.

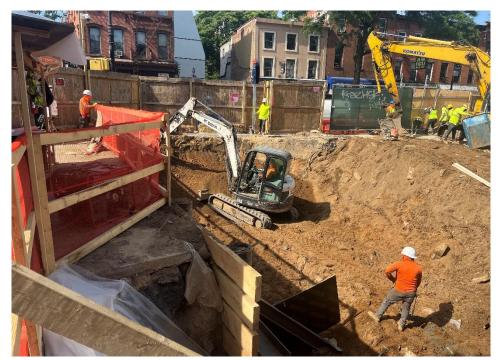
Photo 2: View of contractor excavating in the northwest portion of site, facing north.

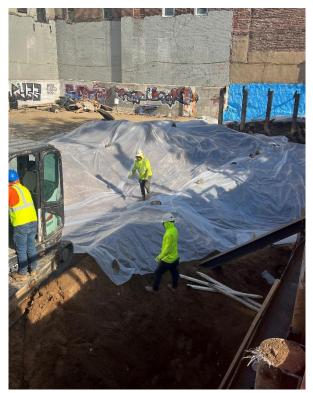
Photo 4: View of site conditions and stockpiled soil covered with poly, facing south.

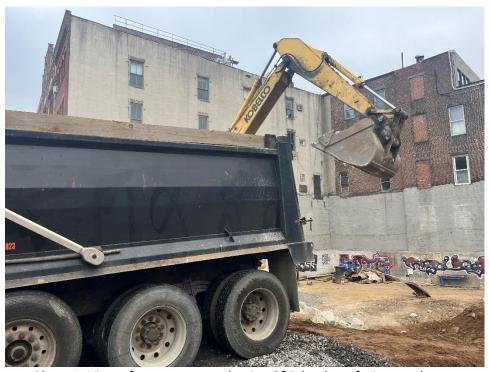
Photo 1: View of contractor conducting C&D loadout, facing southeast.

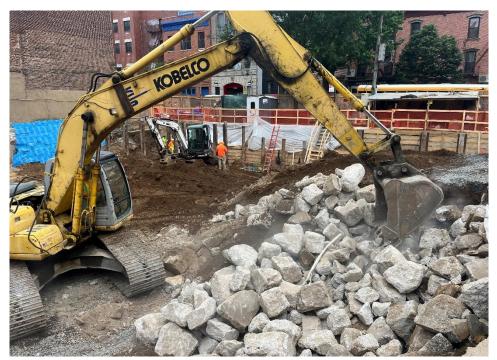
Photo 2: View of Site conditions and stockpiled C&D, facing west.

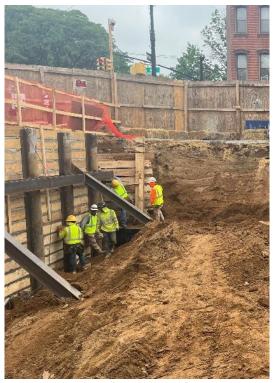
Photo 3: View of SOE work, facing north.

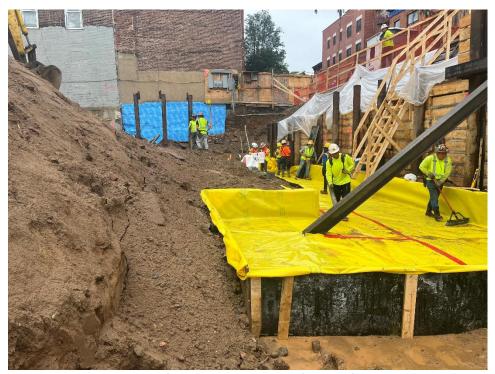
Photo 1: View of contractor preparing footing, facing south.

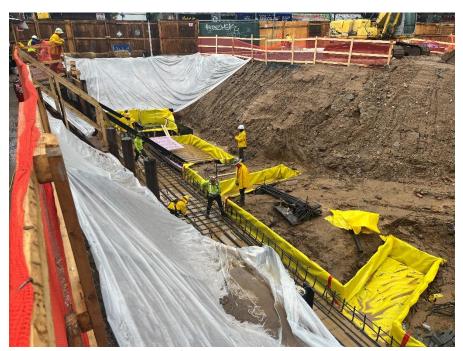
Photo 4: View of site conditions, facing northeast.

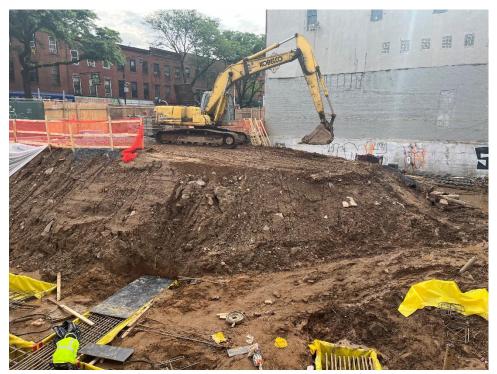
Photo 1: View of contractor creating trucking pad surface, facing east.

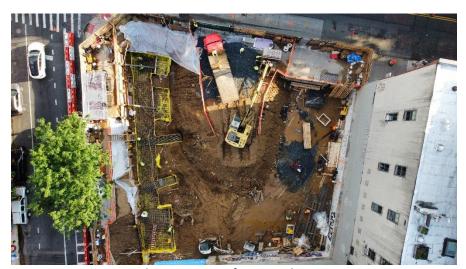
Photo 4: View of site conditions.

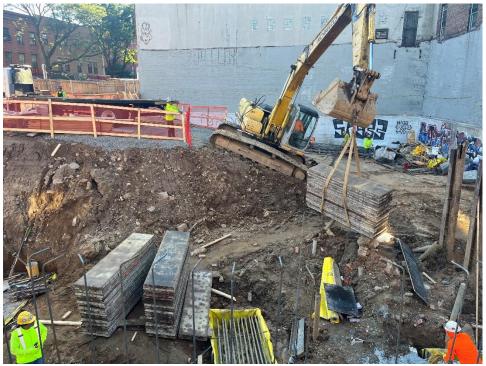
Photo 1: View of Site conditions and contractor delivery of SOE materials, facing east.

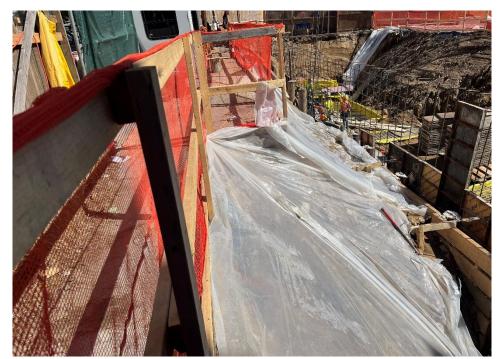
Photo 2: View of contractor preparing foundation elements along western portion of Site, facing north.

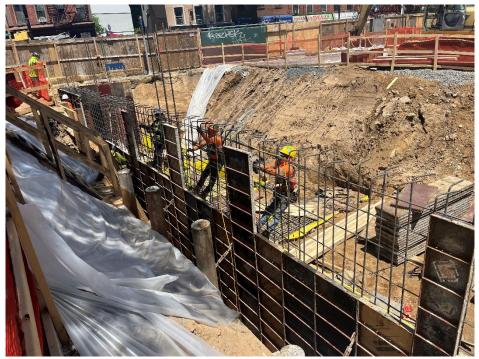
Photo 3: View of contractor preparing foundation elements along western portion of Site, facing northeast.

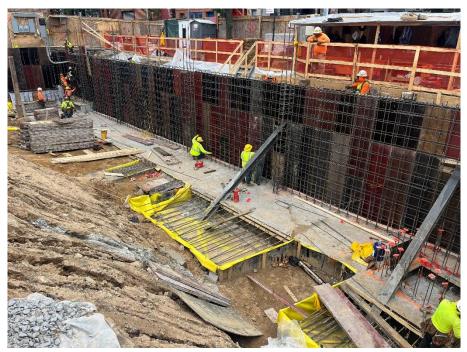
Photo 4: View of Site conditions and contractor installing foundation elements, facing southwest.

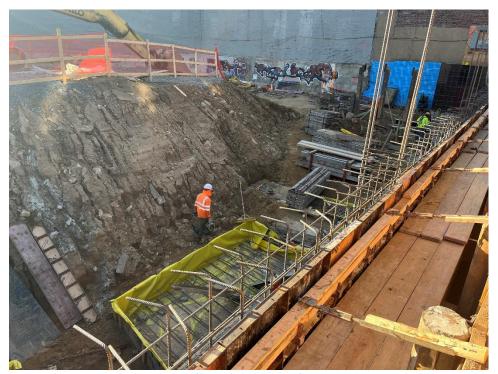
Photo 1: View of Site conditions, facing southeast.

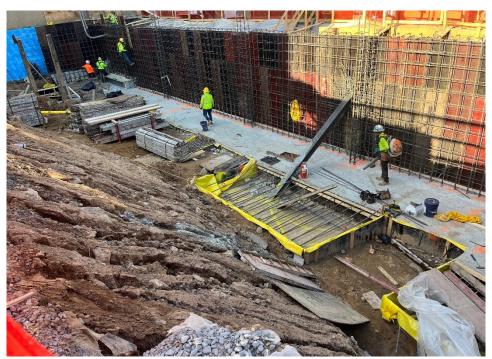
Photo 2: View of contractor preparing foundation elements along western portion of Site, facing southwest.

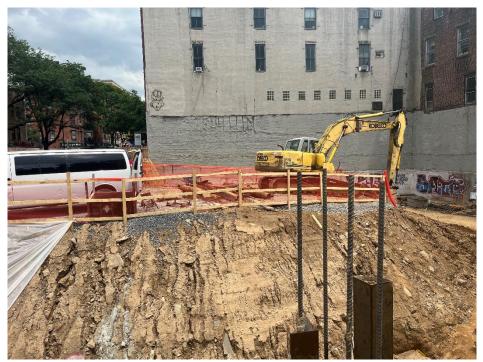
Photo 3: View of contractor removing SOE materials from the Site, facing east.

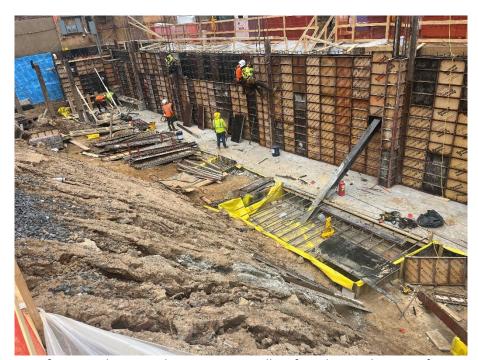
Photo 4: View of Site conditions and contractor installing foundation elements, facing southwest.

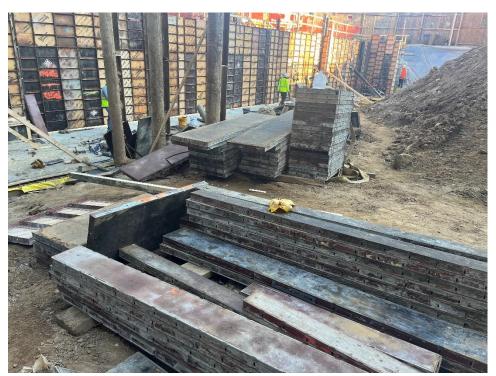
Photo 1: View of Site conditions, facing northwest.

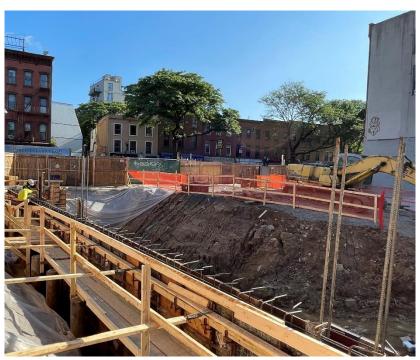
Photo 2: View of Site conditions, facing northeast.

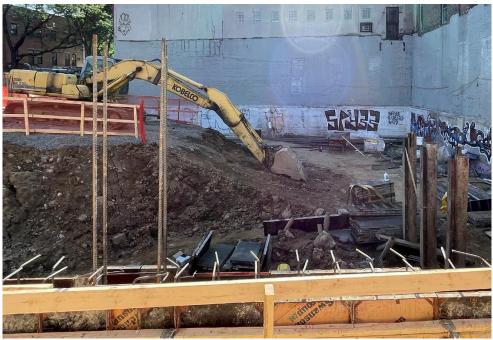
Photo 3: View of CAMP Station 1, CAMP Station 2, and contractor grading ramp, facing east.

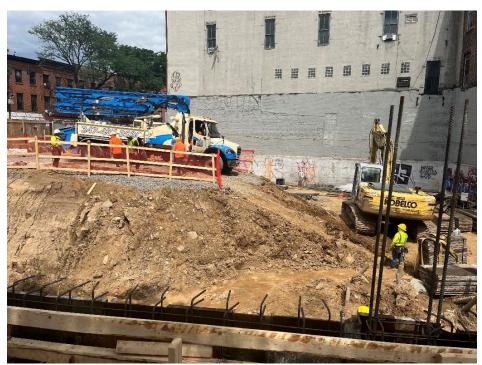
Photo 4: View of Site conditions and contractor prepping for concrete pour of foundation elements, facing east.

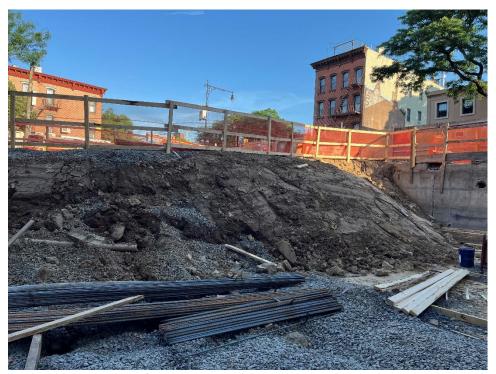
Photo 1: View of stockpiled soil forming loading ramp, facing west.

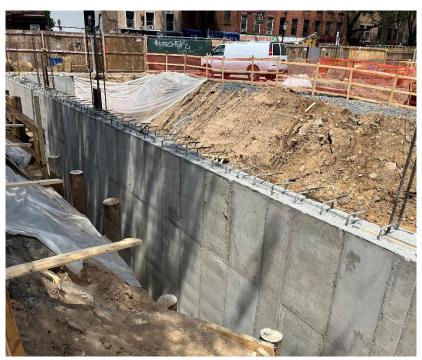
Photo 2: View of Site conditions, facing northeast.

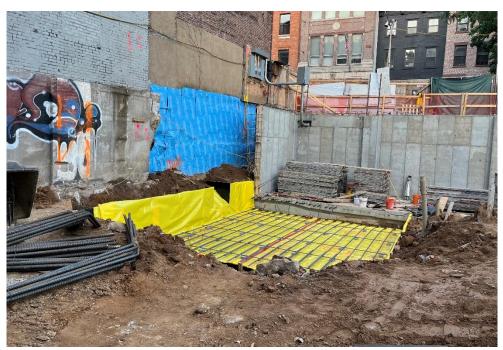
Photo 3: View of installation of building foundation elements and composite cover system, facing southwest.

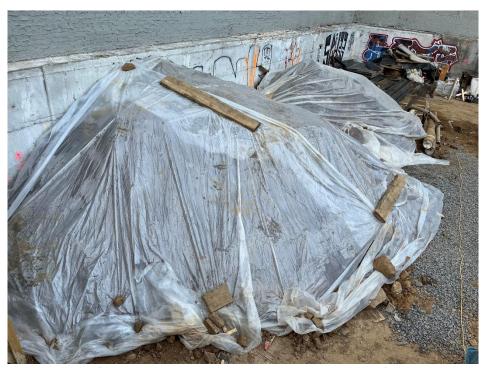
Photo 4: View of Site conditions and segregated stockpiled soil, facing southeast.

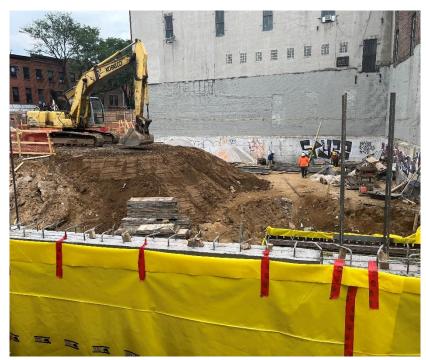
Photo 2: View of Site conditions, facing east.

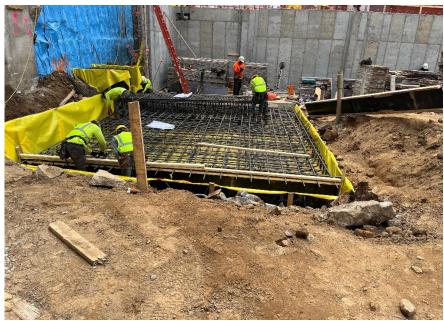
Photo 3: View of installation of building foundation elements and composite cover system, facing west.

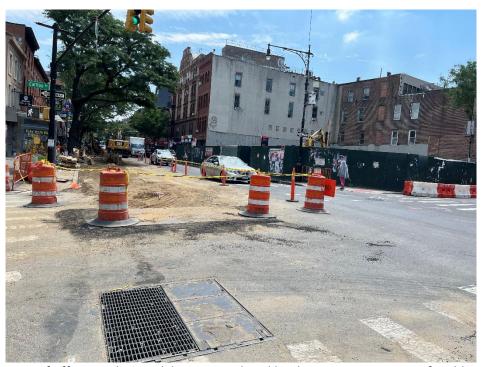
Photo 4: View of off-Site utility work being completed by the NYC Department of Buildings, facing south.

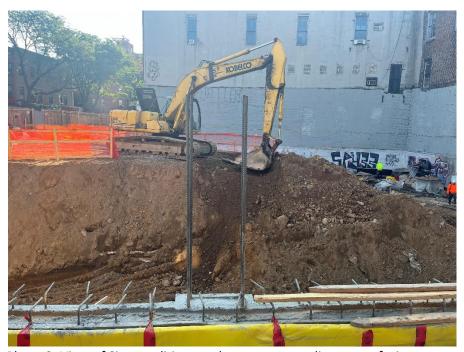
Photo 2: View of Site conditions and contractor grading ramp, facing east.

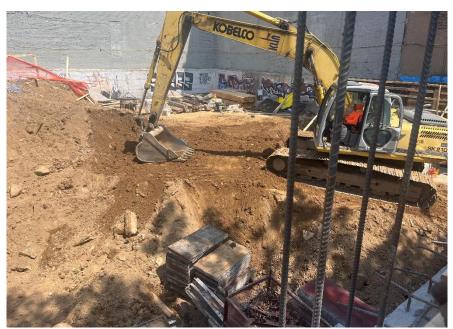
Photo 3: View of contractor grading ramp, facing southeast.

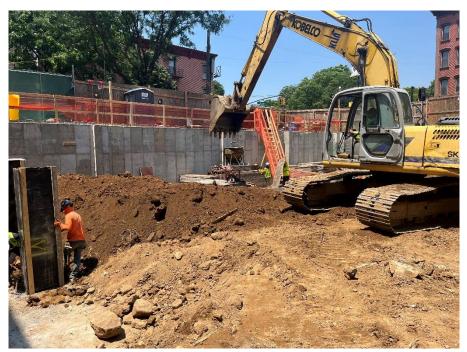
Photo 2: View of Site conditions and contractor grading ramp, facing northwest.

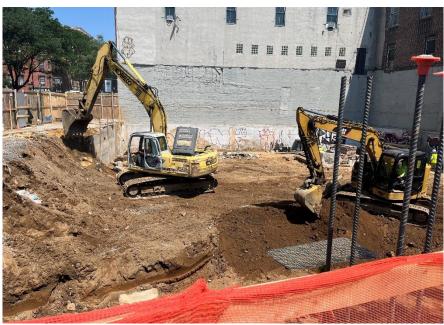
Photo 3: View of Site conditions and contractor excavating northern portion of Site, facing east.

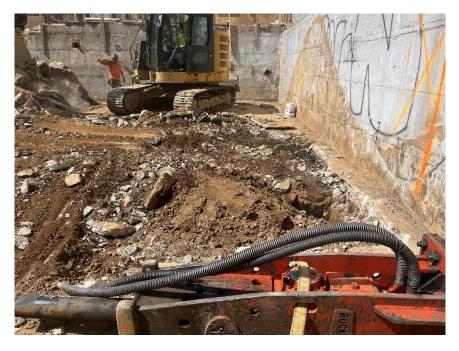
Photo 4: View of contractor breaking concrete slab for SOE prep along eastern portion of Site, facing north.

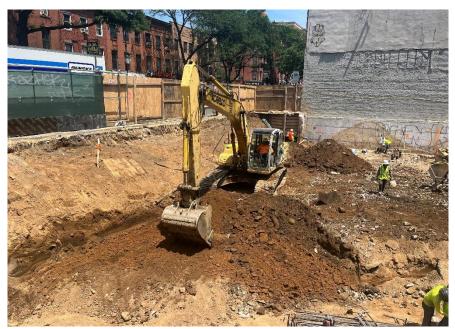
Photo 3: View of Site conditions and contractor excavating northern portion of Site, facing east.

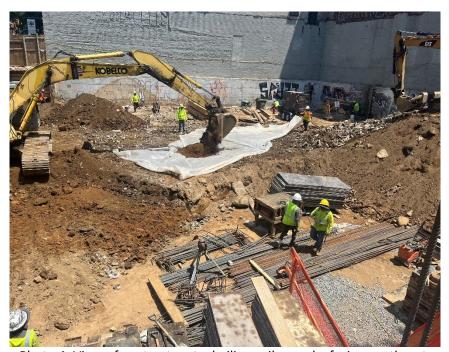
Photo 4: View of contractor stockpiling soil on poly, facing southeast.

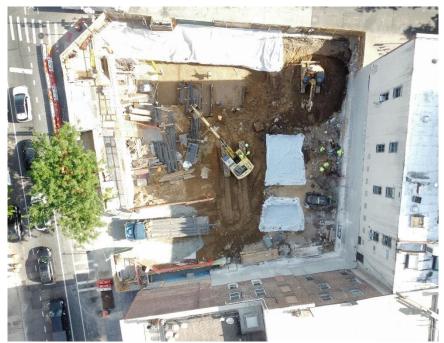
Photo 4: View of site conditions.

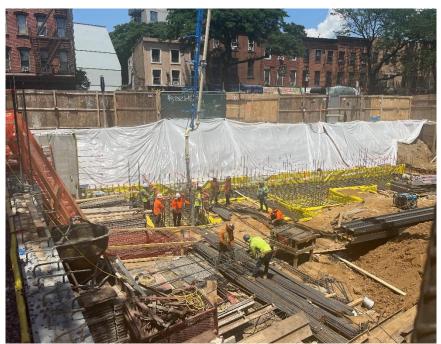
Photo 4: View of Site conditions and contractors installing SOE, facing northeast.

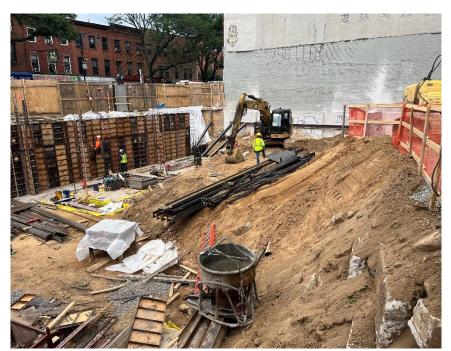
Photo 4: View of Site conditions and contractors installing SOE, facing northeast.

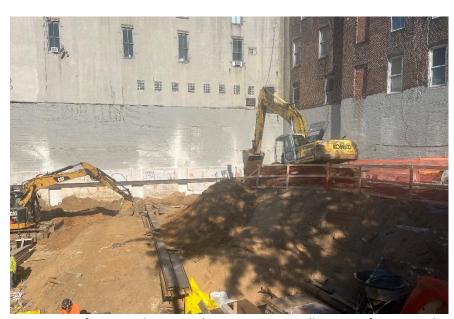
Photo 4: View of Site conditions and contractors installing SOE, facing southeast.

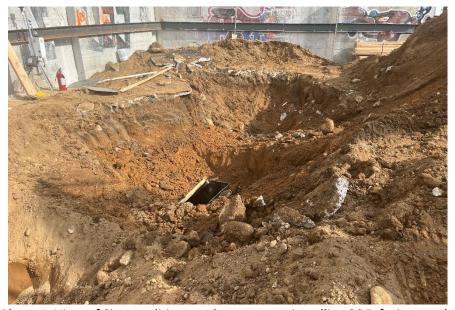
Photo 4: View of Site conditions and contractors installing SOE, facing south.

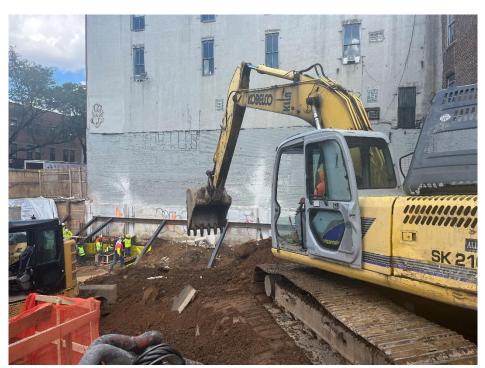
Photo 2: View of contractor preparing for SOE installation, facing east.

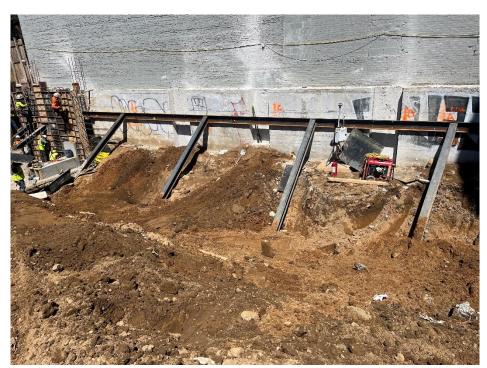
Photo 2: View of contractor preparing for SOE installation along eastern portion of Site, facing east.

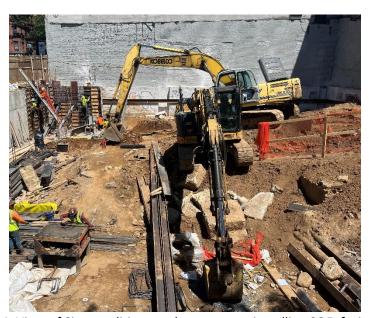
Photo 4: View of Site conditions and contractors installing SOE, facing east.
