CLIENT: Orange Management Inc.	DATE: Wednesday, May 18, 2022
PROJECT No.: 170698601	WEATHER: Partly cloudy, 60-70 °F, Wind: 10-20 mph WNW
PROJECT: Third Street Gowanus	TIME: 06:45 – 18:30
LOCATION: 125 Third Street, Brooklyn, New York	BCP SITE No.: C224346
EQUIPMENT: Soilmeco SM20 Drill Rig Grout Mixer Excavator MiniRAE 3000 Photoionization Detector (3) TSI DustTrak II (2)	PRESENT AT SITE: Langan: Caleb Bogin and Kate Marino, PE Allstate 12: Jaydev Sonani Orange Management Inc.: Andrew Bradfield Sterling Town Equities LLC: Paul Amit Quality Solutions: Woody Brown

Langan was at the site to document soil/fill management and implementation of the November 2021 Soil/Fill Management Plan during initial foundation construction, as required by the New York State Department of Environmental Conservation (NYSDEC) for Brownfield Cleanup Program (BCP) Site No. C224346.

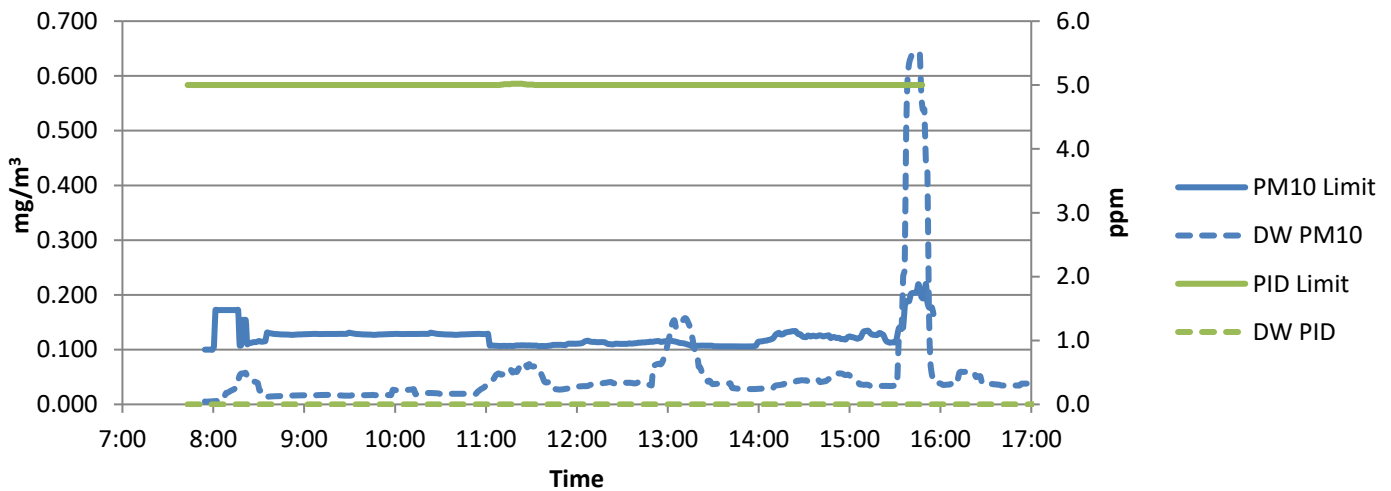
Air Monitoring Data Summary

- Langan conducted continuous air monitoring for volatile organic compounds (VOC) and particulate matter smaller than 10 microns in diameter (PM10) at the upwind and downwind perimeters of the work area during ground-intrusive activities. VOC action levels were not exceeded during the monitoring period. PM10 action levels were exceeded between 13:01 and 13:16, and 15:35 to 15:51 because the downwind station was in close proximity to work area; however, no fugitive dust was observed leaving the work area or migrating off-site. Recorded air monitoring data is presented on the following graph:

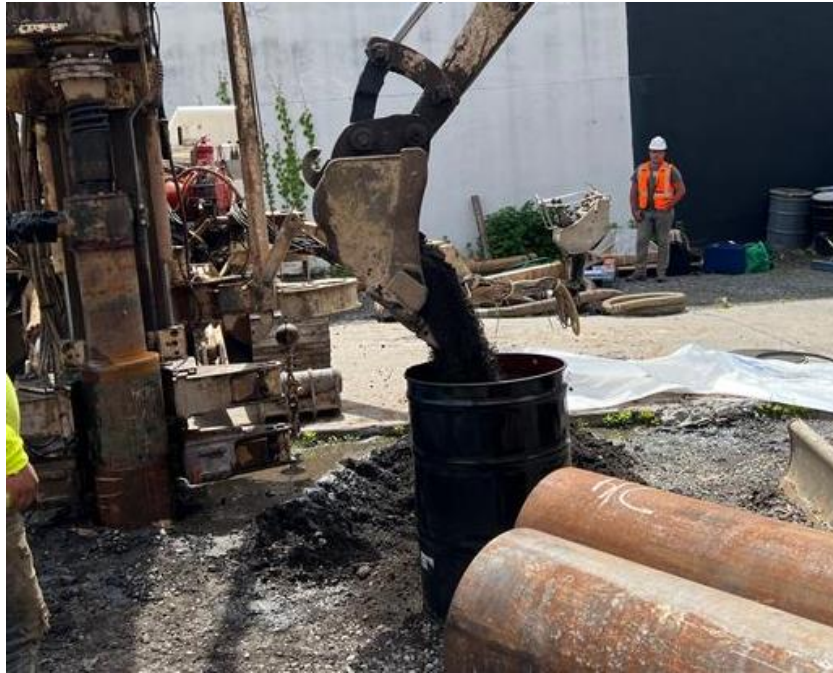
- Allstate 12 excavated an approximately 7-foot by 5-foot area to about 2 feet below grade surface (bgs) in the southern part of the site to create a temporary drilling fluid collection sump. The temporary sump and surrounding area were lined/covered with 20-millimeter-thick polyethylene sheeting. Excavated soil/fill consisted of sand with varying amounts of construction and demolition (C&D) debris and gravel. Visual, olfactory, and photoionization detector (PID) evidence of contamination was not observed. Allstate 12 containerized the soil/fill in three 55-gallon drums that were staged in the southwestern part of the site, pending waste characterization and off-site disposal.

Photo 1: Allstate 12 excavating temporary sump and placing soil/fill into drums (facing east)

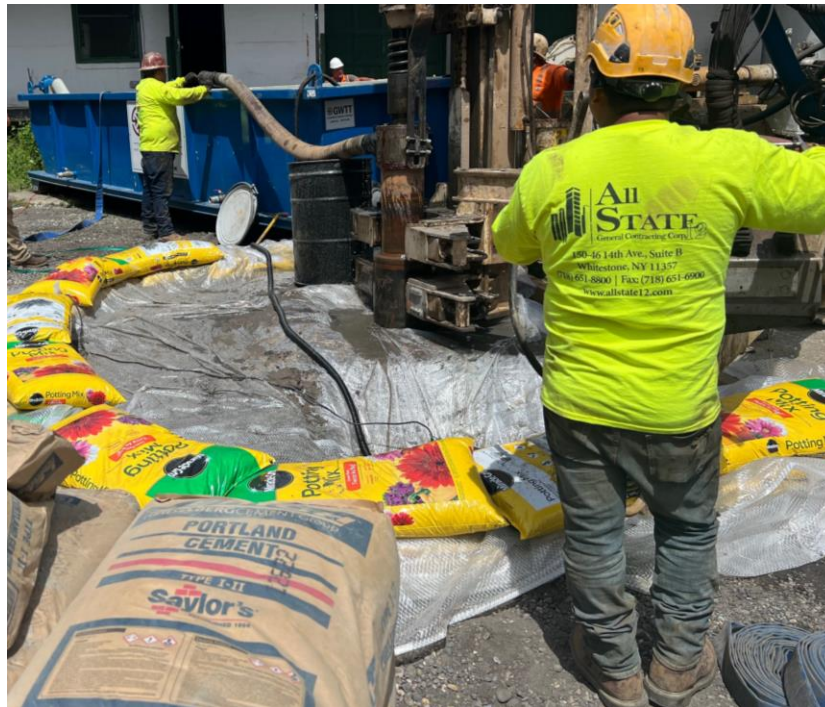
- Municipally-supplied water was used during pile installation and recirculated to facilitate installation of the pile. Excess water generated during pile installation was collected in the sump and pumped into a settling tank in the southern part of the site.

Photo 2: Polyethylene sheeting-lined sump at P-1 and settling tank (facing north)
