PHASE I ENVIRONMENTAL SITE  
ASSESSMENT – JULY 1997

# ENVIRONMENTAL SITE ASSESSMENT

PROPERTY LOCATED AT:  
SOUTHEAST CORNER OF  
FLATLANDS & LOUISIANA AVENUES  
BROOKLYN, NEW YORK

97-494

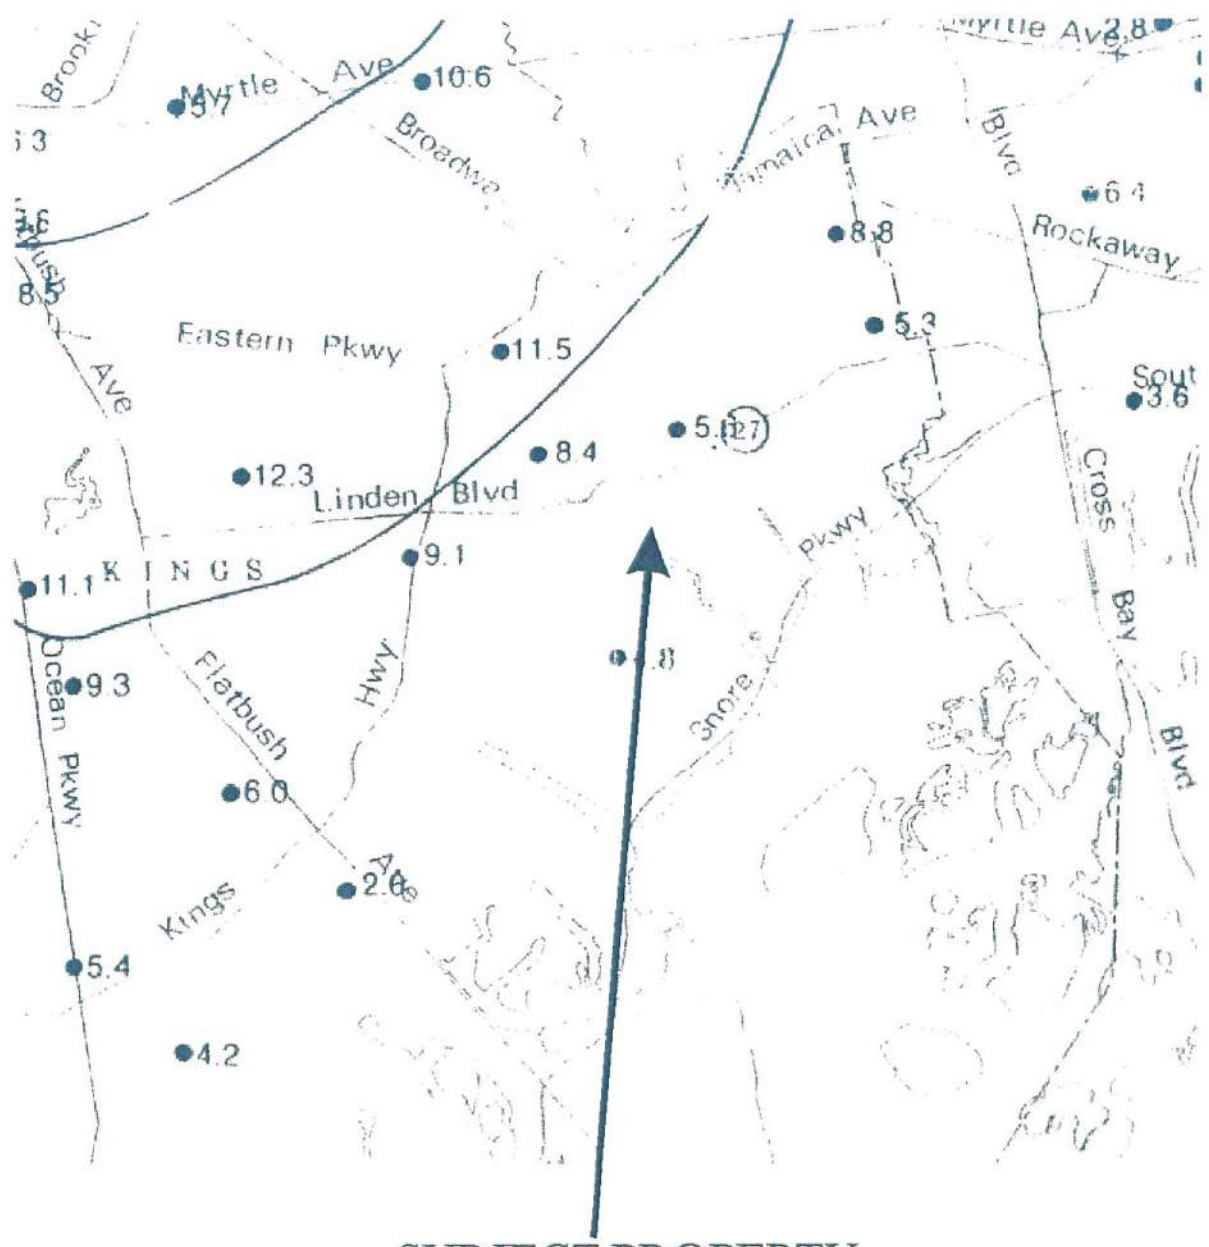
<b>SOIL MECHANICS ENVIRONMENTAL SERVICES</b> <small>3770 MERRICK ROAD SEAFORD, NEW YORK 11783 (516) 221-7500</small>	
	<b>GROUND CONTOUR MAP FIGURE #5 BROOKLYN, N.Y.</b>	
SCALE:	DATE:	JOB #:
N.T.S.	07/16/97	97-494

Information obtained from the **Water Table on Long Island, New York**, prepared by the US Department of the Interior, Geological Survey, indicated an existing depth to ground water of approximately ten to fifteen (10-15) feet below existing grade. This map appears to indicate a southeasterly trending ground water flow component in this area (see Ground Water Contour Map - Figure #5).
