DAILY STATUS REPORT

Langan Project No:	100688803	Project:	12074 Flatlands Avenue p/o Lot 1	Date:	08/07/2024
NYSDEC BCP Site No:	C224353			Time:	06:30 – 18:00

Langan Engineering, Environmental, Surveying, Landscape Architecture and Geology, D.P.C.

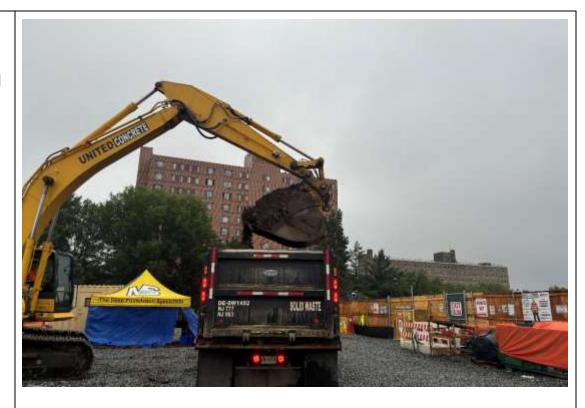
- 3 truckloads of non-hazardous material were removed for off-Site disposal to Clean Earth Philadelphia in Philadelphia, PA.
 - United excavated an approximately 10-foot long by 15-foot-wide area between 6 feet below ground surface (bgs) and 12 feet bgs in disposal grids WC20, WC21, WC26, and WC27. No staining, odors, or elevated PID readings were observed during excavation. All excavated material was loaded for off-Site disposal to Clean Earth Philadelphia in Philadelphia, PA.

Photo 1 – United loading non-hazardous material for off-Site disposal to Clean Earth Philadelphia, facing south.

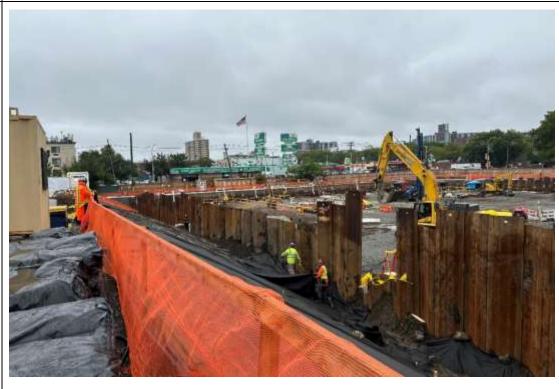
- United placed filter fabric above the exposed soil on the Support of Excavation (SOE) slope for the adjacent Site to the east (BCP Site No. C224290) along the eastern boundary of the Site. The slope has been fully re-covered.

Photo 2 – United placing filter fabric above exposed soil in the eastern portion of the Site, facing north.

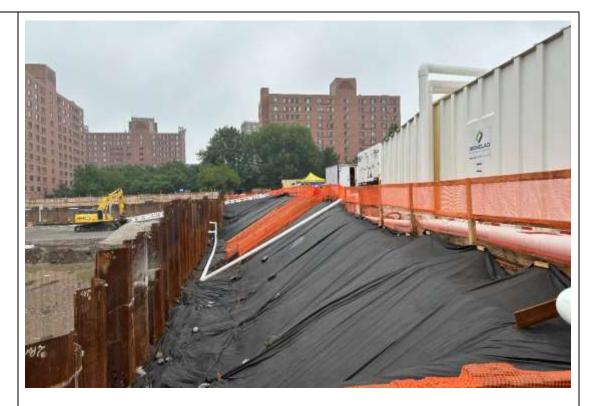
Photo 3 – View of filter fabric above exposed soil in the northeastern portion of the Site, facing south.

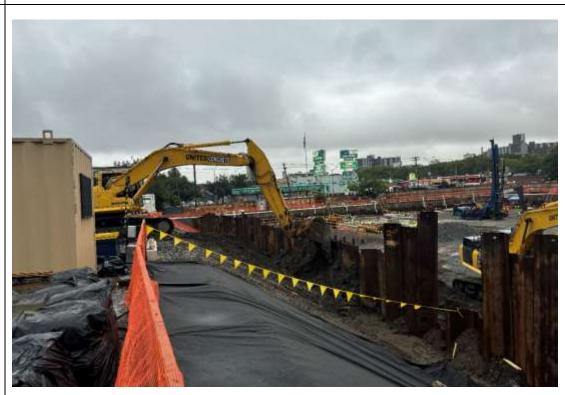
Photo 4 – United excavating material for off-site disposal to Clean Earth Philadelphia in the eastern portion of the site, facing north.
