Project	Bedford Beverly Brownfield Site	Report No.	29
BCP Site	BCP Site No. C224384	Date	11/14/2023
Location	2359 and 2360 Bedford Avenue, Brooklyn, NY	File No.	0205432
Client	Bedford Beverly Acquisitions LLC, Star Demolition (Star), Maman Contracting (Maman), International Concrete	Temperature	40-53 °F
Contractor	Haley & Aldrich	Wind Direction	NW to SE, 14 mph
Weather	Sunny	Personnel on Site	D.Djombalic & E. Nunez
Humidity	74%	Time on Site	6:50am to 3:30pm

Haley & Aldrich of New York (Haley & Aldrich) was present to document implementation of the Remedial Action Work Plan (RAWP) prepared by Haley & Aldrich currently under review by NYSDEC and the NYSDEC-approved Change of Use dated 17 August 2023 to begin support of excavation work. Site observations are summarized below.

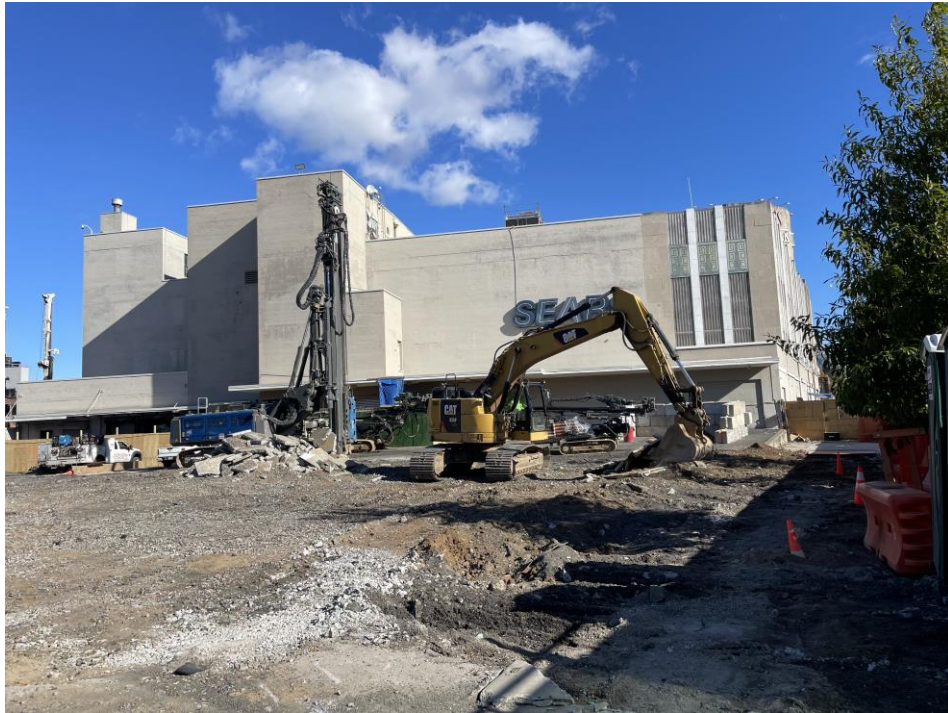
Photo 1: View of asphalt and concrete stripping in Lot 14, facing east.

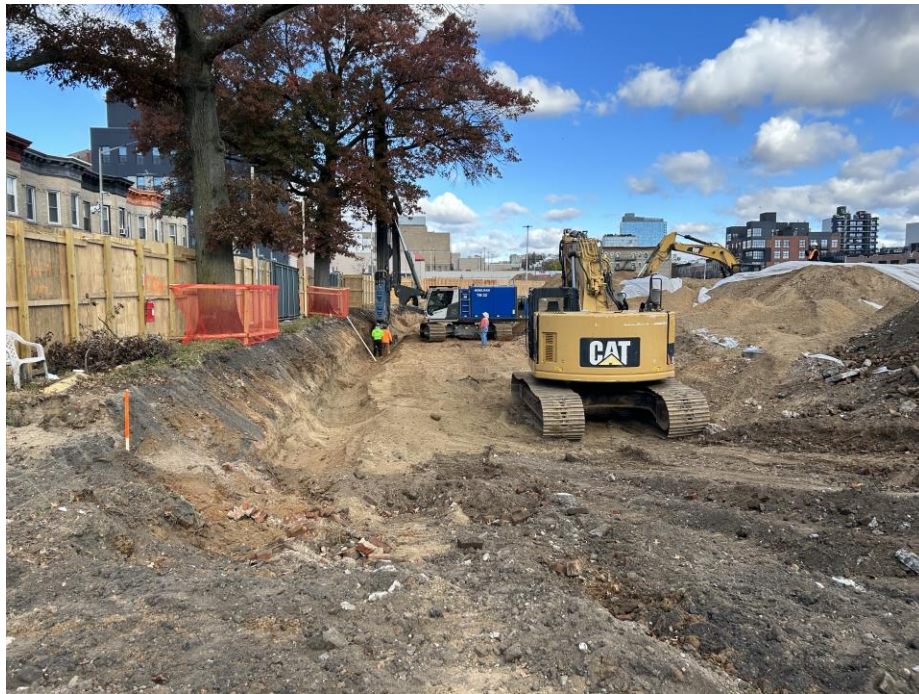
Photo 2: View of H piles and lagging installation in Lot 14, facing north-northwest.
