Project	Bedford Beverly Brownfield Site	Report No.	93
BCP Site	BCP Site No. C224384	Date	02/16/2024
Location	2359 and 2360 Bedford Avenue, Brooklyn, NY	File No.	0205432
Client	Bedford Beverly Acquisitions LLC	Temperature	31-41°F
Contractor	Haley & Aldrich, Maman Contracting (Maman), International Concrete, Cascade Remediation Services (Cascade)	Wind Direction	NW to SE, 16 mph
Weather	Windy	Personnel on Site	D. Djombalic & E. Nunez
Humidity	56%	Time on Site	7:00 am to 3:00 pm

Haley & Aldrich of New York Engineering and Geology, LLP (Haley & Aldrich) was present to document implementation of the January 2024 NYSDEC-approved Remedial Action Work Plan (RAWP) prepared by Haley & Aldrich for the Bedford Beverly BCP Site (C224384), located at 2359 and 2360 Bedford Avenue, Brooklyn, NY. Site observations are summarized below.

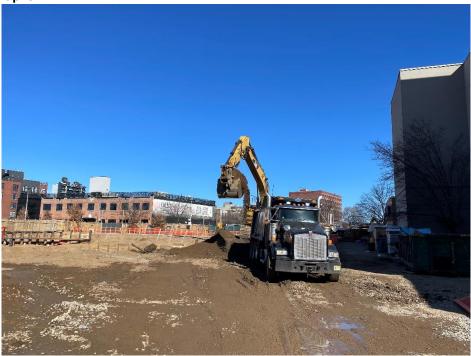
Photo 1: View of contractor loading soil in Lot 14, facing east.

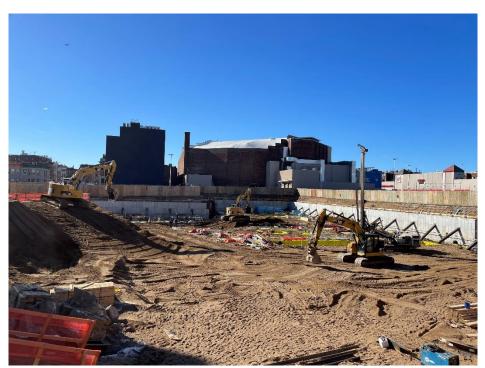
Photo 2: View of site conditions in Lot 14, facing northwest.

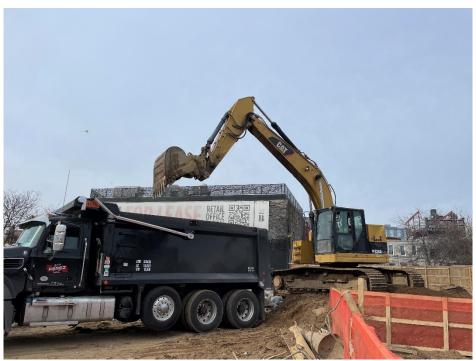
Photo 3: View of contractor loading soil on Lot 53, facing north.

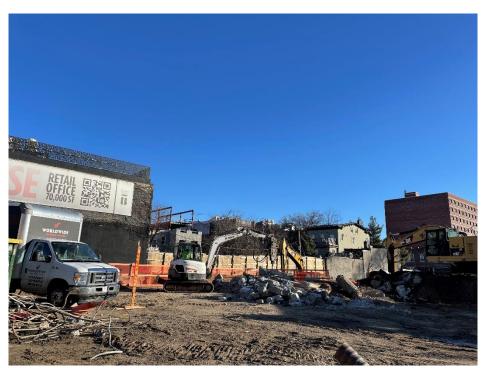
Photo 4: View of contractor breaking C&D on lot 53, facing northeast.
