# DAILY FIELD REPORT

<b>Project</b>	Bedford Beverly Brownfield Site	<b>Report No.</b>	99
<b>BCP Site</b>	BCP Site No. C224384	<b>Date</b>	02/26/2024
<b>Location</b>	2359 and 2360 Bedford Avenue, Brooklyn, NY	<b>File No.</b>	0205432
<b>Client</b>	Bedford Beverly Acquisitions LLC	<b>Temperature</b>	33-52°F
<b>Contractor</b>	Haley & Aldrich, Maman Contracting (Maman), International Concrete	<b>Wind Direction</b>	SW to NE, 6 mph
<b>Weather</b>	Sunny	<b>Personnel on Site</b>	E. Nunez & A. Stewart
<b>Humidity</b>	88%	<b>Time on Site</b>	6:45 am to 3:00 pm

Haley & Aldrich of New York Engineering and Geology, LLP (Haley & Aldrich) was present to document implementation of the January 2024 NYSDEC-approved Remedial Action Work Plan (RAWP) prepared by Haley & Aldrich for the Bedford Beverly BCP Site (C224384), located at 2359 and 2360 Bedford Avenue, Brooklyn, NY. Site observations are summarized below.

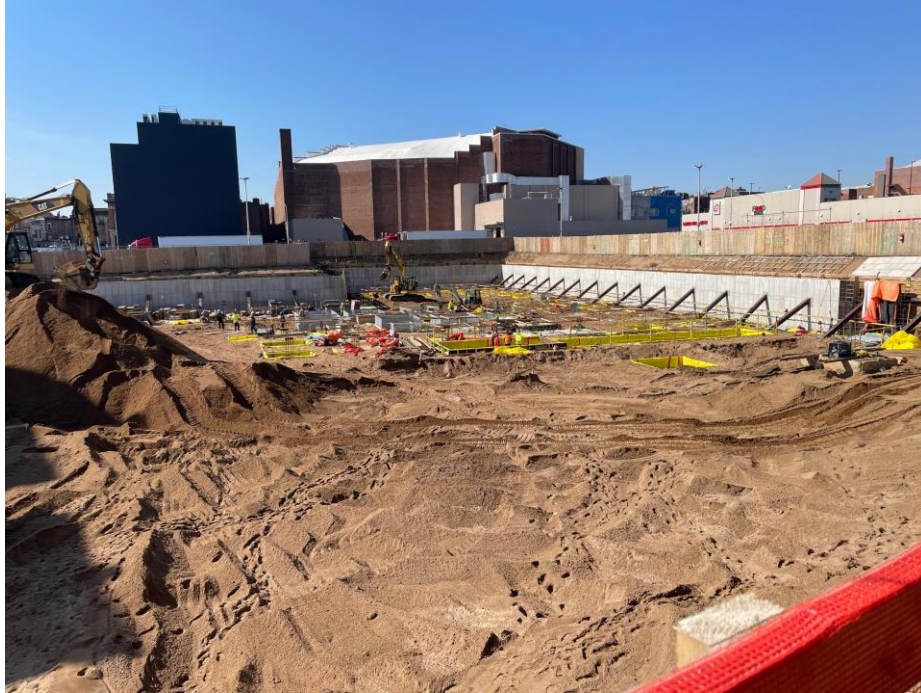
*Photo 1: View of soil conditions Lot 14, facing south.*

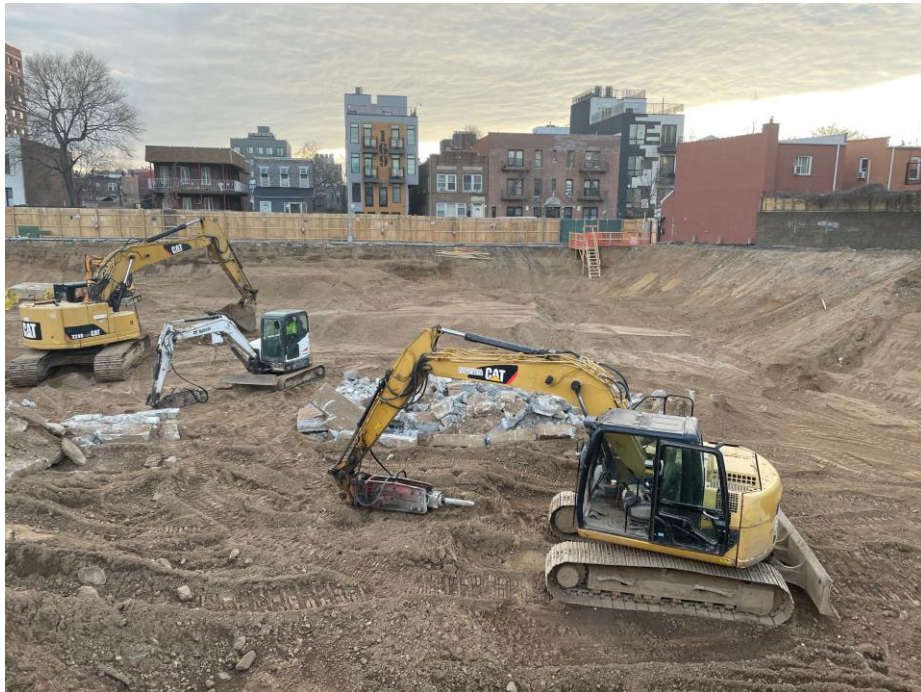
*Photo 2: View of site conditions on Lot 53, facing east.*

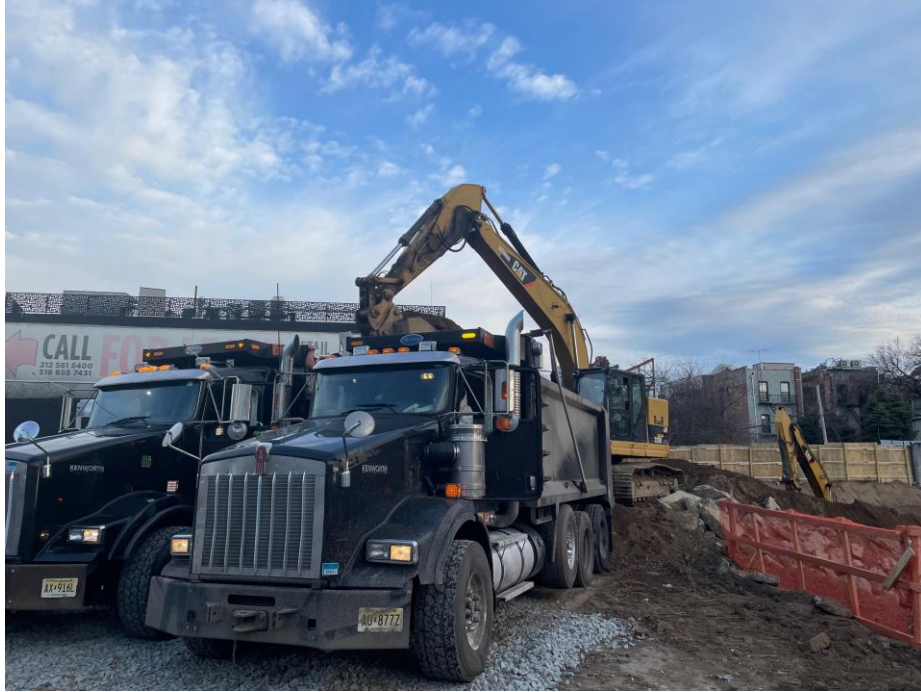
*Photo 3: View of soil loadout on Lot 53, facing northeast.*

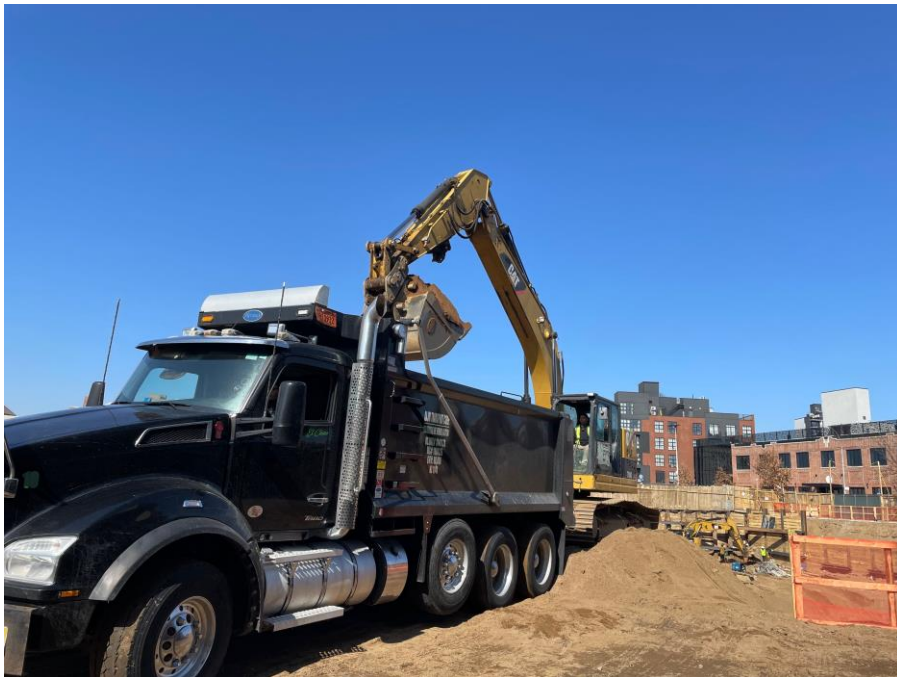
*Photo 4: View of soil loadout on Lot 14, facing northwest.*
