DAILY FIELD REPORT

Project	Bedford Beverly Brownfield Site	Report No.	106
BCP Site	BCP Site No. C224384	Date	03/06/2024
Location	2359 and 2360 Bedford Avenue, Brooklyn, NY	File No.	0205432
Client	Bedford Beverly Acquisitions LLC	Temperature	43-53°F
Contractor	Haley & Aldrich, Maman Contracting (Maman), International Concrete	Wind Direction	NE to SW, 13 mph
Weather	Cloudy	Personnel on Site	E. Nunez & A. Stewart
Humidity	87%	Time on Site	6:45 am to 2:30 pm

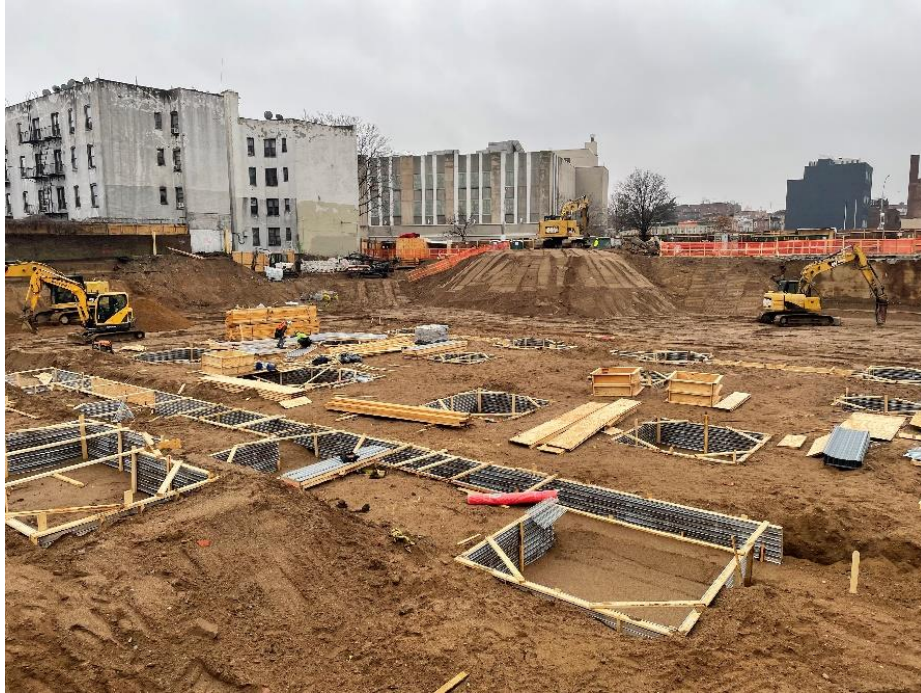
Photo 1: View of site conditions in Lot 53, facing southwest.

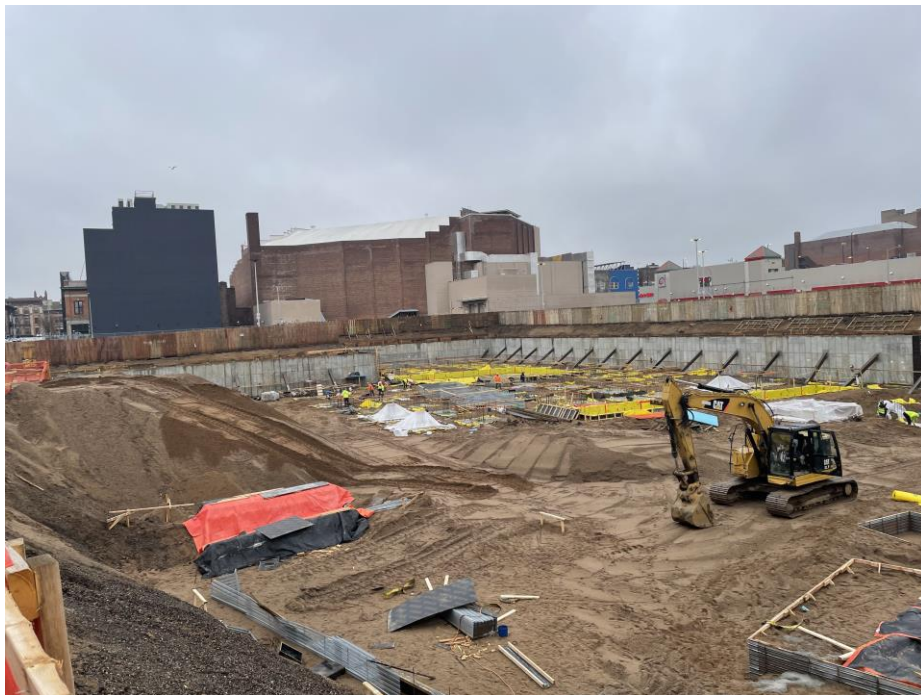
Photo 2: View of site conditions in Lot 14, facing northwest.

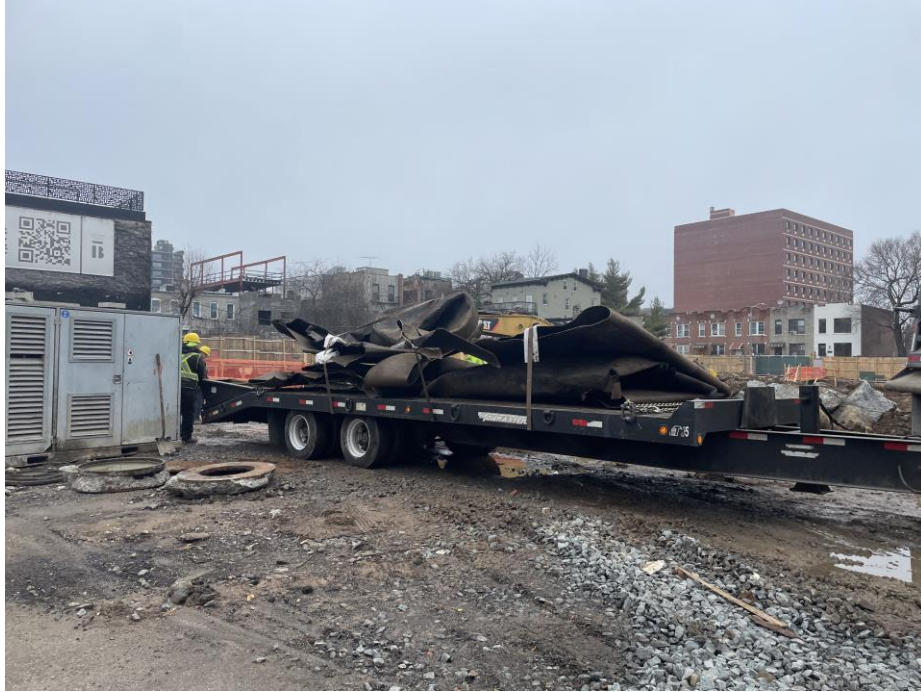
Photo 3: View of Eastern Environmental exporting USTs on Lot 14, facing northeast.
