Project	Bedford Beverly Brownfield Site	Report No.	123
BCP Site	BCP Site No. C224384	Date	03/29/2024
Location	2359 and 2360 Bedford Avenue,	File No.	0205432
	Brooklyn, NY		
Client	Bedford Beverly Acquisitions LLC	Temperature	41-55°F
Contractor	Haley & Aldrich, Maman	Wind	NW to SE, 13 mph
	Contracting (Maman),	Direction	
	International Concrete		
Weather	Cloudy	Personnel on	E. Nunez
		Site	
l l	F00/	Time on Cite	C.45 are to 1.00 per
Humidity	58%	Time on Site	6:45 am to 1:00 pm

Haley & Aldrich of New York Engineering and Geology, LLP (Haley & Aldrich) was present to document implementation of the January 2024 NYSDEC-approved Remedial Action Work Plan (RAWP) prepared by Haley & Aldrich for the Bedford Beverly BCP Site (C224384), located at 2359 and 2360 Bedford Avenue, Brooklyn, NY. Site observations are summarized below.

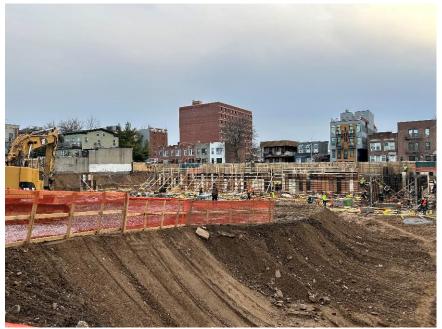
Photo 1: View of site conditions in Lot 53, facing east.

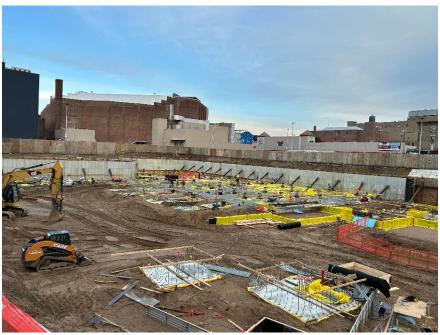
Photo 2: View of site conditions in Lot 14, facing northwest.
