Project	Bedford Beverly Brownfield Site	Report No.	196
BCP Site	BCP Site No. C224384	Date	07/29/2024
Location	2359 and 2360 Bedford Avenue, Brooklyn, NY	File No.	0205432
Client	Bedford Beverly Acquisitions LLC	Temperature	69-84 °F
Contractor	Haley & Aldrich, Maman Contracting (Maman), International Concrete	Wind Direction	S to N, 8 mph
Weather	Cloudy	Personnel on Site	E. Nunez
Humidity	78%	Time on Site	7:30am to 2:30pm

Haley & Aldrich of New York Engineering and Geology, LLP (Haley & Aldrich) was present to document implementation of the January 2024 NYSDEC-approved Remedial Action Work Plan (RAWP) prepared by Haley & Aldrich for the Bedford Beverly BCP Site (C224384), located at 2359 and 2360 Bedford Avenue, Brooklyn, NY. Site observations are summarized below.

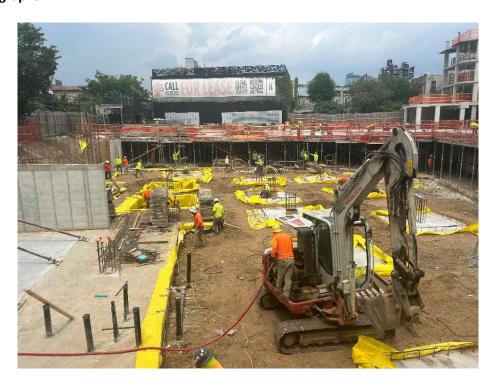
Photo 1: View of footing preparation in Lot 53, facing north.

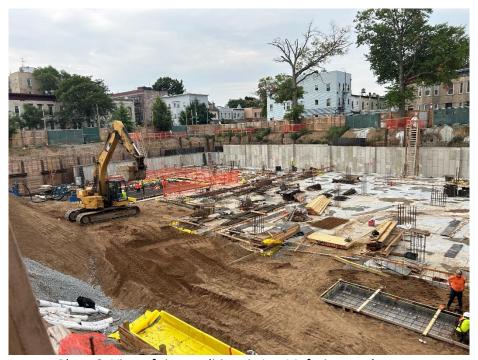
Photo 2: View of site conditions in Lot 14, facing southwest.
