Project	Bedford Beverly Brownfield Site	Report No.	197
BCP Site	BCP Site No. C224384	Date	07/30/2024
Location	2359 and 2360 Bedford Avenue, Brooklyn, NY	File No.	0205432
Client	Bedford Beverly Acquisitions LLC	Temperature	77-87 °F
Contractor	Haley & Aldrich, Maman Contracting (Maman), International Concrete	Wind Direction	S to N, 9 mph
Weather	Sunny	Personnel on Site	C. Jackson
Humidity	80%	Time on Site	8:25am to 5:45pm

Haley & Aldrich of New York Engineering and Geology, LLP (Haley & Aldrich) was present to document implementation of the January 2024 NYSDEC-approved Remedial Action Work Plan (RAWP) prepared by Haley & Aldrich for the Bedford Beverly BCP Site (C224384), located at 2359 and 2360 Bedford Avenue, Brooklyn, NY. Site observations are summarized below.

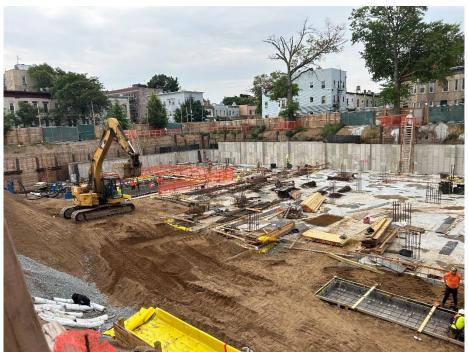
Photo 1: View of footing preparation in Lot 53, facing east.
