Project	Bedford Beverly Brownfield Site	Report No.	201
BCP Site	BCP Site No. C224384	Date	08/05/2024
Location	2359 and 2360 Bedford Avenue,	File No.	0205432
	Brooklyn, NY		
Client	Bedford Beverly Acquisitions LLC	Temperature	73-88°F
Contractor	Haley & Aldrich, Maman	Wind	S to N, 7 mph
	Contracting (Maman),	Direction	
	International Concrete		
Weather	Sunny	Personnel on	E. Nunez
		Site	
Humidity.	54%	Time on Site	7:20 am to 2:20nm
Humidity	34%	Time on Site	7:30 am to 2:30pm

Haley & Aldrich of New York Engineering and Geology, LLP (Haley & Aldrich) was present to document implementation of the January 2024 NYSDEC-approved Remedial Action Work Plan (RAWP) prepared by Haley & Aldrich for the Bedford Beverly BCP Site (C224384), located at 2359 and 2360 Bedford Avenue, Brooklyn, NY. Site observations are summarized below.

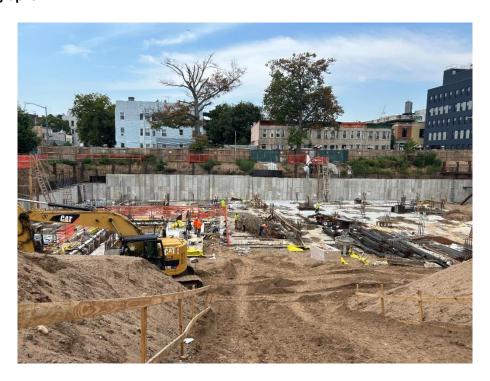
Photo 1: View of site conditions in Lot 14, facing west.

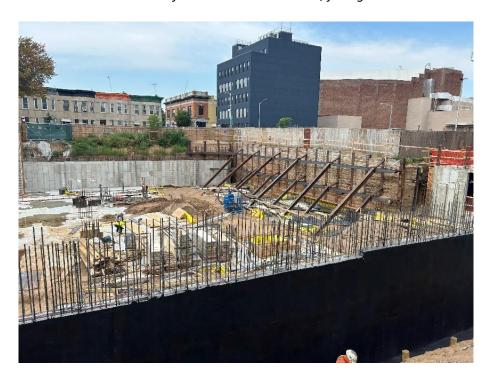
Photo 2: View of site conditions in Lot 14, facing west.
