Project	Bedford Beverly Brownfield Site	Report No.	203
BCP Site	BCP Site No. C224384	Date	08/07/2024
Location	2359 and 2360 Bedford Avenue,	File No.	0205432
	Brooklyn, NY		
Client	Bedford Beverly Acquisitions LLC	Temperature	69-74°F
Contractor	Haley & Aldrich, Maman	Wind	NE to SW, 10 mph
	Contracting (Maman),	Direction	
	International Concrete		
Weather	Rainy	Personnel on	E. Nunez
		Site	
l la consi elita e	0.00/	Time on Cite	7:00 am to 3:45 am
Humidity	86%	Time on Site	7:00 am to 2:45pm

Haley & Aldrich of New York Engineering and Geology, LLP (Haley & Aldrich) was present to document implementation of the January 2024 NYSDEC-approved Remedial Action Work Plan (RAWP) prepared by Haley & Aldrich for the Bedford Beverly BCP Site (C224384), located at 2359 and 2360 Bedford Avenue, Brooklyn, NY. Site observations are summarized below.

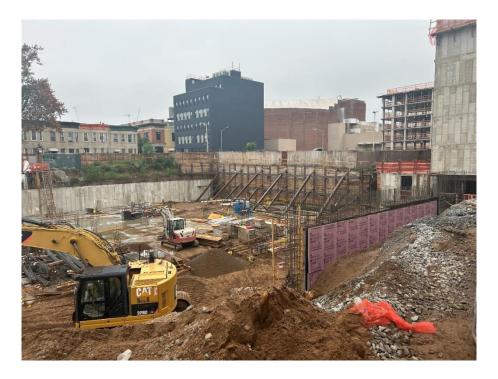
Photo 1: View of site conditions in Lot 14, facing northwest.

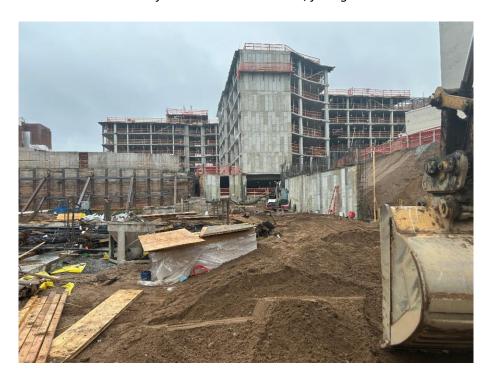
Photo 2: View of site conditions in Lot 14, facing north.
