0			
Project	Bedford Beverly Brownfield Site	Report No.	210
BCP Site	BCP Site No. C224384	Date	08/19/2024
Location	2359 and 2360 Bedford Avenue,	File No.	0205432
	Brooklyn, NY		
Client	Bedford Beverly Acquisitions LLC	Temperature	69-83 °F
Contractor	Haley & Aldrich, Maman	Wind	NW to SE, 5 mph
	Contracting (Maman),	Direction	
	International Concrete		
Weather	Cloudy	Personnel on	E. Nunez
		Site	
	0.00/	Time on Cite	8:00am to 2:45 am
Humidity	88%	Time on Site	8:00am to 2:45pm

Haley & Aldrich of New York Engineering and Geology, LLP (Haley & Aldrich) was present to document implementation of the January 2024 NYSDEC-approved Remedial Action Work Plan (RAWP) prepared by Haley & Aldrich for the Bedford Beverly BCP Site (C224384), located at 2359 and 2360 Bedford Avenue, Brooklyn, NY. Site observations are summarized below.

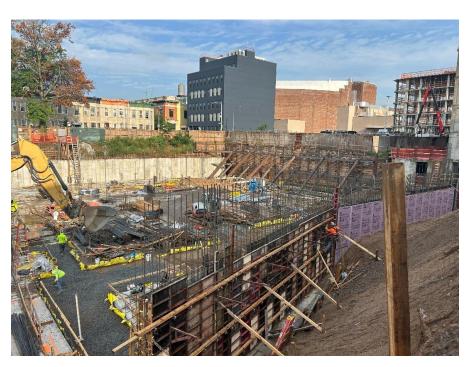
Photo 1: View of site conditions in Lot 14, facing northwest.

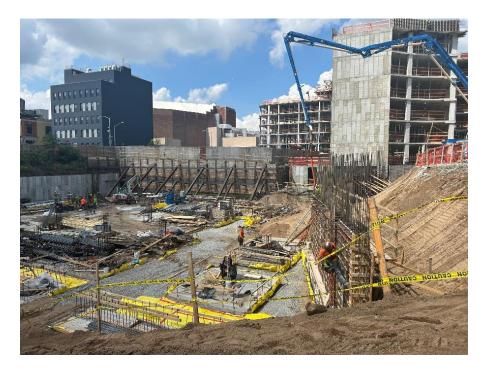
Photo 2: View of site conditions in Lot 14, facing northwest.
