Project	Bedford Beverly Brownfield Site	Report No.	211
BCP Site	BCP Site No. C224384	Date	08/20/2024
Location	2359 and 2360 Bedford Avenue,	File No.	0205432
	Brooklyn, NY		
Client	Bedford Beverly Acquisitions LLC	Temperature	62-74 °F
Contractor	Haley & Aldrich, Maman	Wind	NW to SE, 11 mph
	Contracting (Maman),	Direction	
	International Concrete		
Weather	Cloudy	Personnel on	E. Nunez
		Site	
11	720/	Times on Cite	8:00am ta 2:00mm
Humidity	72%	Time on Site	8:00am to 3:00pm

Haley & Aldrich of New York Engineering and Geology, LLP (Haley & Aldrich) was present to document implementation of the January 2024 NYSDEC-approved Remedial Action Work Plan (RAWP) prepared by Haley & Aldrich for the Bedford Beverly BCP Site (C224384), located at 2359 and 2360 Bedford Avenue, Brooklyn, NY. Site observations are summarized below.

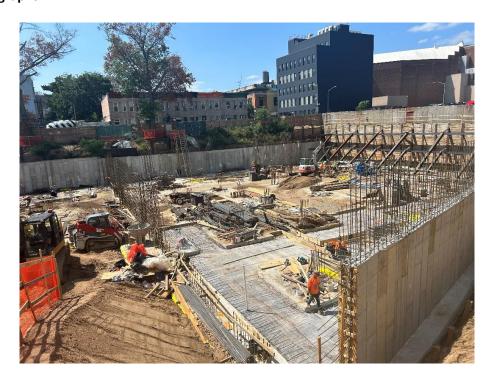
Photo 1: View of site conditions in Lot 14, facing northwest.

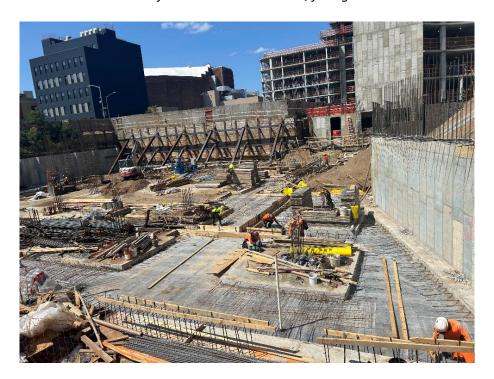
Photo 2: View of site conditions in Lot 14, facing north.
