Project	Bedford Beverly Brownfield Site	Report No.	215
BCP Site	BCP Site No. C224384	Date	08/26/2024
Location	2359 and 2360 Bedford Avenue,	File No.	0205432
	Brooklyn, NY		
Client	Bedford Beverly Acquisitions LLC	Temperature	68-84 °F
Contractor	Haley & Aldrich, Maman	Wind	NW to SE, 4 mph
	Contracting (Maman),	Direction	
	International Concrete		
Weather	Sunny	Personnel on	E. Nunez
		Site	
Humidity	71%	Time on Site	8:00am to 3:00am
numarty	/170	Time on Site	8:00am to 3:00pm

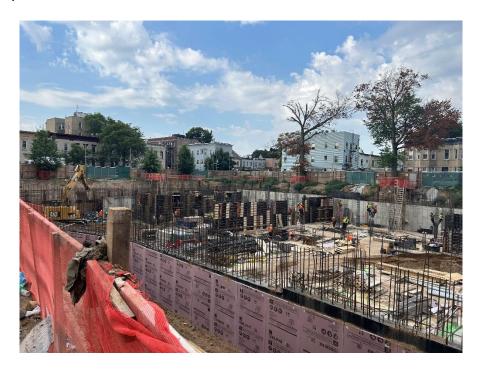
Photo 1: View of site conditions in Lot 14, facing northwest.

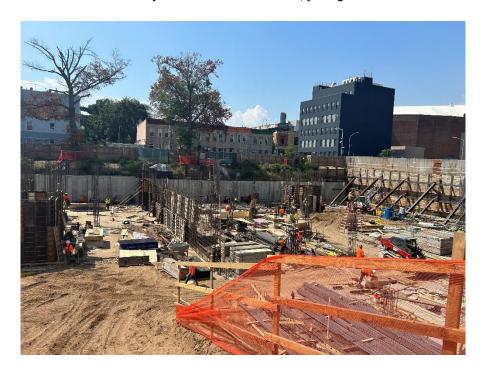
Photo 2: View of site conditions in Lot 14, facing northwest.
