Project	Bedford Beverly Brownfield Site	Report No.	238
BCP Site	BCP Site No. C224384	Date	09/16/2024
Location	2359 and 2360 Bedford Avenue,	File No.	0205432
	Brooklyn, NY		
Client	Bedford Beverly Acquisitions LLC	Temperature	59-77 °F
Contractor	Haley & Aldrich, Maman	Wind	NE to SW, 8 mph
	Contracting (Maman),	Direction	
	International Concrete		
Weather	Sunny	Personnel on	E. Nunez
		Site	
Humidity	79%	Time on Site	6:20am to 2:20nm
number	1370	Time on Site	6:30am to 2:30pm

Haley & Aldrich of New York Engineering and Geology, LLP (Haley & Aldrich) was present to document implementation of the January 2024 NYSDEC-approved Remedial Action Work Plan (RAWP) prepared by Haley & Aldrich for the Bedford Beverly BCP Site (C224384), located at 2359 and 2360 Bedford Avenue, Brooklyn, NY. Site observations are summarized below.

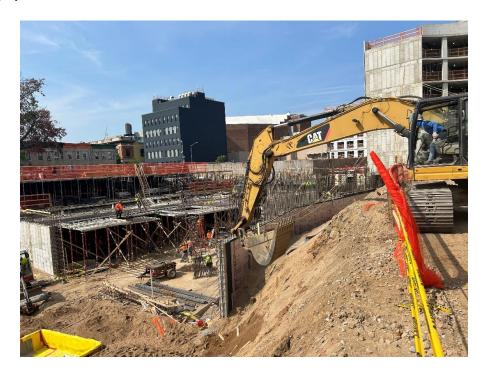
Photo 1: View of site conditions in Lot 14, facing northwest.

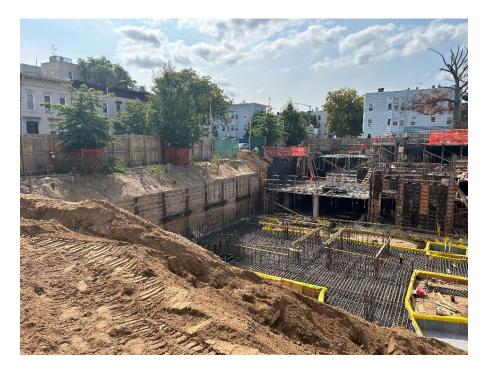
Photo 2: View of site conditions in Lot 14, facing southwest.
