PHASE I ENVIRONMENTAL SITE ASSESSMENT REPORT

817 Bedford Avenue

Brooklyn, New York 11205

Partner Project No. 21-338967.1

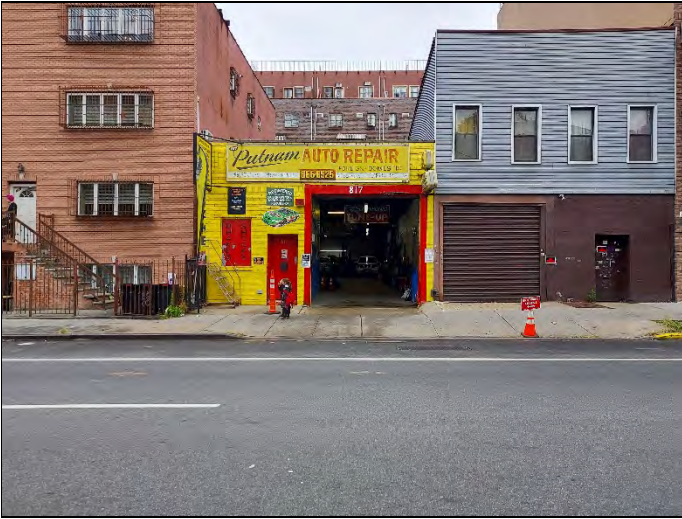
1. West view of the subject property

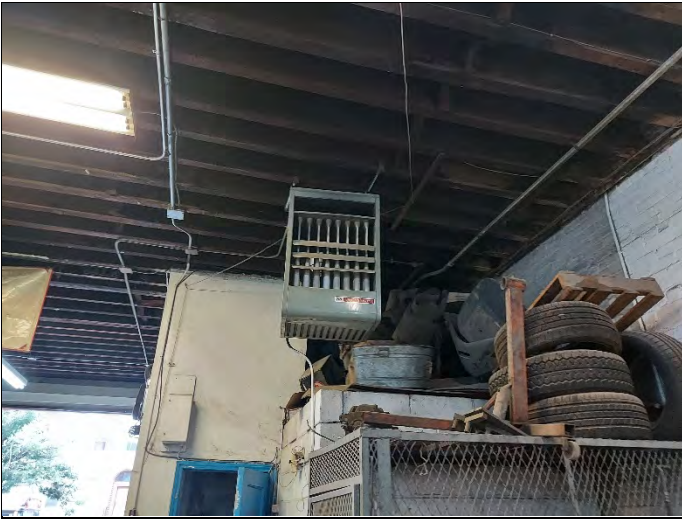
7. Ceiling-hung natural gas-fired blower

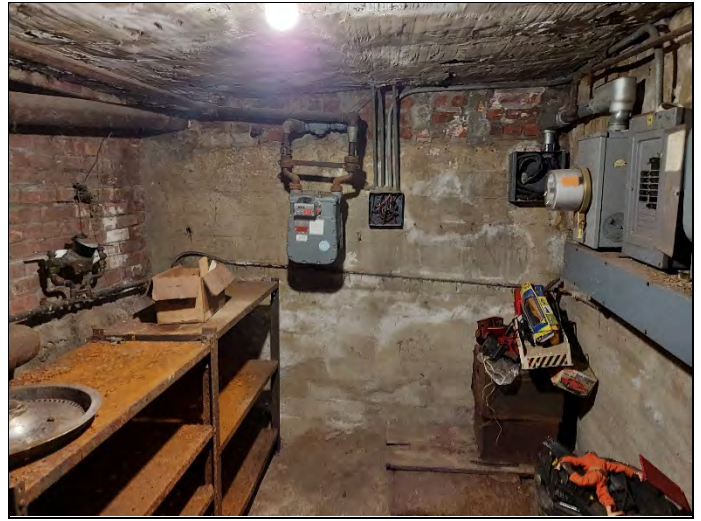
8. General view of partial basement

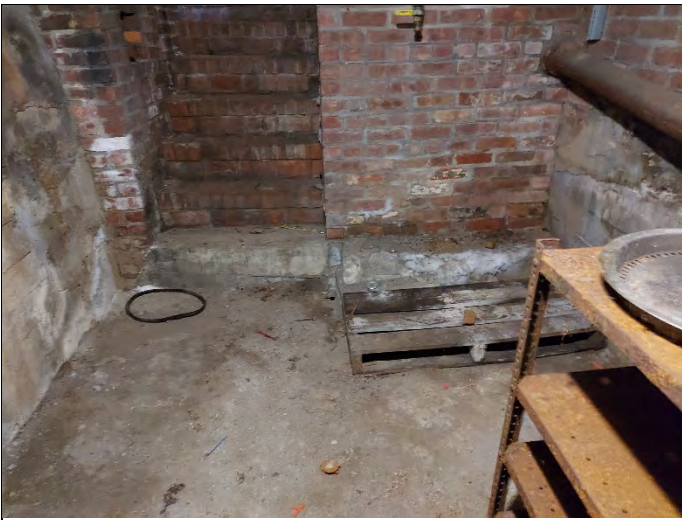
9. Additional view of partial basement

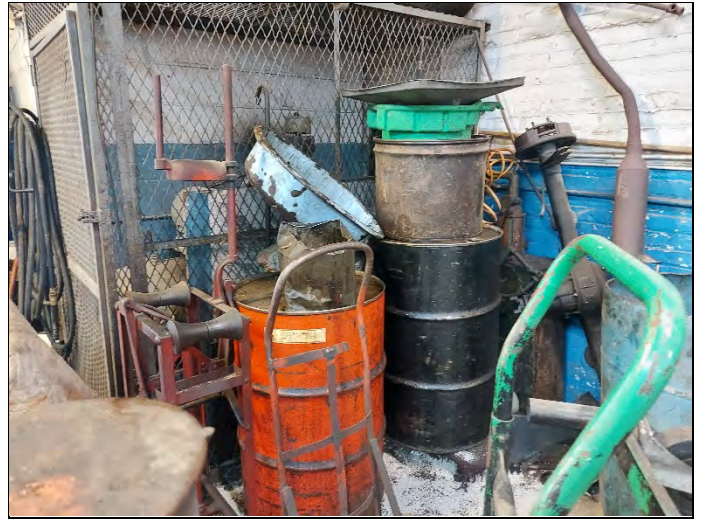
14. General waste storage area

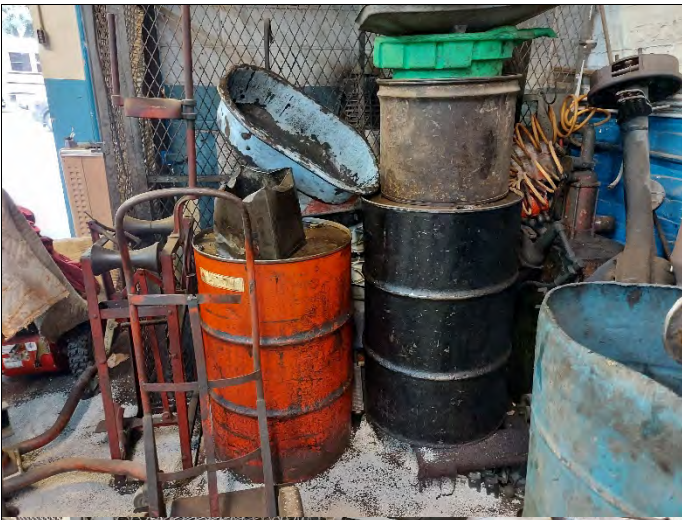
15. 55-gallon drums of waste oil

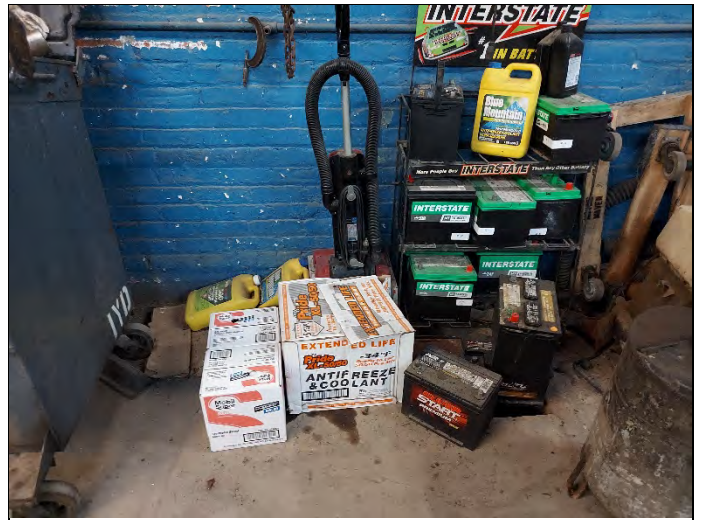
16. New and spent batteries, antifreeze and coolant

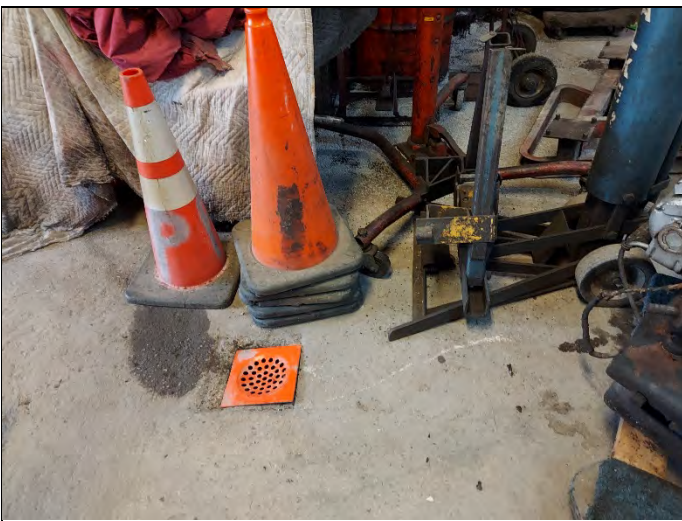
- Based on the historical information review, the subject property has been occupied by automotive repair businesses since as early as 1987 to Present. During the site reconnaissance, Partner observed a floor drain in the northwest portion of the subject building. The floor drain appears to have been installed during the original construction of the building and is connected directly to the municipal sanitary sewer system. Drainage systems have potential to impact the subsurface of the subject property should the system become compromised. Based on the years of automotive repair operations for at least 34 years, and the floor drain/drainage system observed in an area where operations appeared to occur, the subsurface drainage system is considered a *recognized environmental condition*.

17. Floor drain in the northwest portion of the building
