DAILY FIELD REPORT

Project	817-819 Bedford Avenue Development	Report No.	001
NYSDEC Site ID	C224399	Date	Monday, 09/09/2024
Location	819 Bedford Avenue, Brooklyn, New York	File No.	0207044
Client	819 Mazel Mit Brucha LLC	Temperature	65°F
Contractor	Coastal Environmental Solutions, Inc.	Wind Direction	7mph East
	(driller) and Radar Dynamics NJ		
	(geophysical investigation)		
Weather	Sunny	Personnel on Site	O. Hennigan
Humidity	55%	Time on Site	6:50am – 4:00pm

Scope of Work: H&A of New York Engineering and Geology, LLP (Haley & Aldrich of New York) performed Remedial Investigation (RI) activities as per Remedial Investigation Work Plan (RIWP) approved on 26 July 2024.

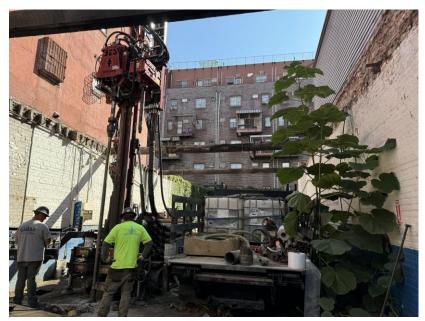
Photo 1: View of contractor installing soil boring SB-06 using a sonic drill rig, facing east.

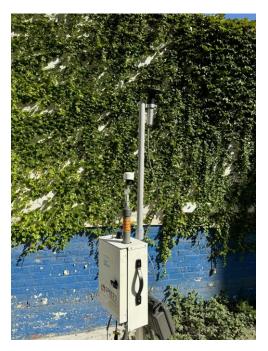
Photo 2: View of downwind CAMP station, facing north.
