DAILY FIELD REPORT

Project	817-819 Bedford Avenue Development	Report No.	002	
NYSDEC Site ID	C224399	Date	Tuesday, 09/10/2024	
Location	819 Bedford Avenue, Brooklyn, New York	File No.	0207044	
Client	819 Mazel Mit Brucha LLC	Temperature	63°F	
Contractor	Coastal Environmental Solutions, Inc. (driller)	Wind Direction	5mph West	
Weather	Sunny	Personnel on Site	O. Hennigan	
Humidity	65%	Time on Site	7:05am – 3:45pm

Scope of Work: H&A of New York Engineering and Geology, LLP (Haley & Aldrich of New York) performed Remedial Investigation (RI) activities as per the Remedial Investigation Work Plan (RIWP) approved on 26 July 2024.

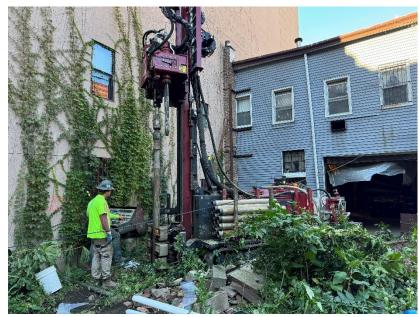
Photo 1: View of contractor installing monitoring well MW-05 using a sonic drill rig, facing southwest.

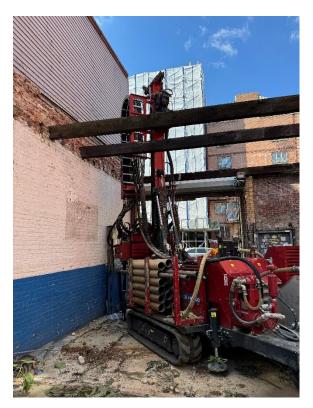
Photo 2: View of contractor installing soil vapor point SV-04 using a sonic drill rig, facing west.
