DAILY FIELD REPORT

| Project | 817-819 Bedford Avenue Development | Report No. | 003 |
| Location | 819 Bedford Avenue, Brooklyn, New York | File No. | 0207044 |

Scope of Work: H&A of New York Engineering and Geology, LLP (Haley & Aldrich of New York) performed Remedial Investigation (RI) activities as per the Remedial Investigation Work Plan (RIWP) approved on 26 July 2024.

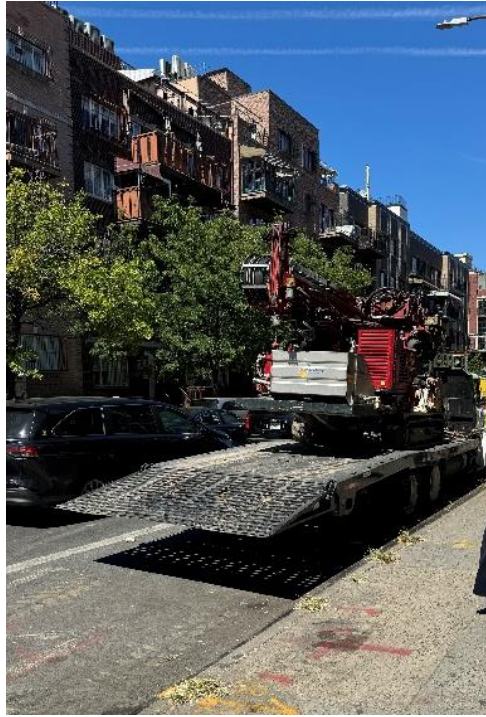
Photo 1: View of Coastal loading sonic drill rig off-Site, facing north.

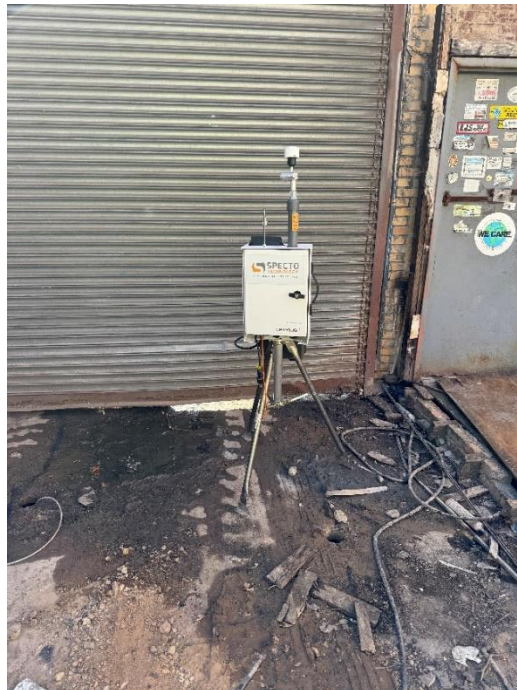
Photo 2: View of upwind CAMP station, facing west.
