Project	817-819 Bedford Avenue Development	Report No.	005
NYSDEC Site ID	C224399	Date	Friday, 09/13/2024
Location	819 Bedford Avenue, Brooklyn, New York	File No.	0207044
Client	819 Mazel Mit Brucha LLC	Temperature	61°F
Contractor	Coastal Environmental Solutions, Inc. (driller)	Wind Direction	3mph East
Weather	Sunny	Personnel on Site	O. Hennigan
Humidity	65%	Time on Site	7:00am – 2:30pm

Scope of Work: H&A of New York Engineering and Geology, LLP (Haley & Aldrich of New York) performed Remedial Investigation (RI) activities as per the Remedial Investigation Work Plan (RIWP) approved on 26 July 2024.

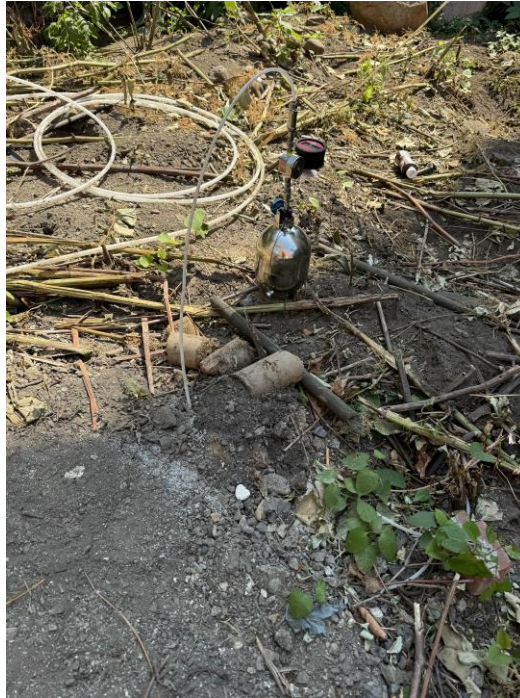
Photo 1: View of soil vapor sample collection.

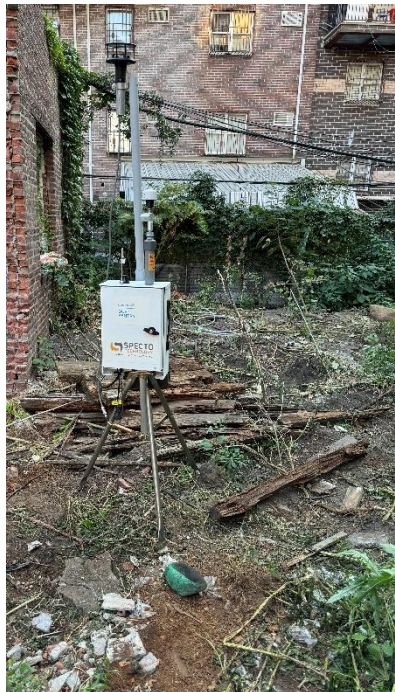
Photo 2: View of downwind CAMP station, facing east.
