MONTHLY FIELD REPORT  
 Prepared By Michel Tetley

<b>BCP Site No.:</b>	C224405	<b>Date:</b>	04/30/2026
<b>Project Name</b>	749 Van Sinderen Avenue		
<b>Address:</b>	719-749 Van Sinderen Avenue, Kings County, Brooklyn New York 11207		
<b>DEC Project Manager:</b>	Brittany Taranto	<b>DOH Project Manager:</b>	Sarita Wagh

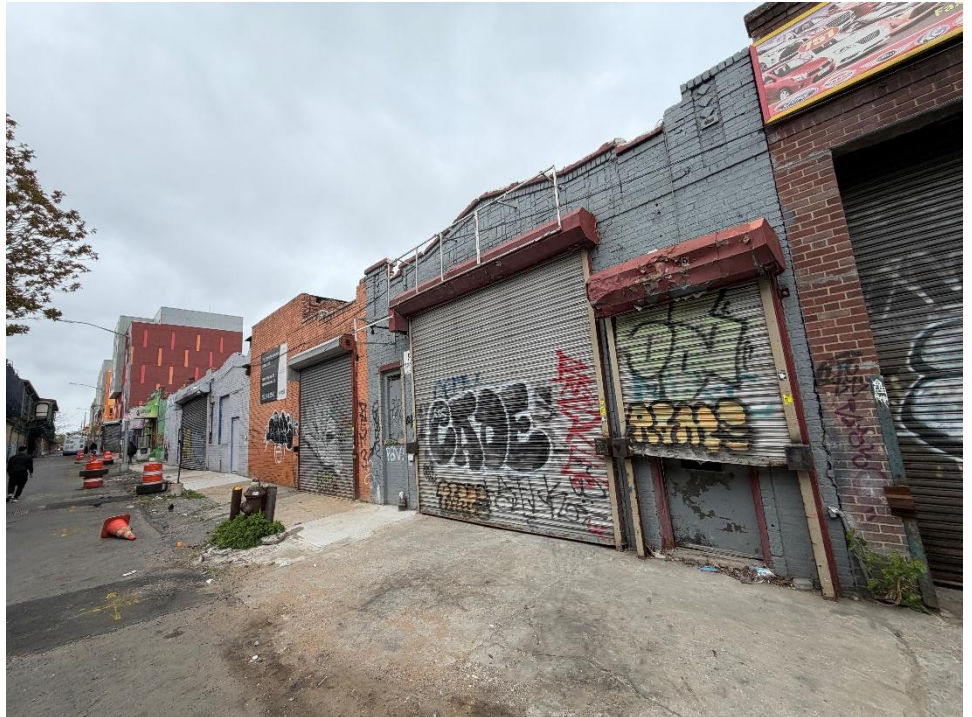
Photo 1 – View of BCP Site and Van Sinderen Avenue of existing structures in late April 2026.

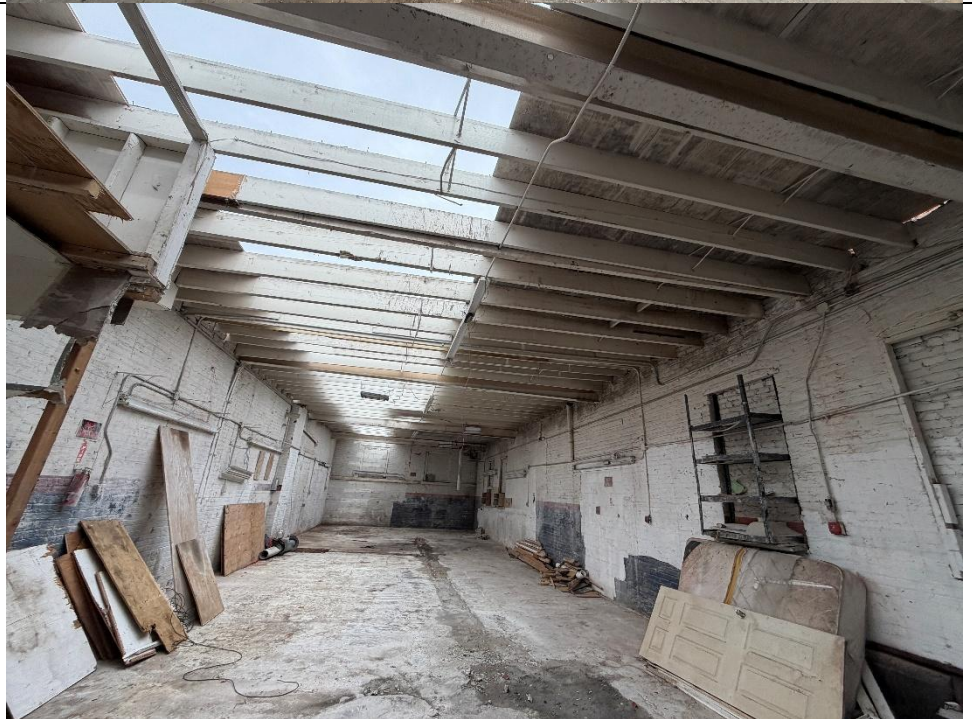
Photo 2- Commencement of demolition activities on site starting with roofing components.

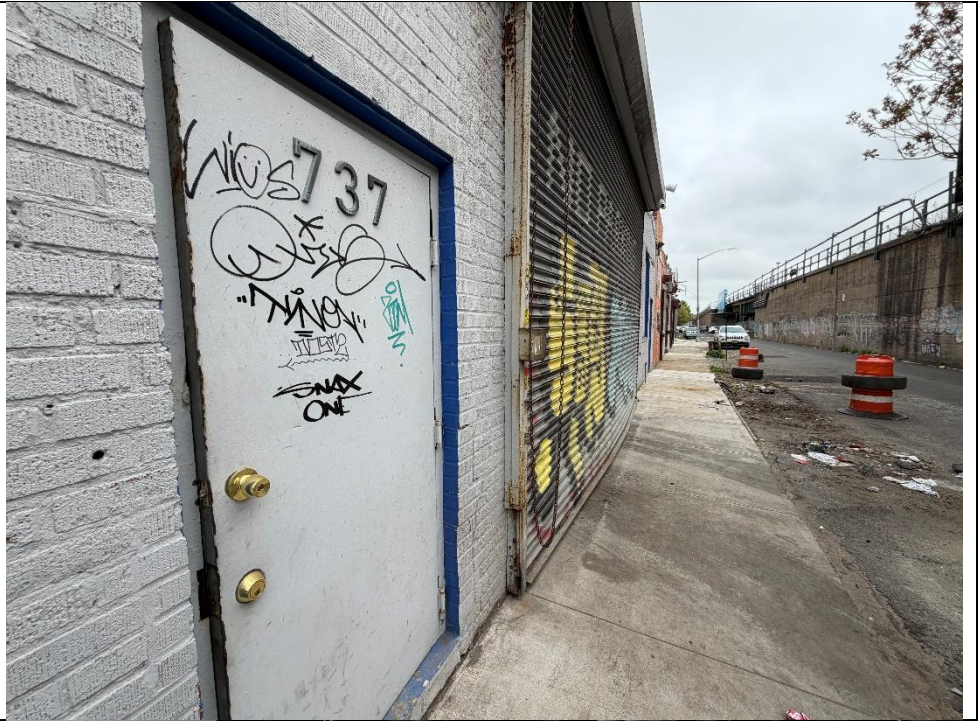
Photo 3- Entrance to BCP site.

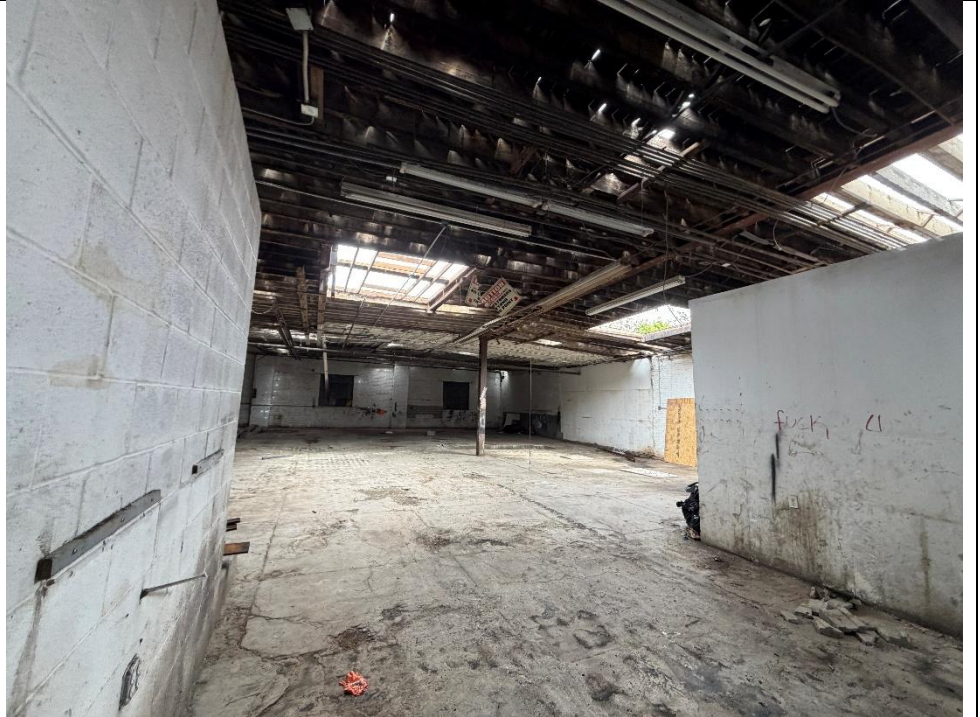
Photo 4- Asbestos removal and roofing status.

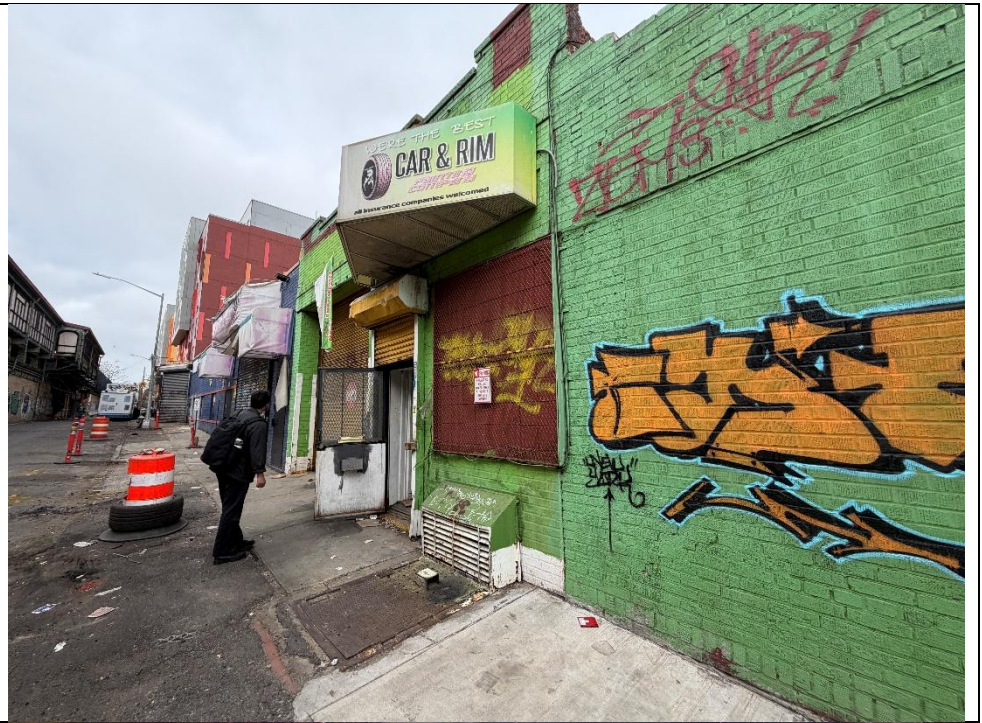
Photo 5- Entrance to BCP site.

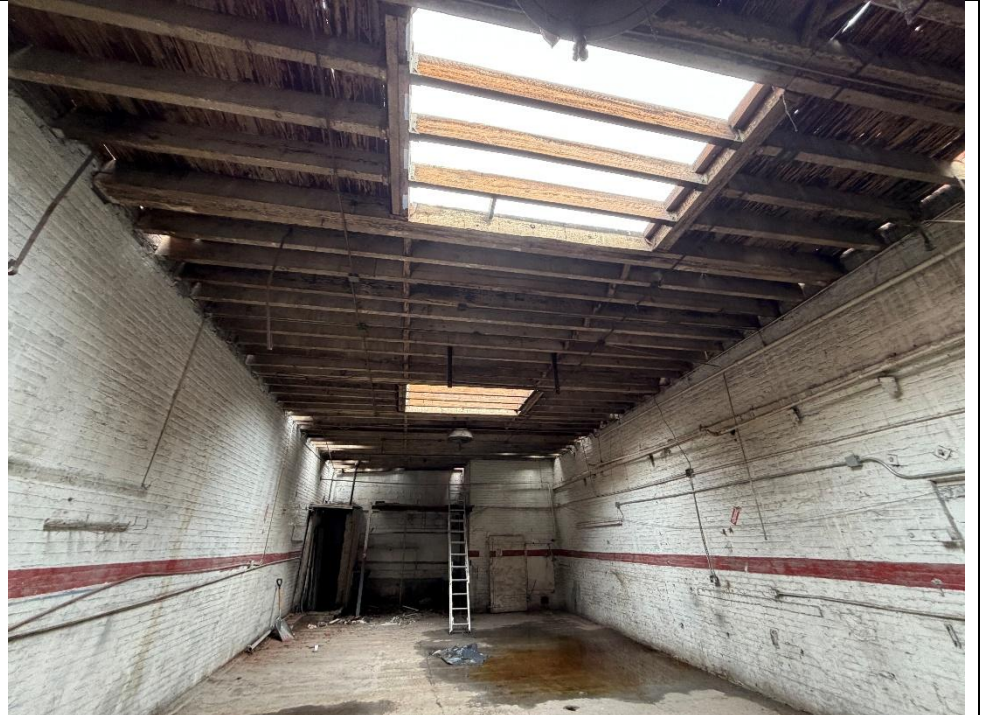
Photo 6- Commencement of demolition activities on site starting with roofing components.
