Monthly FIELD REPORT  
 Prepared By Erik Draijer

| <b>BCP Site No.:</b> | C224405 | <b>Date:</b> | June 2026 |
| <b>Project Name</b> | 749 Van Sinderen Avenue | | |
| <b>Address:</b> | 719-749 Van Sinderen Avenue, Kings County, Brooklyn New York 11207 | | |

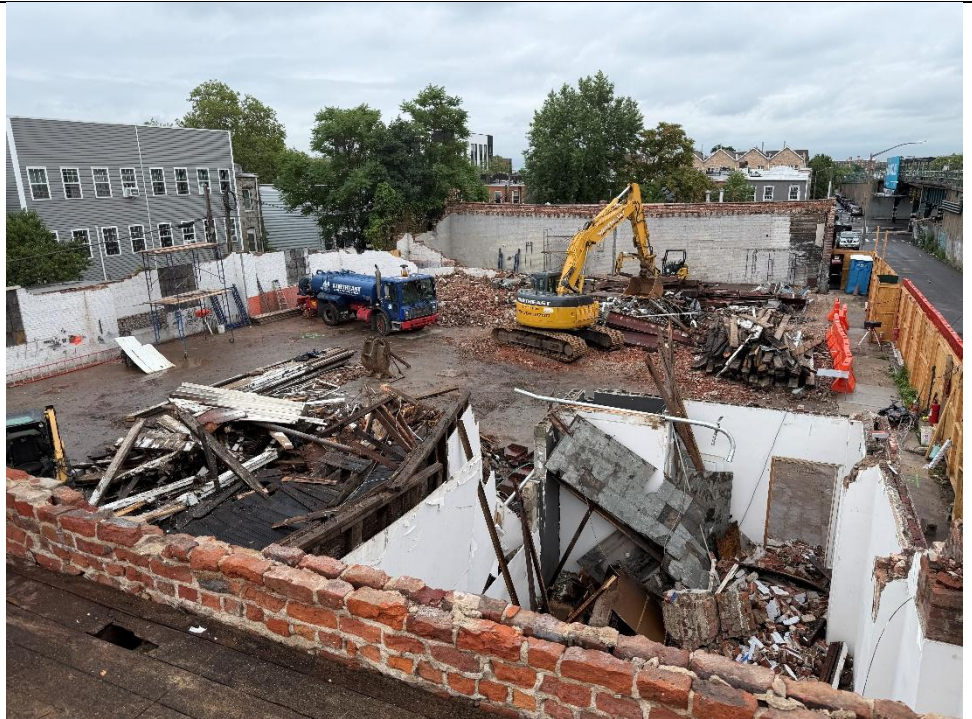
Photo 1 – View of BCP Site and Van Sinderen from roof top of site displaying demolition activities and stockpiled C & D at 751 Van Sinderen Ave.

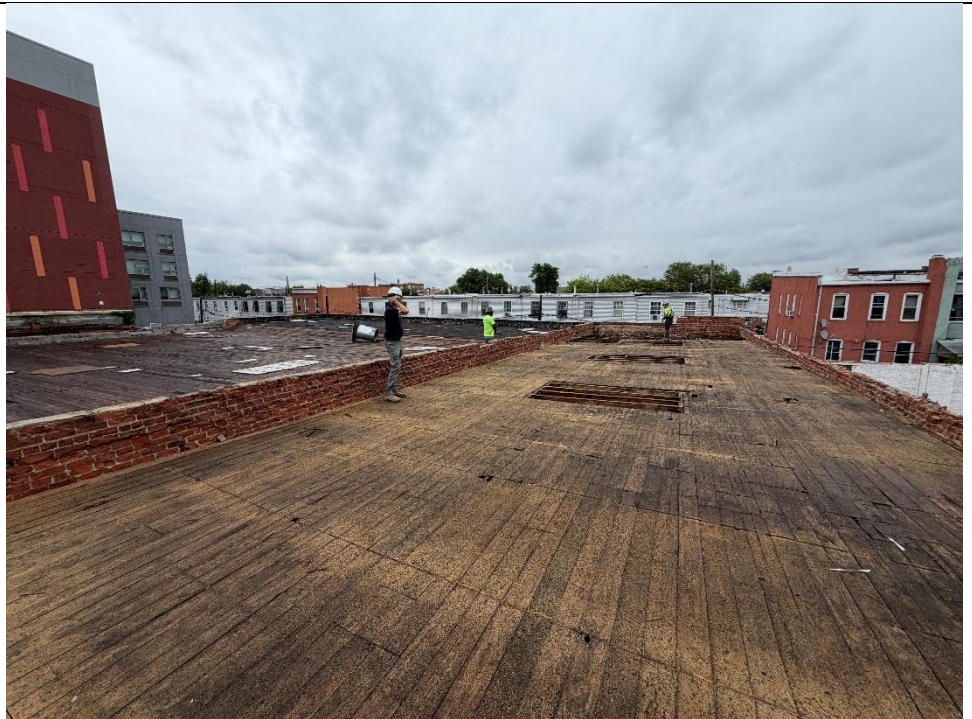
Photo 2 – View of BCP Site roofing demolition still in progress.

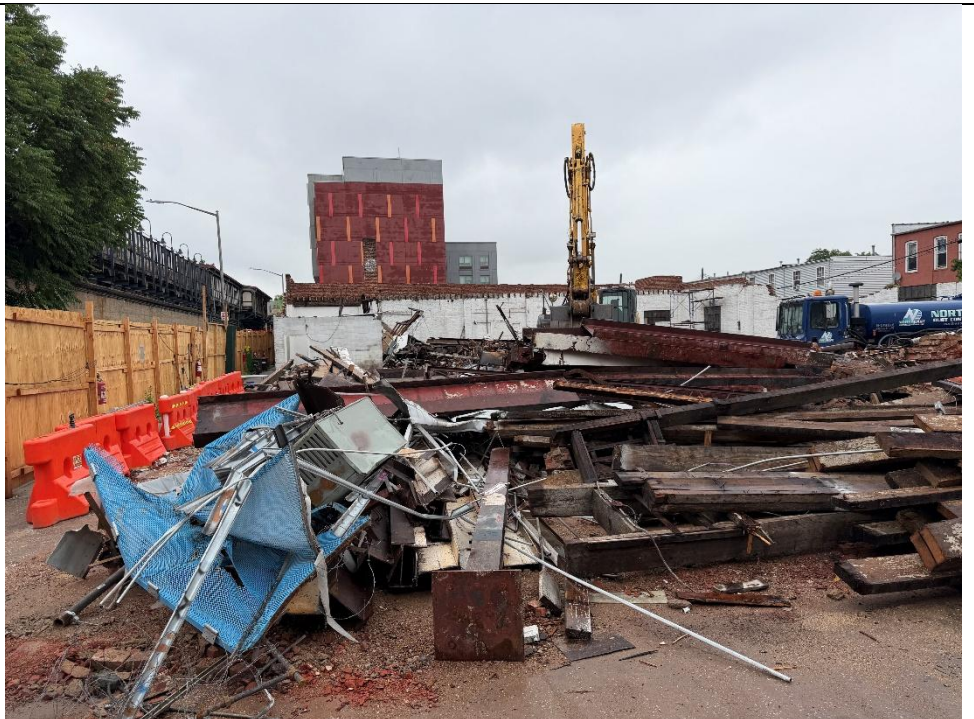
Photo 3 – View of BCP Site displaying stockpile of C & D on site post demolition activities.

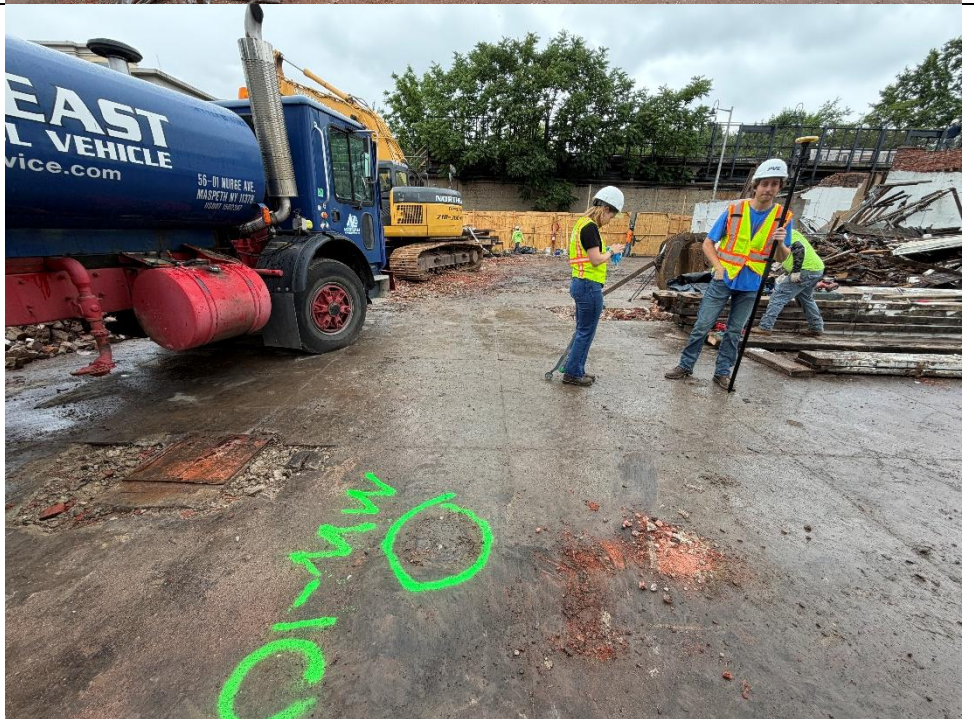
Photo 4 – View of BCP Site displaying location of MW10 on site post demolition.

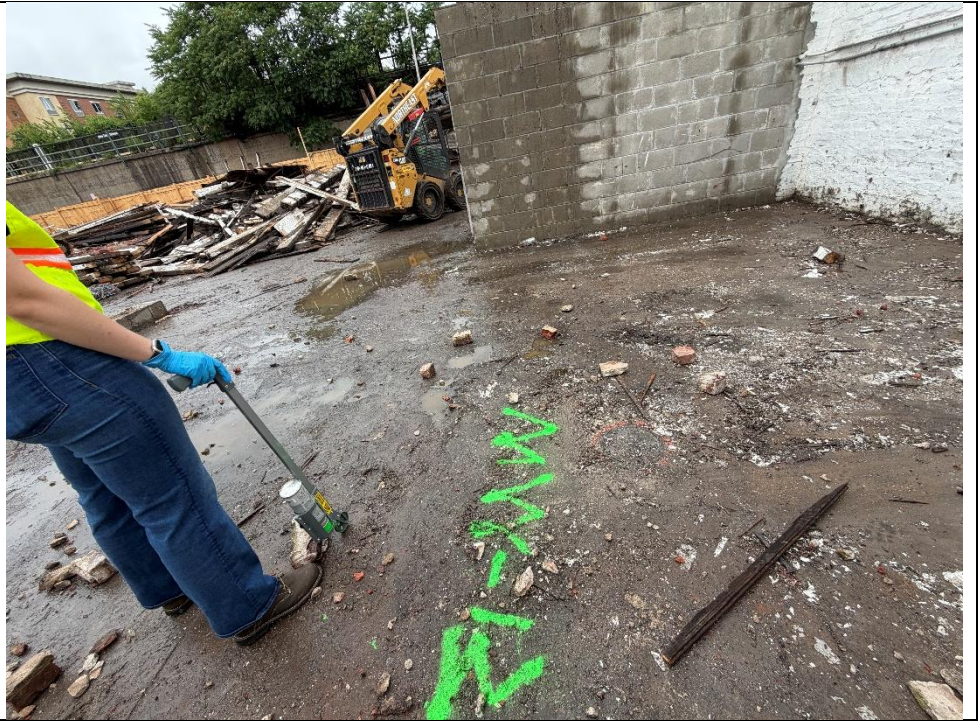
Photo 5 – View of BCP Site displaying location of MW13 on site post demolition.
