**Re: Cooper Tank & Welding – Sensitive Receptor Survey**  
**215 Moore Street**  
**Brooklyn, NY**  
**NYSDEC Spill No. 03-12904**

**Re: Cooper Tank & Welding  
215 Moore Street  
Brooklyn, NY  
NYSDEC Spill No. 03-12904**

This letter summarizes the results of a Sensitive Receptor Survey conducted to quantify the risks associated with a release from an underground storage tank (UST) reported to the NYSDEC in 2003. A site location map is included as **Figure 1** and a site diagram is included as **Figure 1A**.

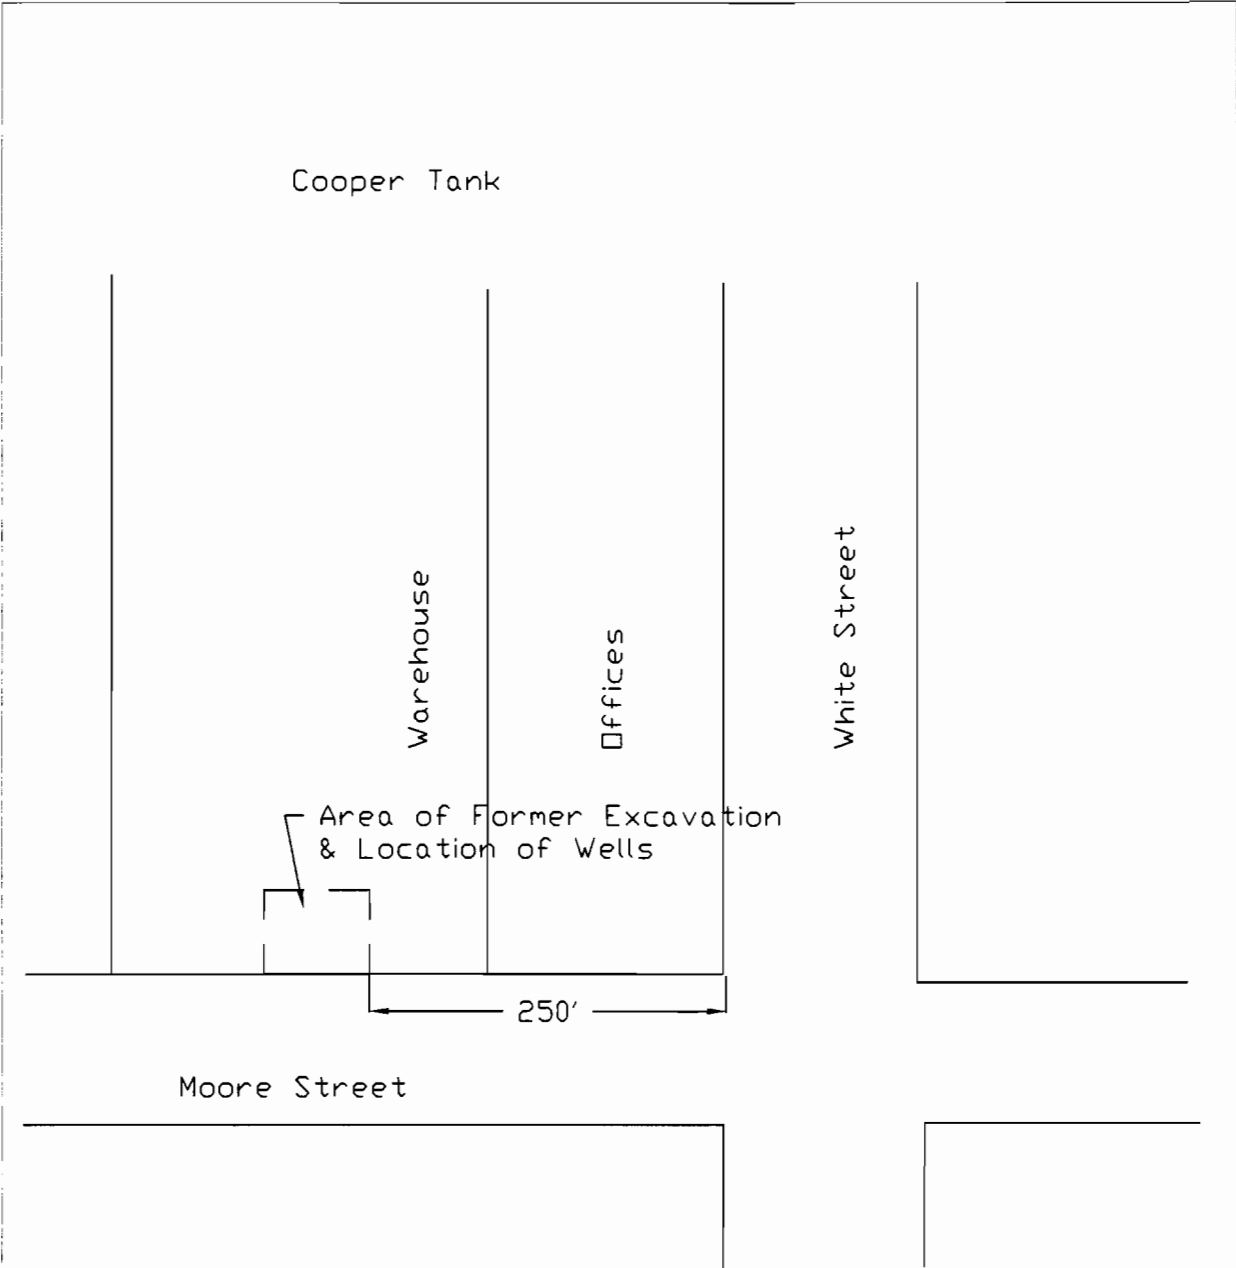
10 Waldron Avenue Nyack, NY 10960	
215 Moore Street Brooklyn, NY			
Installation Date:		RND Project No:	
Scale: NA		Drawing No: Figure 1A

The architectural survey identified electrical conduit, natural gas mains, sewer systems, and water mains which run parallel with Moore Street. The only underground utility connection to the Property shown on the survey is the electrical conduit connecting approximately 30 feet east (toward White Street) of the original tank location. A copy of the architectural survey is included as **Attachment 2**.

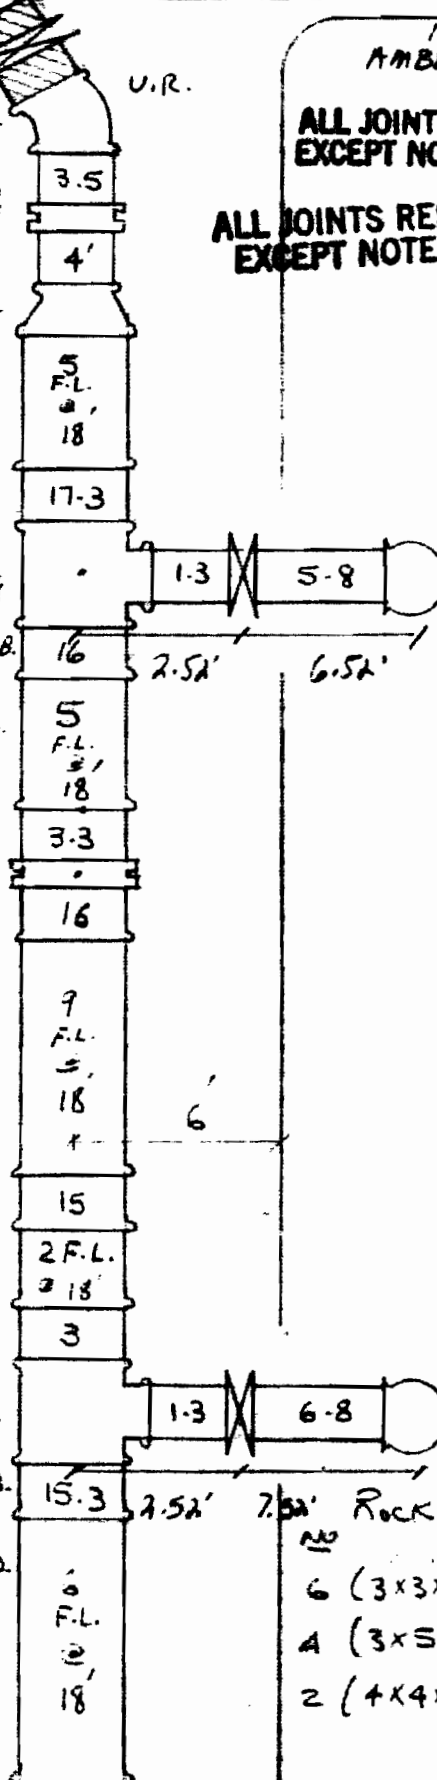
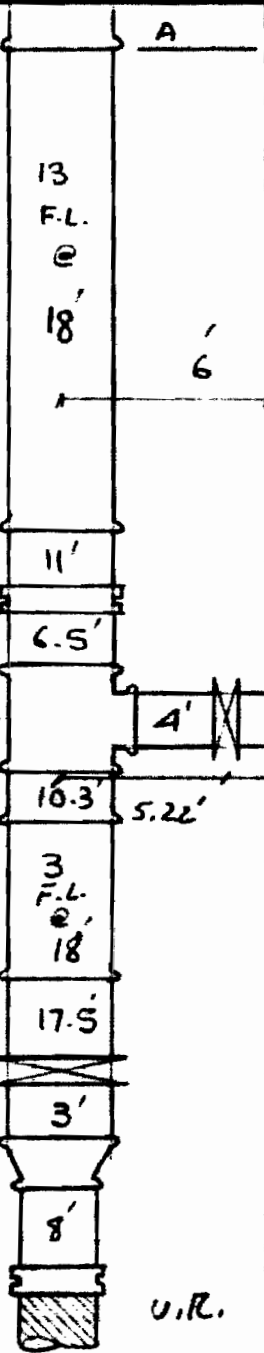
MOORE ST. BET. BUSHWICK AVE AND  
WHITE ST., NEW 12" MAIN - BED 730

On April 16, 2008 a FOIL request was sent to the NYCDEP Bureau of Water and Sewer Operations (BWSO) to determine the size, depth and locations of municipal sewer and water main lines. A copy of the NYCDEP Water Main Distribution Map is located in **Attachment 3**. One (1) 12-inch water main runs under Moore Street, parallel to the Cooper Tank building 6 feet from the curb. The curb is 15' wide, therefore the water main line is located approximately 21 feet from the southern extent of the excavation. According to the Water Main Distribution Map the water main is connected to three fire hydrant breakaways. Since no other water lines are indicated on the Water Main Distribution Map, it is assumed that this water line also supplies the warehouse with potable water. Depth of the water main could not be determined, however, New York City mains are typically buried at a depth of 3 to 4 feet below grade.

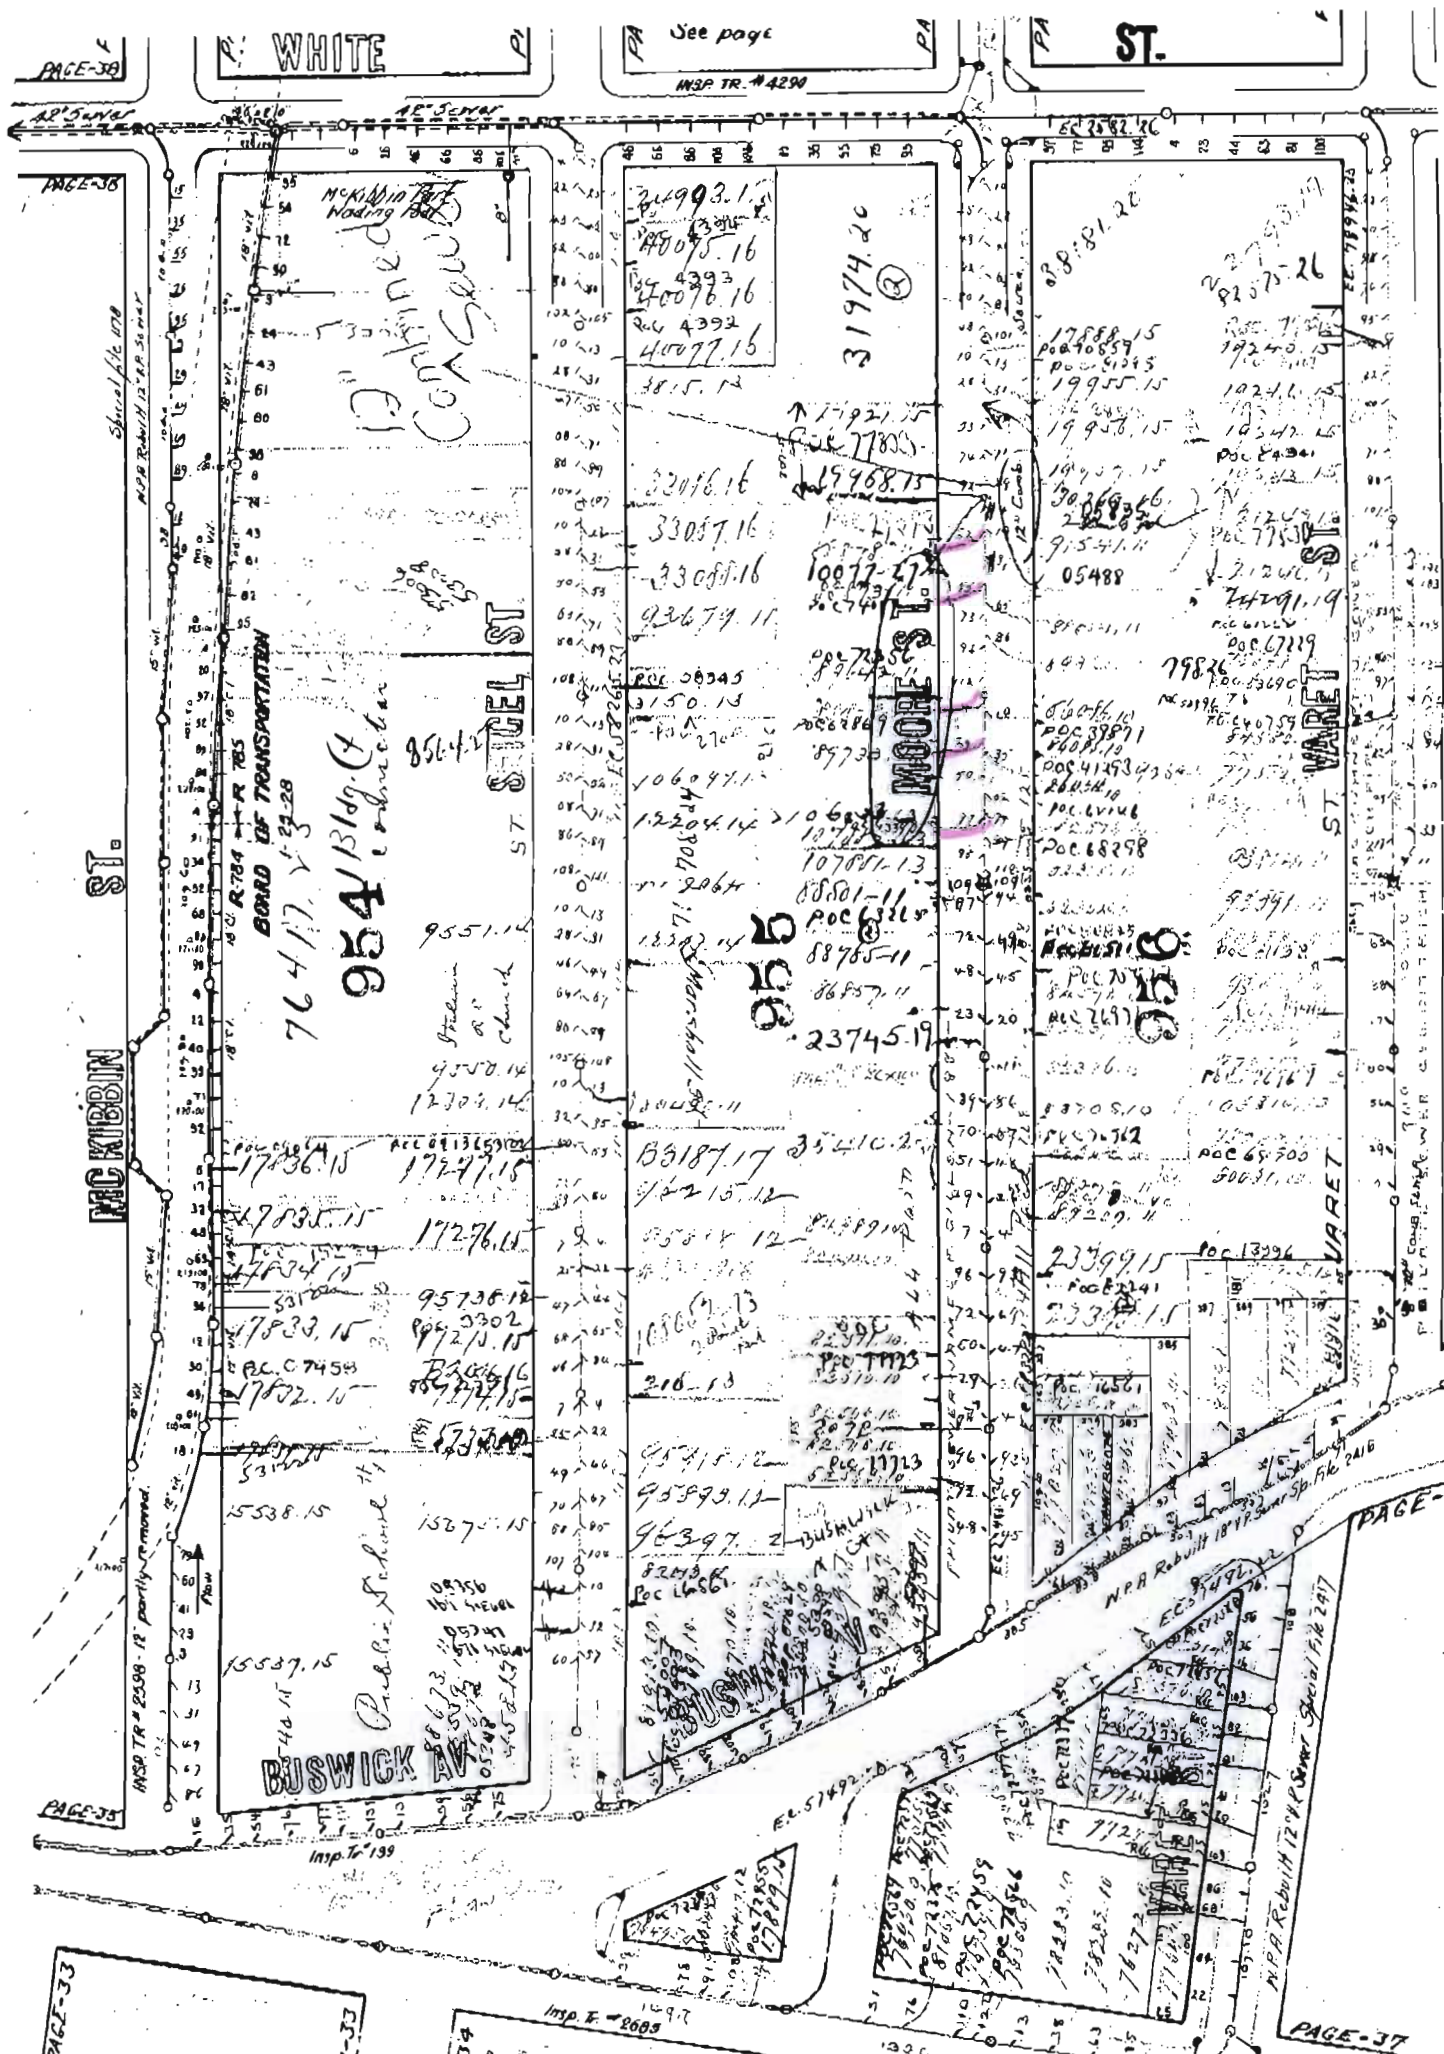
**ATTACHMENT 4  
NYCDEP SEWER MAP**

On April 14, 2008 a request was sent to the NYCDEP Sewer Department to determine the location of sewer lines near the target area. A copy of the NYCDEP sewer map is included as **Attachment 4**. According to the NYCDEP sewer map, one (1) 12 inch combined sewer pipe runs parallel to the Cooper Tank warehouse in the middle of Moore Street approximately. It appears that five (5) sewer lines from the Cooper tank warehouse connect to the sewer main at various points, but due to the complexity of the map, the exact position in reference to the excavation could not be determined. The five (5) lines from Cooper Tank connect to the sewer main that flows towards White Street with an ultimate end point to a New York City Wastewater Treatment Plant. Depth of the sewer main could not be determined.
